**EMERGENCY TRANSPORTATION INFRASTRUCTURE RECOVERY**  
**WATER BASIN ASSESSMENT**  
**AND FLOOD HAZARD MITIGATION ALTERNATIVES**

**MUD CREEK**  
**ONEIDA COUNTY, NEW YORK**

April 2014

MMI #5231-01

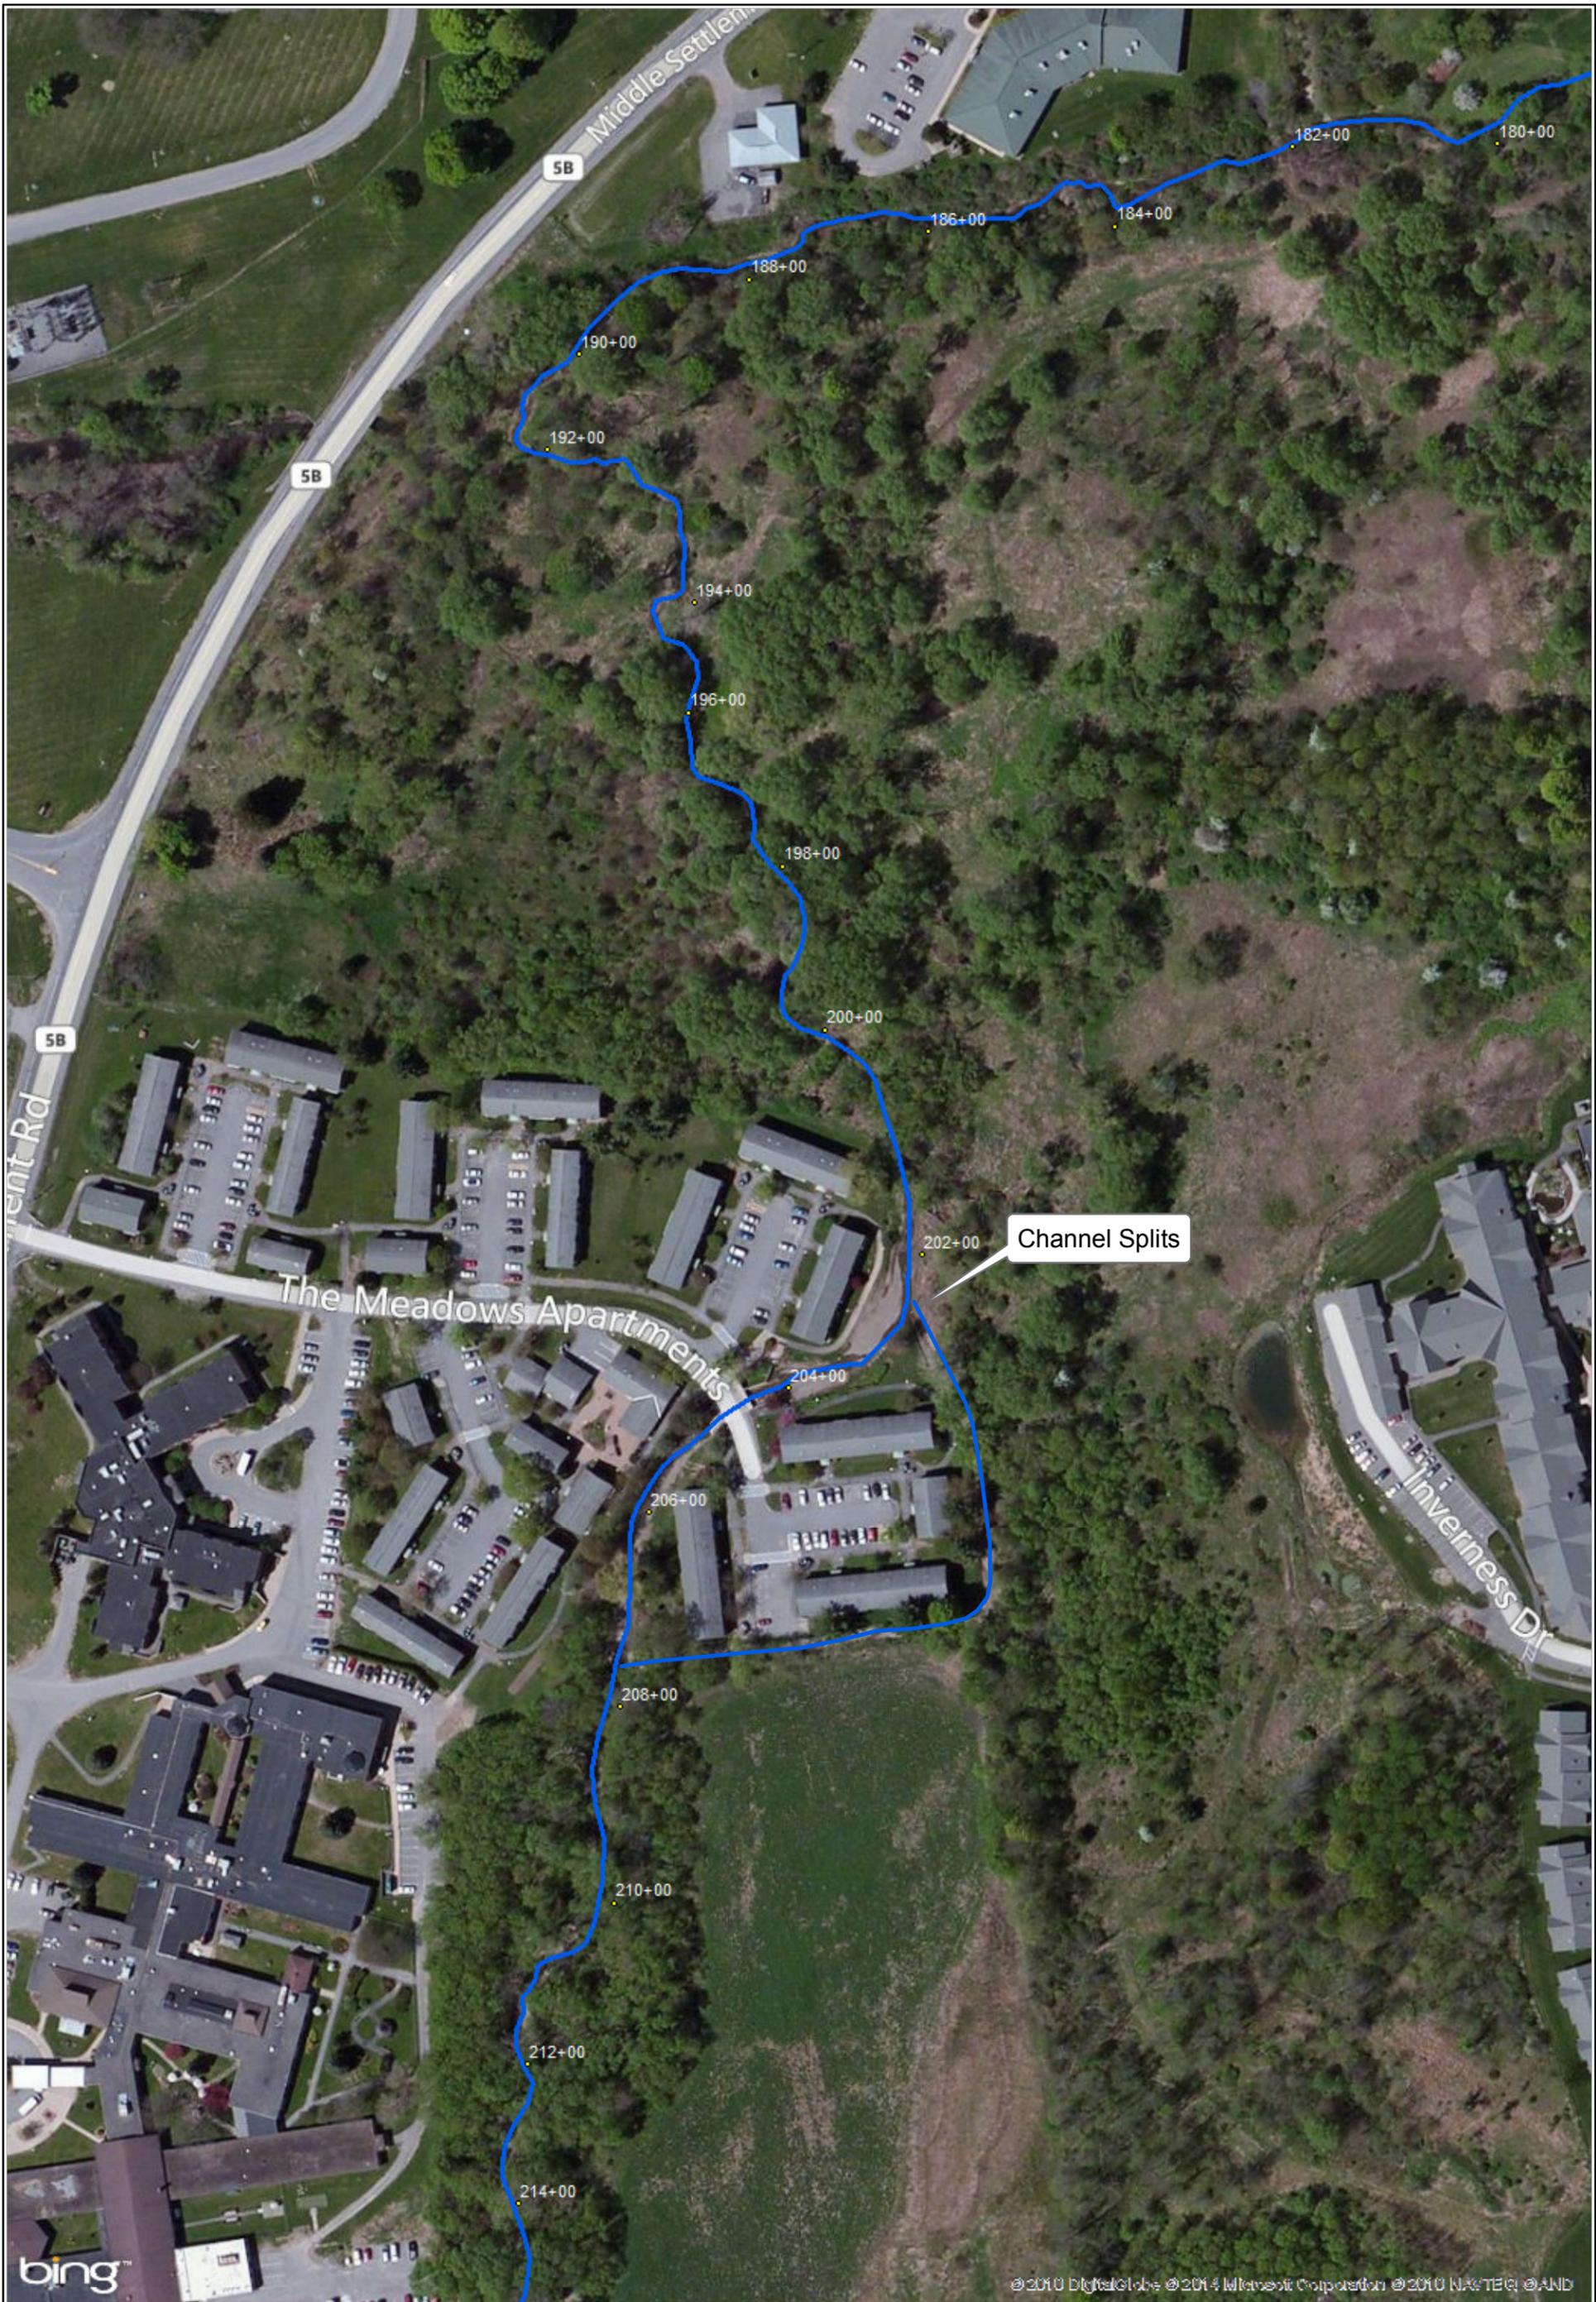
**Figure 6: Mud Creek High Risk Area #1**

A flow diversion has been created at the upstream end of the four eastern apartment buildings near STA 207+90 for the purpose of diverting water around the south and east of the four eastern buildings. However, this causes floodwaters to flow around all sides of the buildings, creating an island during flooding conditions. Reports from community representatives indicate that this diversion was not successful in mitigating flooding during the June 2013 event and created an unsafe situation where floodwaters were directed on all sides of the residential structures, stranding residents.

Alternative 1-3 would provide the most permanent, long-term solution and would have less impact to residents. However, the feasibility of this alternative will depend upon the ability to gain an easement over the agricultural land and the cost of the project. The cost of stream relocation should be compared against the cost of acquisition of the buildings (Alternative 1-1). An acquisition would also depend upon the willingness of the owner to sell.

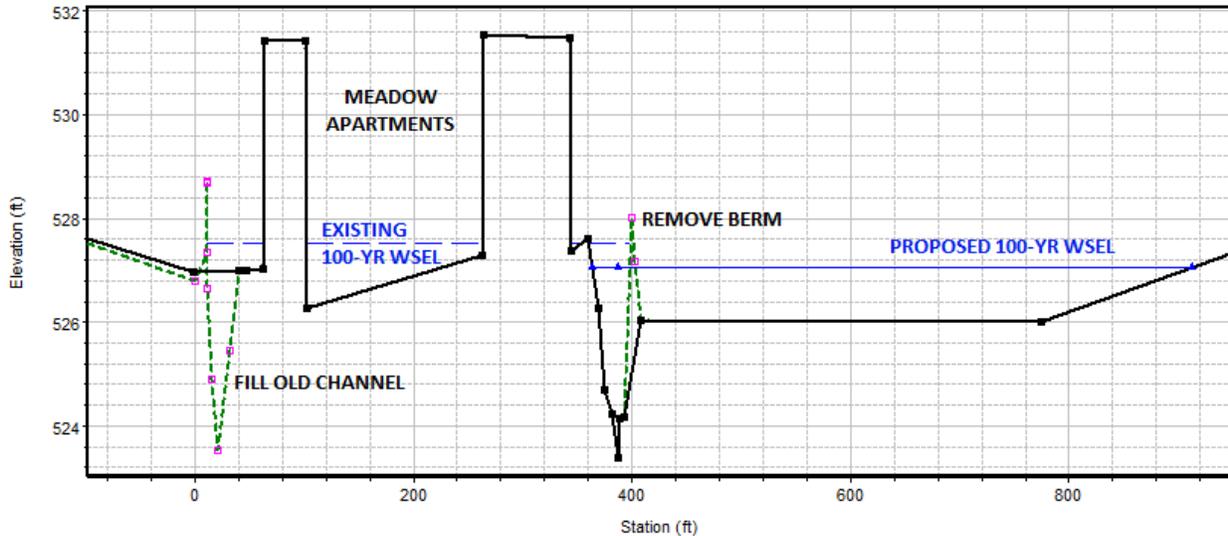
**FIGURE 7**  
**Hydraulic Modeling Output – Cross Section Through Meadows Apartments**

Figure 7 presents a cross section through the apartments, showing flooding during a 100-year event under current conditions, as well as the anticipated reduction in flooding after relocation of Mud Creek. Filling of the old channel would discourage floodwaters from entering the complex, and relocating the channel around the apartments would allow it to access a floodplain. A more detailed analysis and site grading plan would have to be developed to ensure the proper design of the flood mitigation measures.

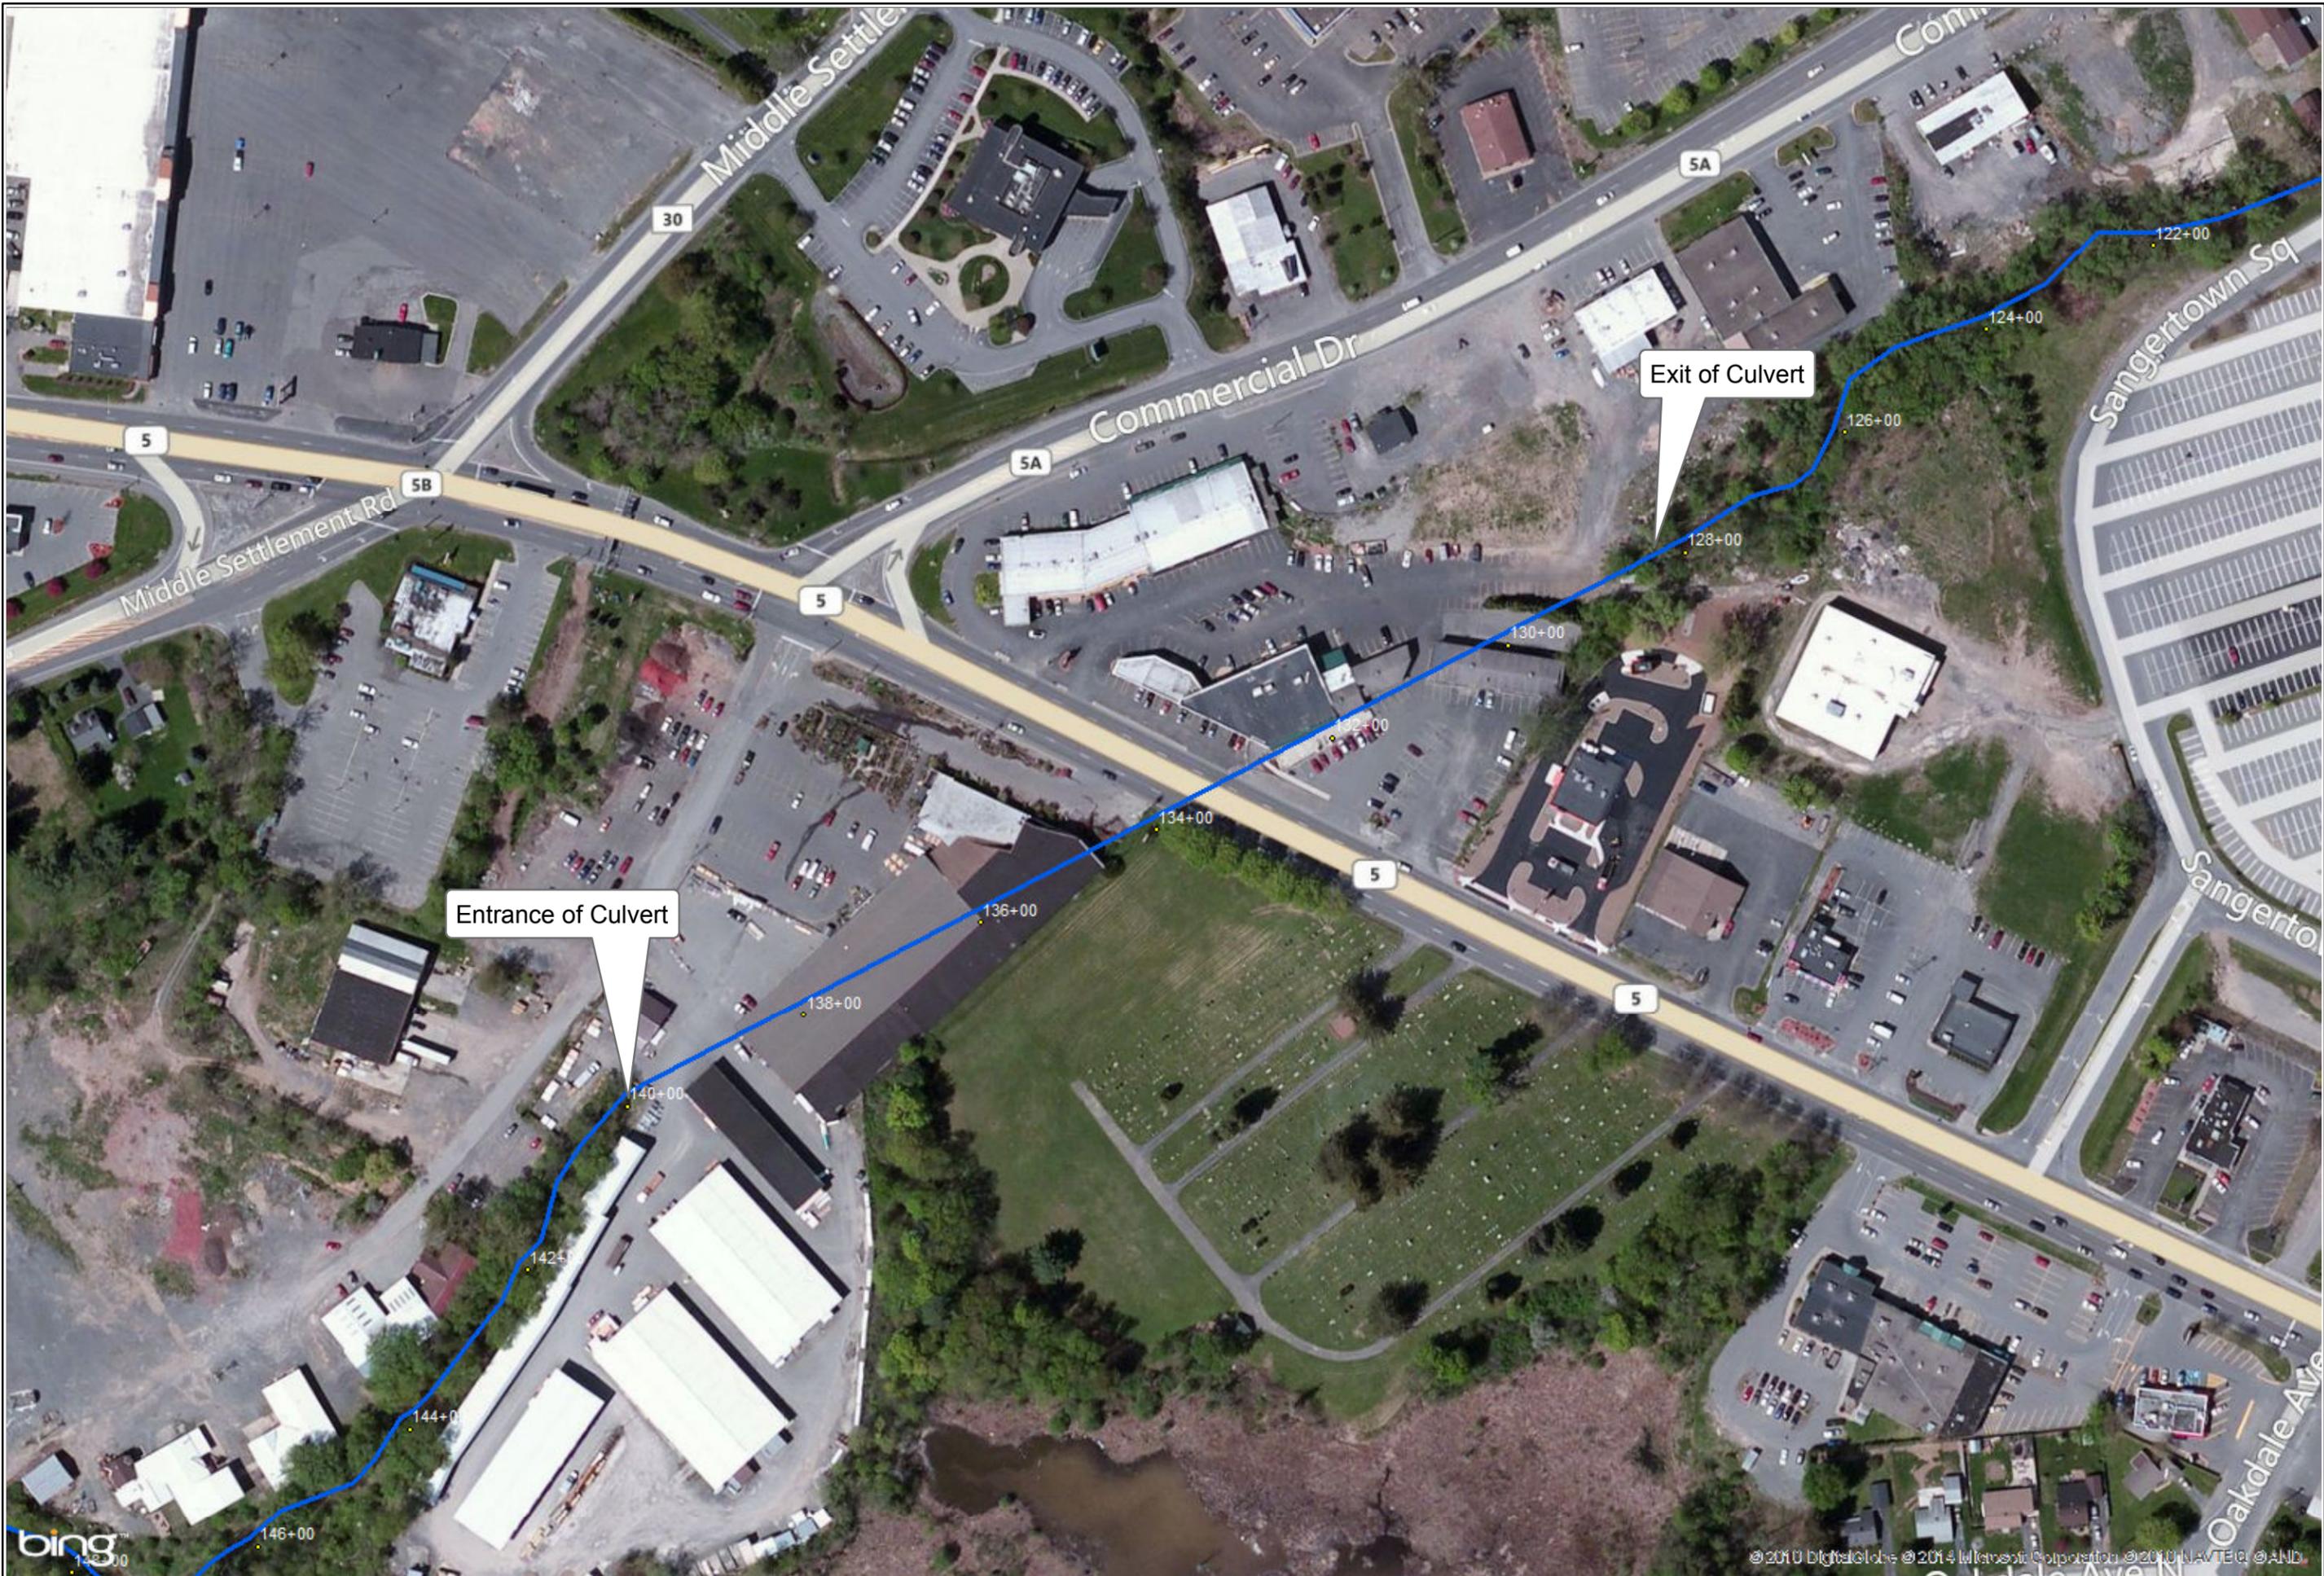
Figure 8 is a location plan of High Risk Area #2 in the area of a ±1,140-foot-long culvert under Seneca Turnpike. The upstream end of the culvert is located at STA 140+10 and was measured as an eight-foot-high by 12.5-foot-wide corrugated metal arch. The interior of the culvert was not measured, and its alignment is not known. The downstream end of the culvert located at STA 128+70 is 13 feet wide by seven feet high. Hydraulic modeling of the existing culvert indicates that it is undersized to carry severe flood flows, which is consistent with the FEMA flood insurance rate mapping that indicates the lumber yard and commercial buildings located closest to the underground culvert are floodprone in a 100-year event.

Daylighting the culvert beneath Seneca Turnpike as described in Alternative 2-3 is recommended. In addition to more effectively conveying flood flows, this alternative may provide opportunity for floodplain restoration in areas where development can be reconfigured. All three alternatives will impact private properties in the floodplain, requiring acquisition of easements for the work. In all cases, addressing the culvert may not effectively mitigate flooding through portions of the Jay-K lumber yard located on the south side of Route 5. Much of this facility appears to have been constructed by filling in the floodplain and is likely subject to frequent inundation.

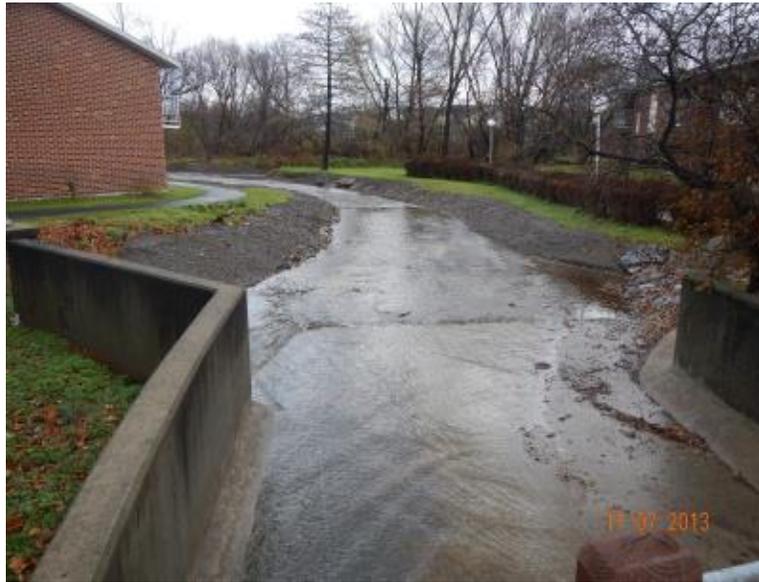
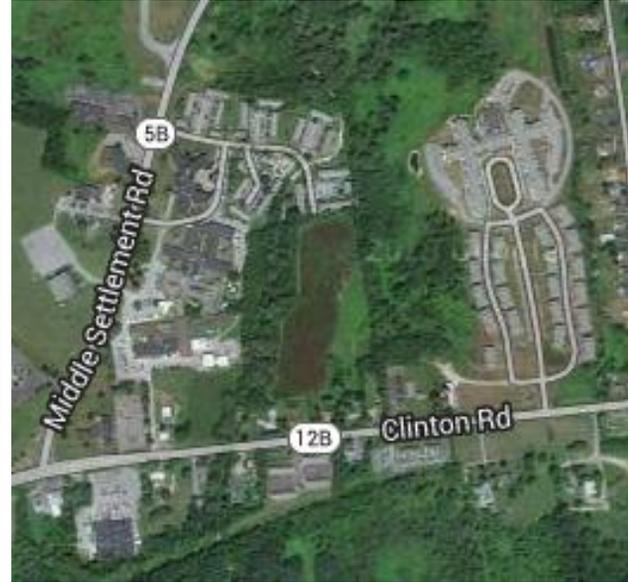
## High-Risk Area #1 – The Meadows at Middle Settlement

**Site Description:** Between STA 209+00 and STA 200+00, parts of the Middle Settlement Complex have been constructed in the floodplain of Mud Creek. A flow diversion has been created to mitigate flooding although is not successful, acting to isolate 4 buildings and strand residents during severe flooding.

- Relocate the primary channel outside of the floodprone buildings.
- Provide armoring and grade changes to encourage floodwaters to overtop into the adjacent agricultural field and natural floodplain rather than towards the apartments.

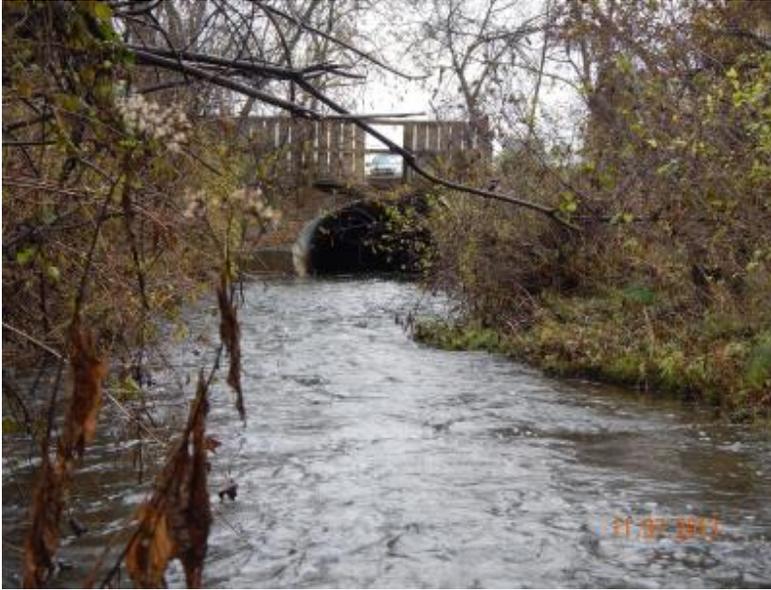
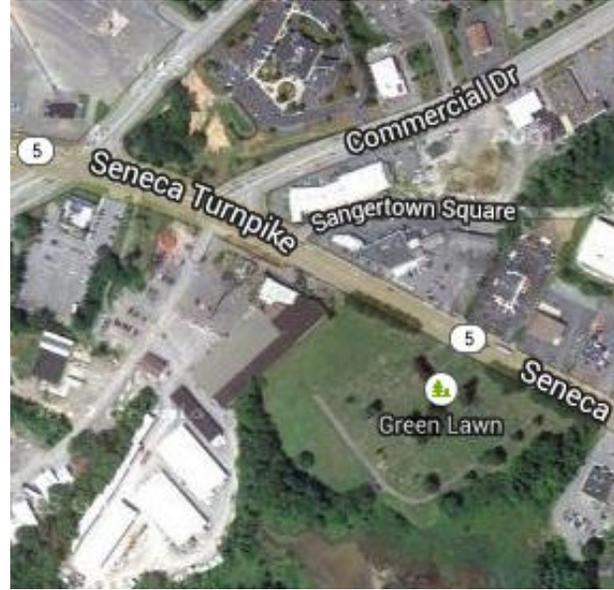
## High-Risk Area #2 – Culvert beneath Seneca Turnpike

**Site Description:** As Mud Creek flows through the heavily developed area near Commercial Drive, the creek flows beneath Route 5- Seneca Turnpike via a large culvert. The culvert is approximately 1,140 feet long overtops during flows greater than a 10-year recurrence.

- Removal of the existing culvert and construction of a new channel in its former location, with a more conventional bridge installed to carry Route 5.
- Either a natural floodplain with a width of 60 feet is recommended or a rectangular channel with concrete walls, 30 feet in width be constructed to adequately convey a minimum of 100-year flow.

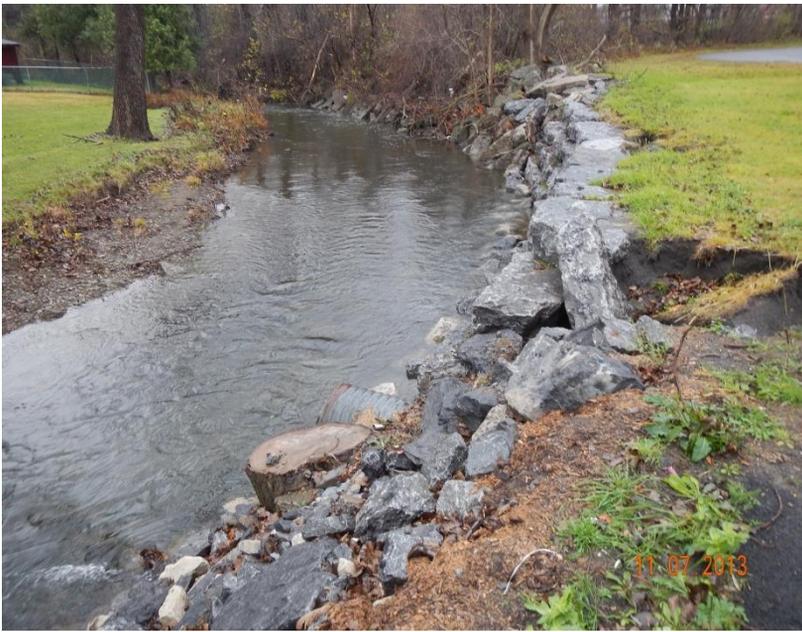
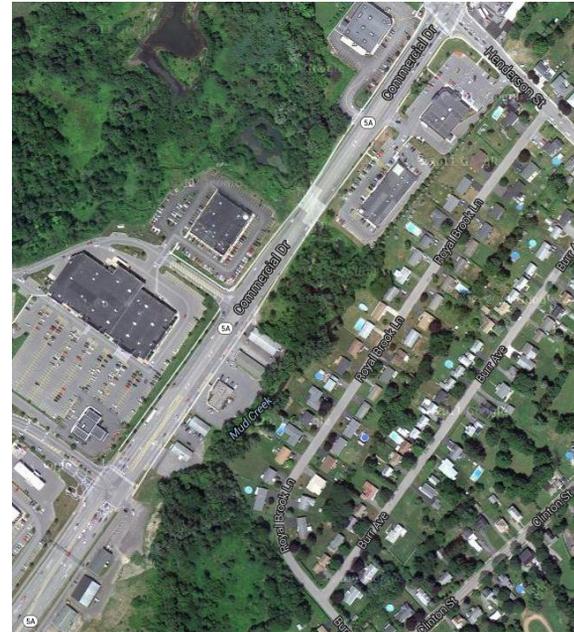
## High-Risk Area #3 – Flooding on Commercial Drive

**Site Description:** Mud Creek flows alongside Commercial Drive where fill was historically placed in the floodplain to allow for increased development, but this additional encroachment has increased velocities causing bank and channel instability through this reach. A number of stabilization measures have been put in place, with limited success.

- Floodplain development should be minimized and eliminated, where possible. Restoration of the natural floodplain should be sought through regulatory restriction of floodplain development, and the long-term procurement of floodprone properties.

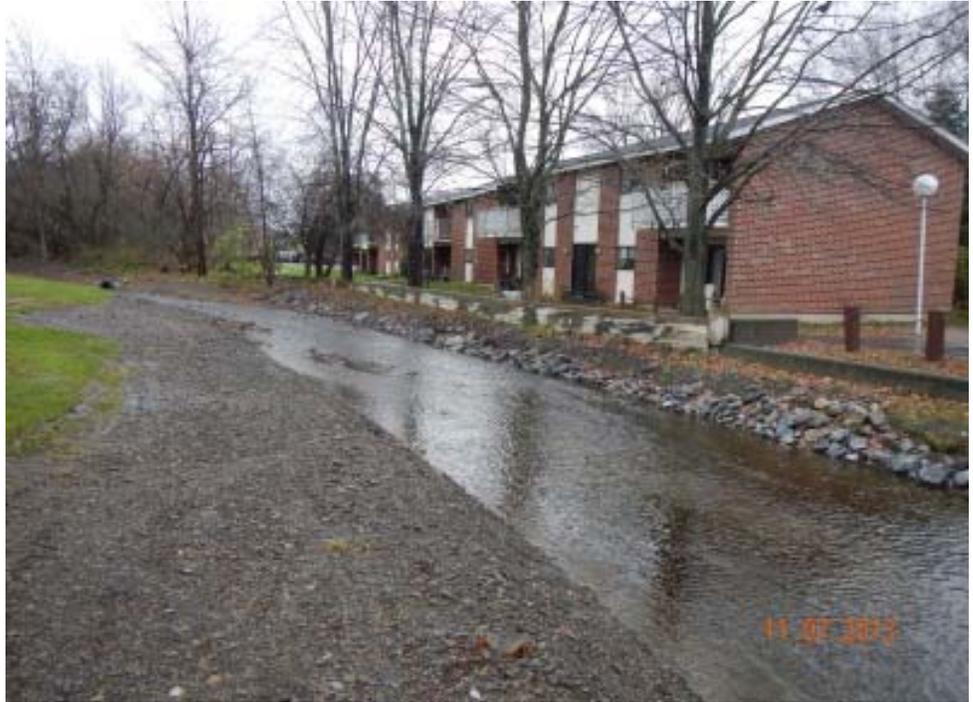
Looking upstream, here the main channel of Big Creek flows into the Middle Settlement Apartment complex.

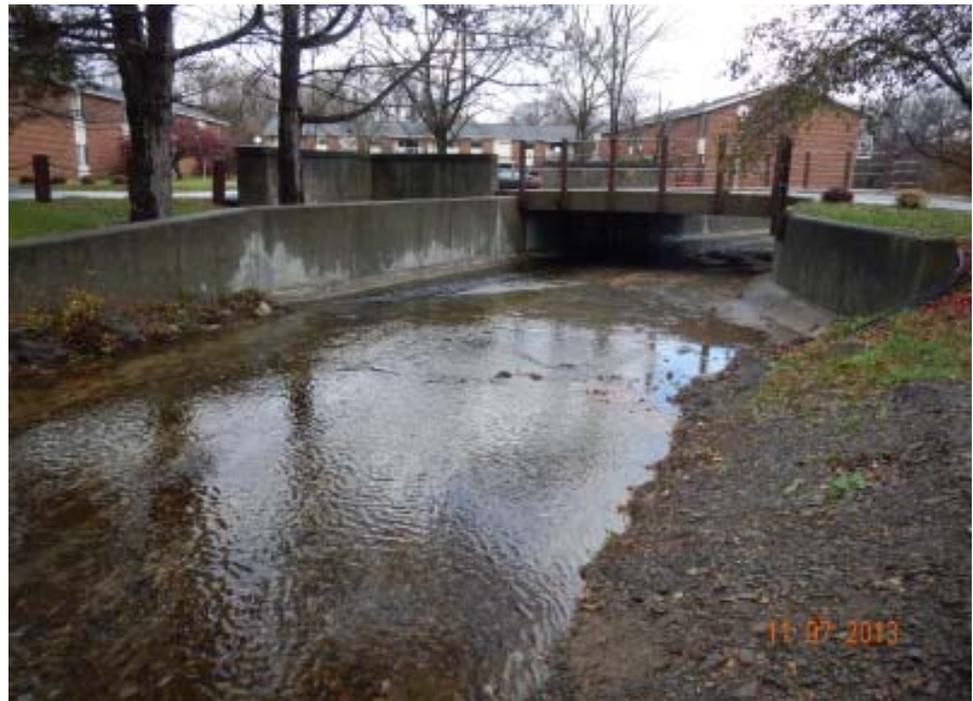
**2**

Flowing through the center of the Middle Settlement Apartment complex, flood flows overtop the banks causing severe flooding to the residences.

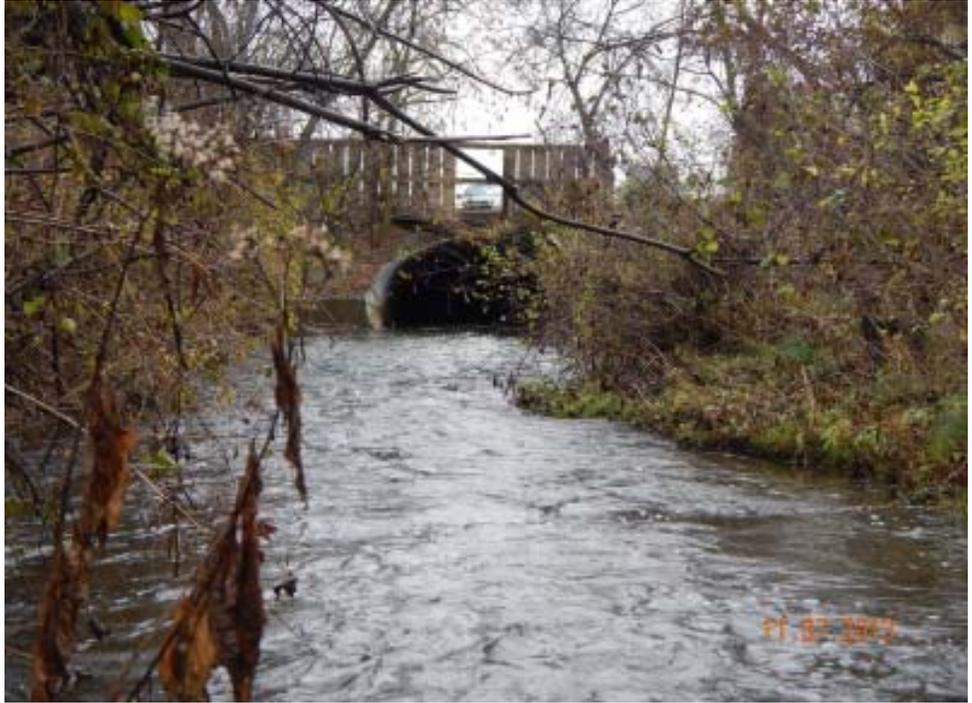
**3**

Shown is the upstream end of Seneca Turnpike (Route 5) culvert crossing.

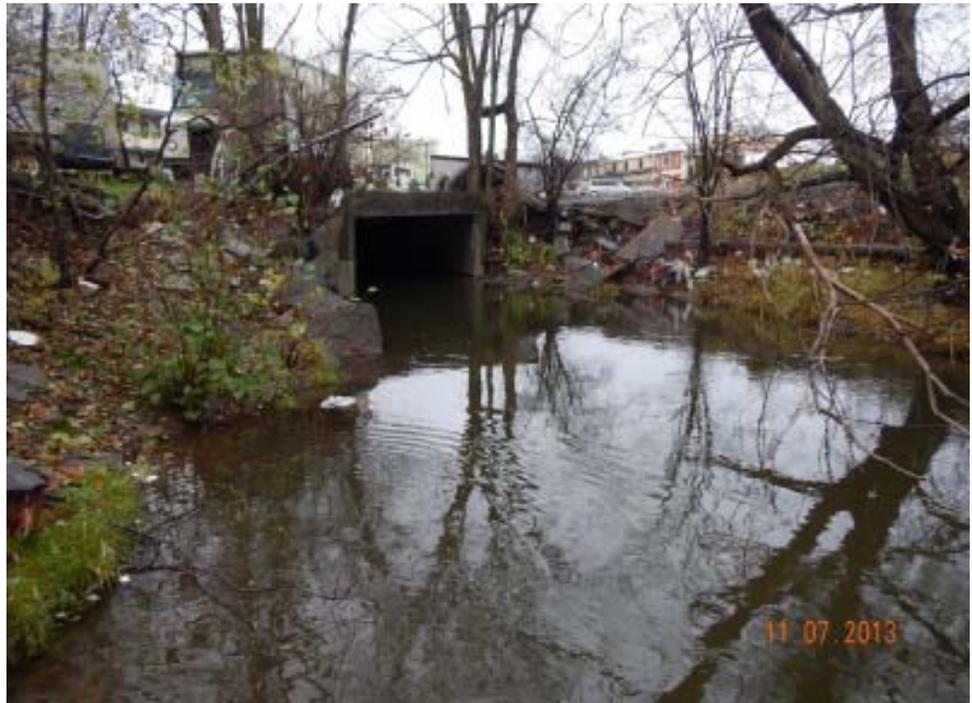
**4**

Depicted is the downstream end of the Seneca Turnpike (Route 5) culvert crossing.

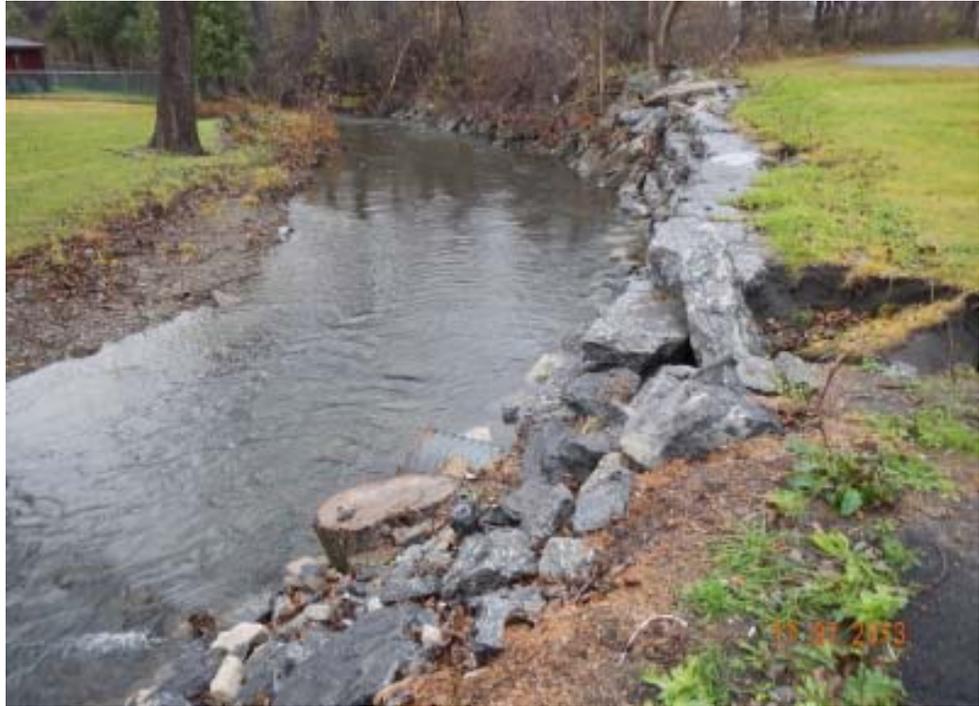
**5**

A stacked stone  
revetment wall in place  
adjacent to commercial  
buildings off of  
Commercial Drive.

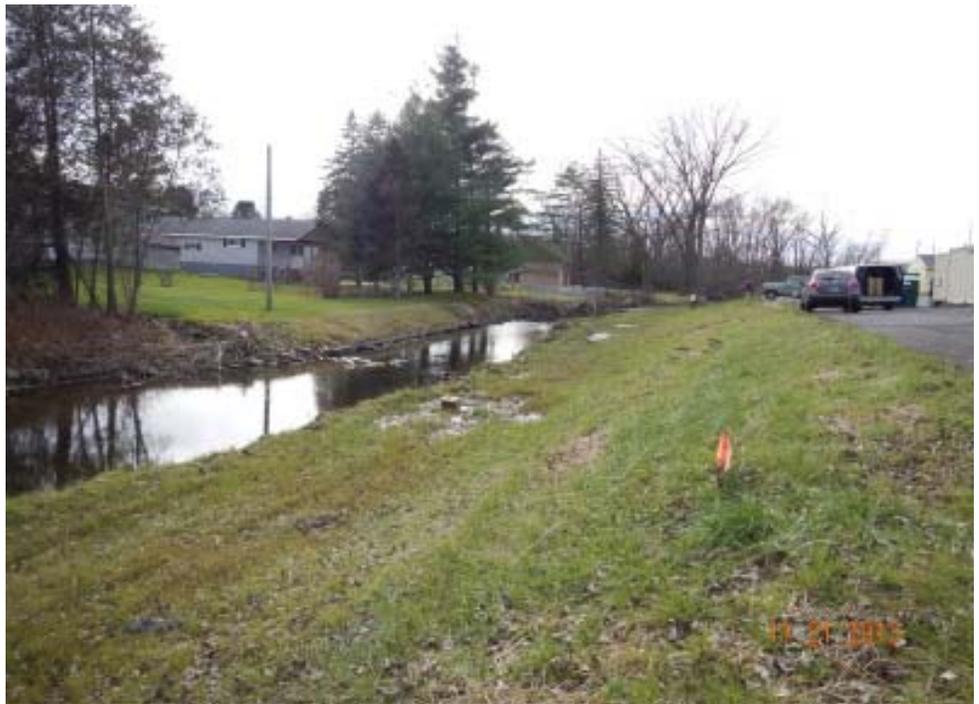
**6**

Just east of Commercial  
Drive, this area becomes  
heavily flooded,  
incorporated into High  
Risk Area #3.

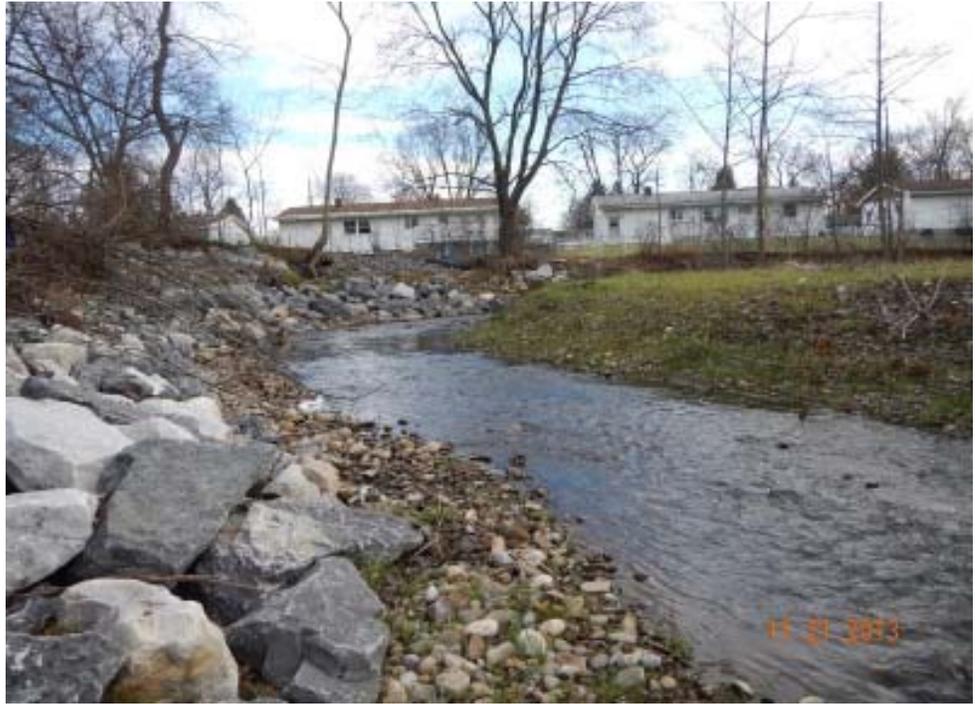
Located just upstream of the Commercial Drive Crossing, this area experiences severe flooding during low frequency storm events.

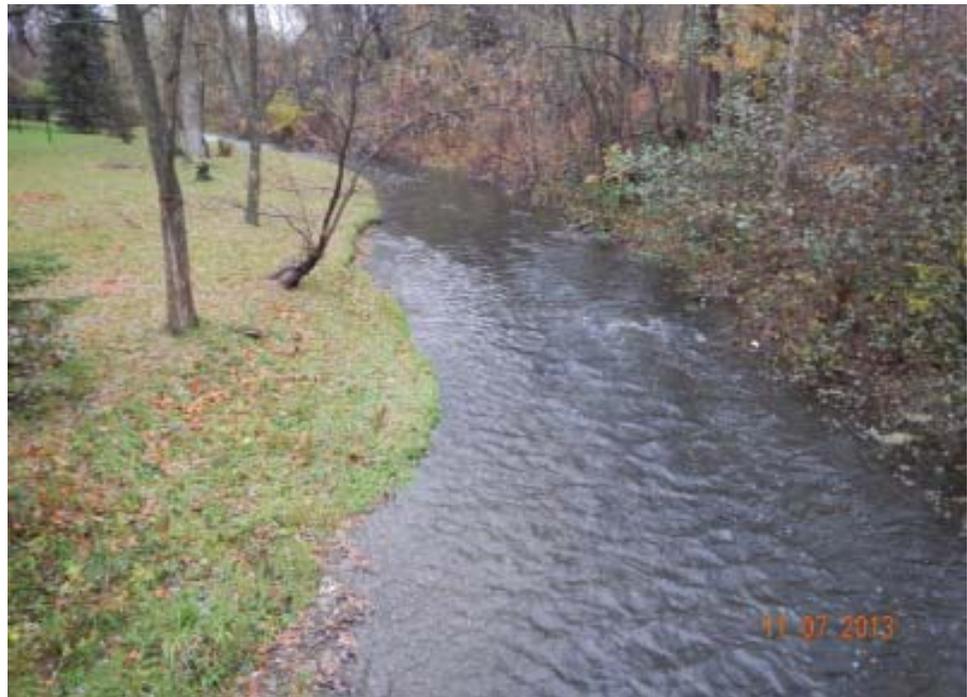
**8**

Photo taken looking downstream from the Henderson Street Bridge.
