EMERGENCY TRANSPORTATION INFRASTRUCTURE RECOVERY
WATER BASIN ASSESSMENT
AND FLOOD HAZARD MITIGATION ALTERNATIVES

STEELE CREEK
HERKIMER COUNTY, NEW YORK

April 2014

MMI #5231-01

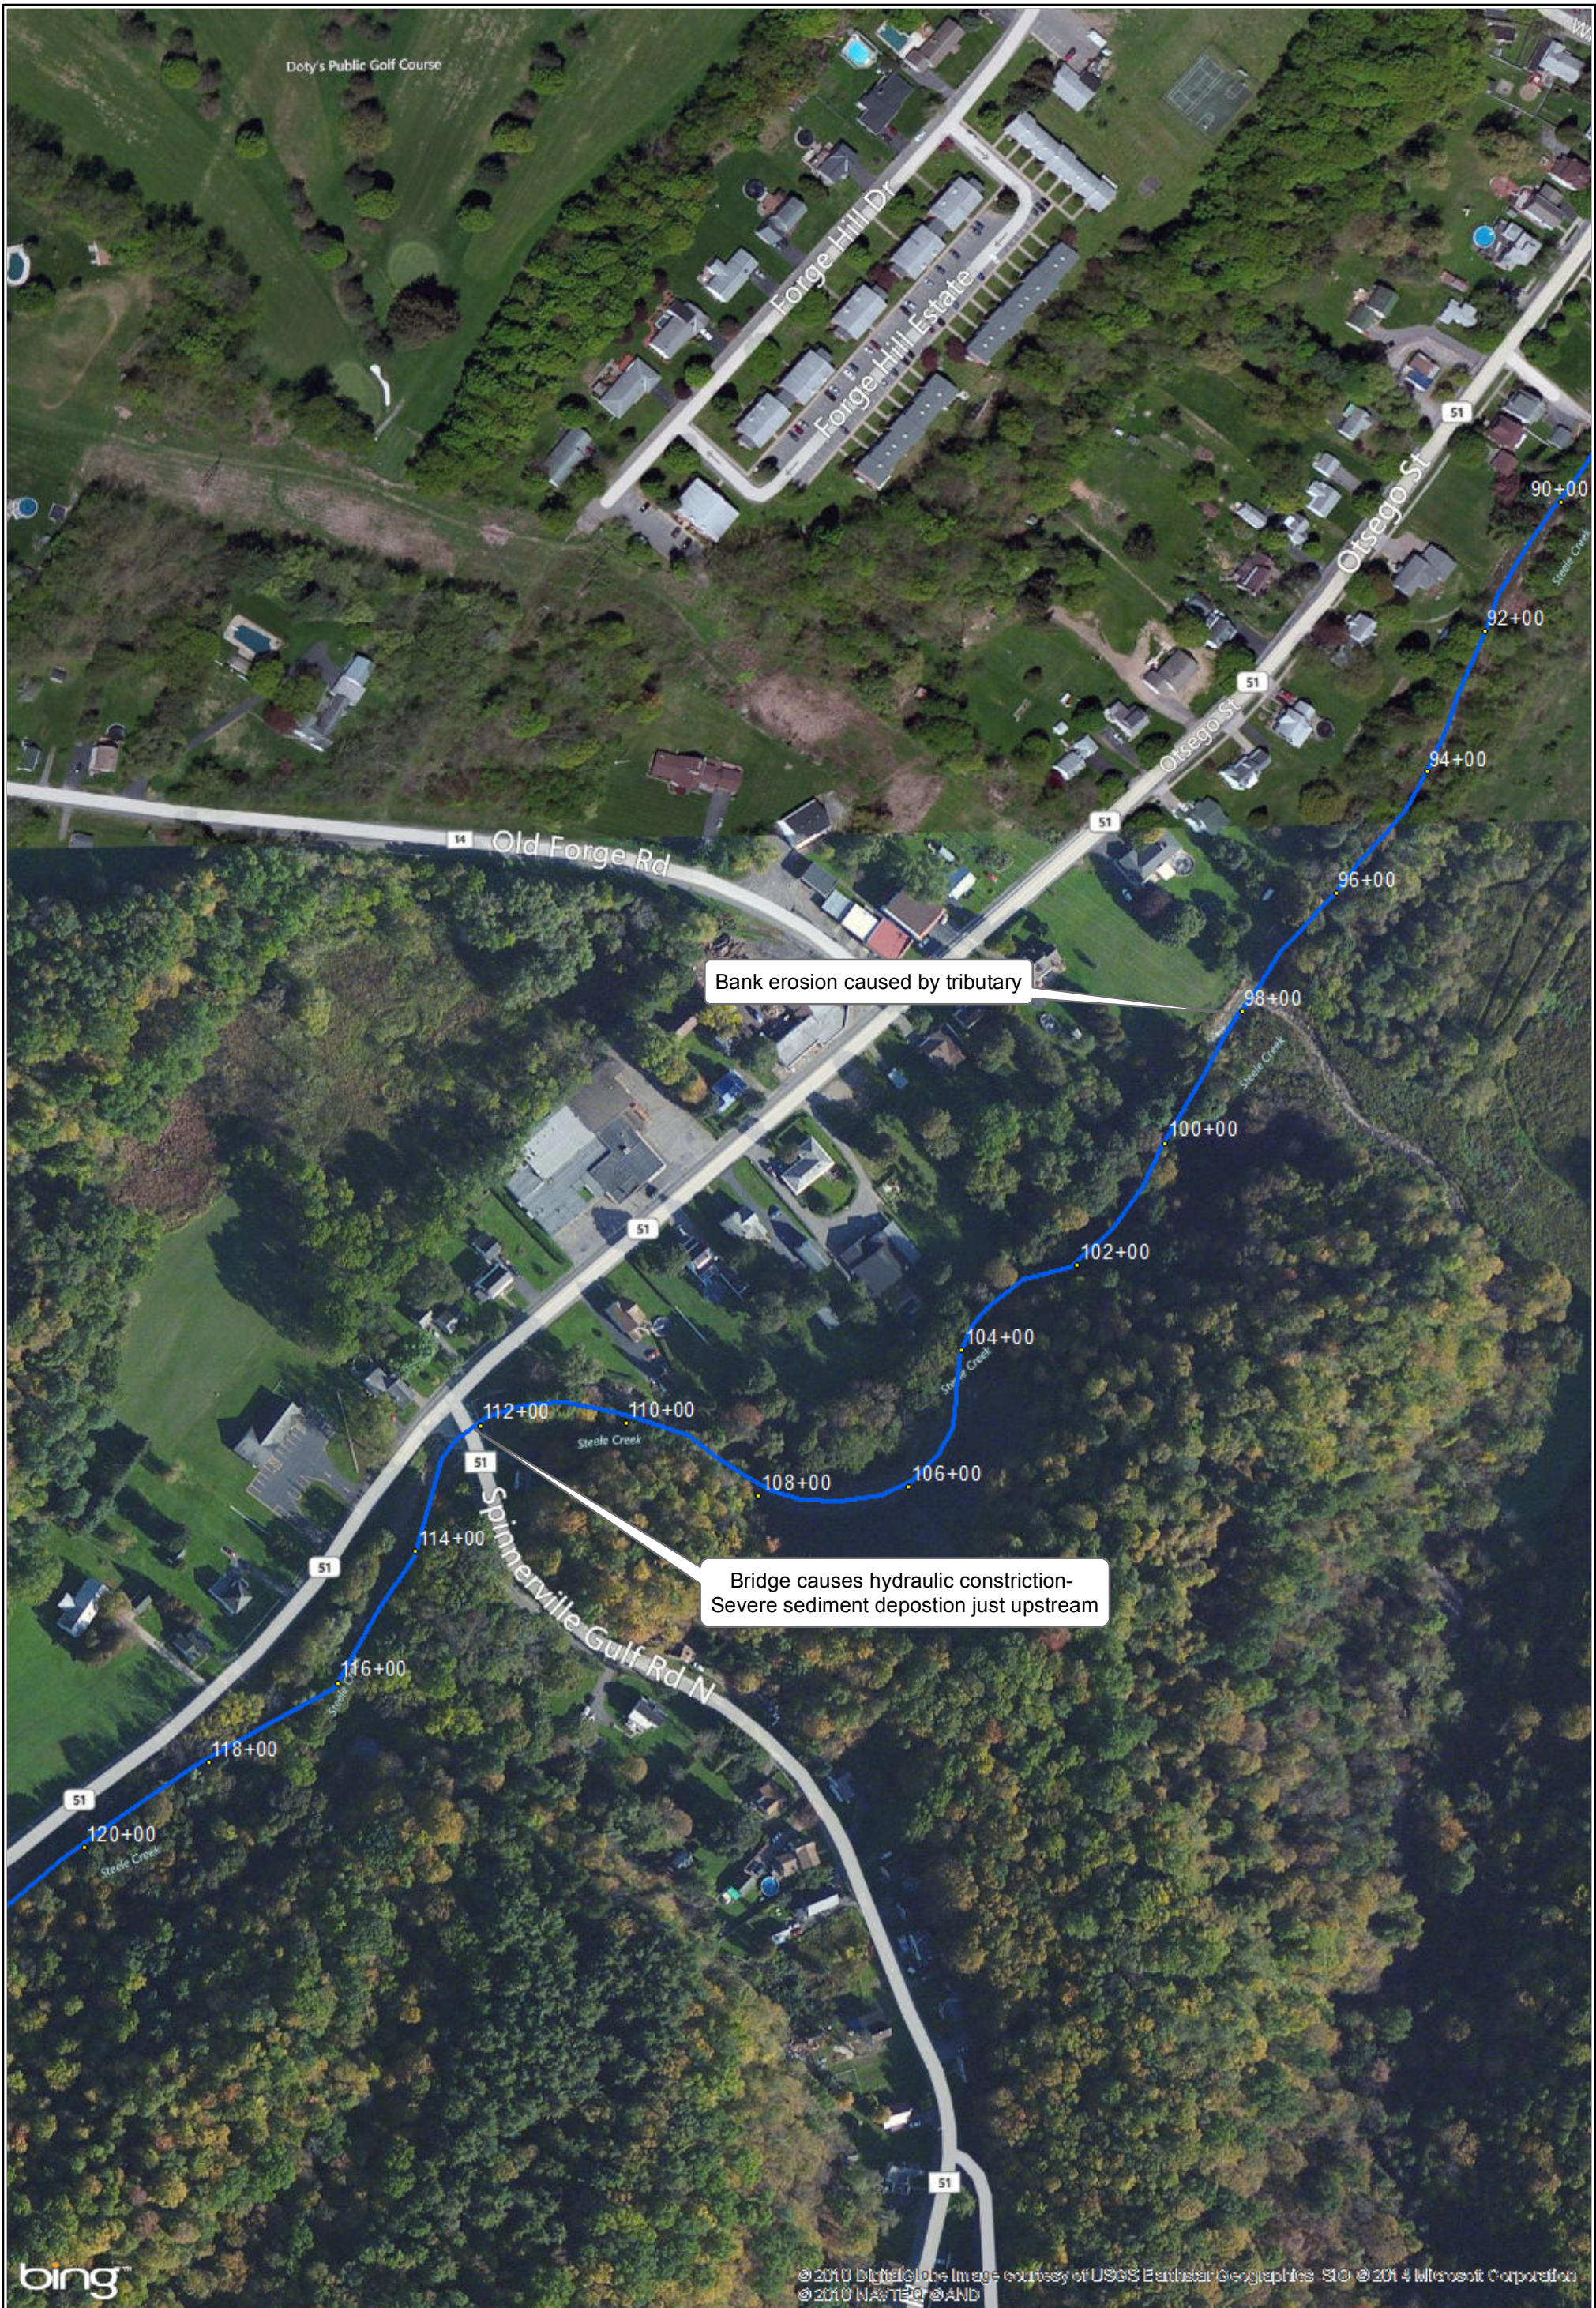
Figure 6: Steele Creek High Risk Area #1

Hydraulic modeling indicates that the Spinnerville Gulf Road bridge does not cause the channel to overtop during a 100-year flood event, but it does overtop during a 500-year event. Based on the model of current conditions, removal or replacement of the bridge would not provide appreciable benefit to flooding in this reach. This model may not reflect the conditions of the channel at the time of the June 2013 floods, which may have had appreciably more sediment deposition at the time. A partially clogged bridge opening will cause floodwaters to overtop the bridge at lower flows.

Spinnerville Gulf Road crosses Steele Creek as the creek exits the steep and confined Ilion Gorge. The gorge walls wash broken pieces of bedrock into the channel and confine flows within a deep channel with high shear strength. As Steele Creek flows through the gorge, it carries the sediment load with it until it reaches the relatively flatter, wider area in the vicinity of Spinnerville Gulf Road bridge. The natural topography of the creek and floodplain indicate that this flat area historically acted as a sediment delta for bedload sediments originating in the gorge. The tributary entering Steele Creek in this area also contributes a high sediment load.

Alternative 1-1: Develop and Implement Sediment Management Plan

Dredging (specifically lowering) Steele Creek was evaluated to determine its merit to mitigate flooding. Such action will further isolate the stream from its natural floodplain, disrupt sediment transport, potentially cause upstream bank/channel scour, and encourage additional downstream sediment deposition. Improperly dredged stream channels often show signs of severe instability, which can cause larger problems after the work is complete. Such a condition is likely to exacerbate flooding on a long-term basis.

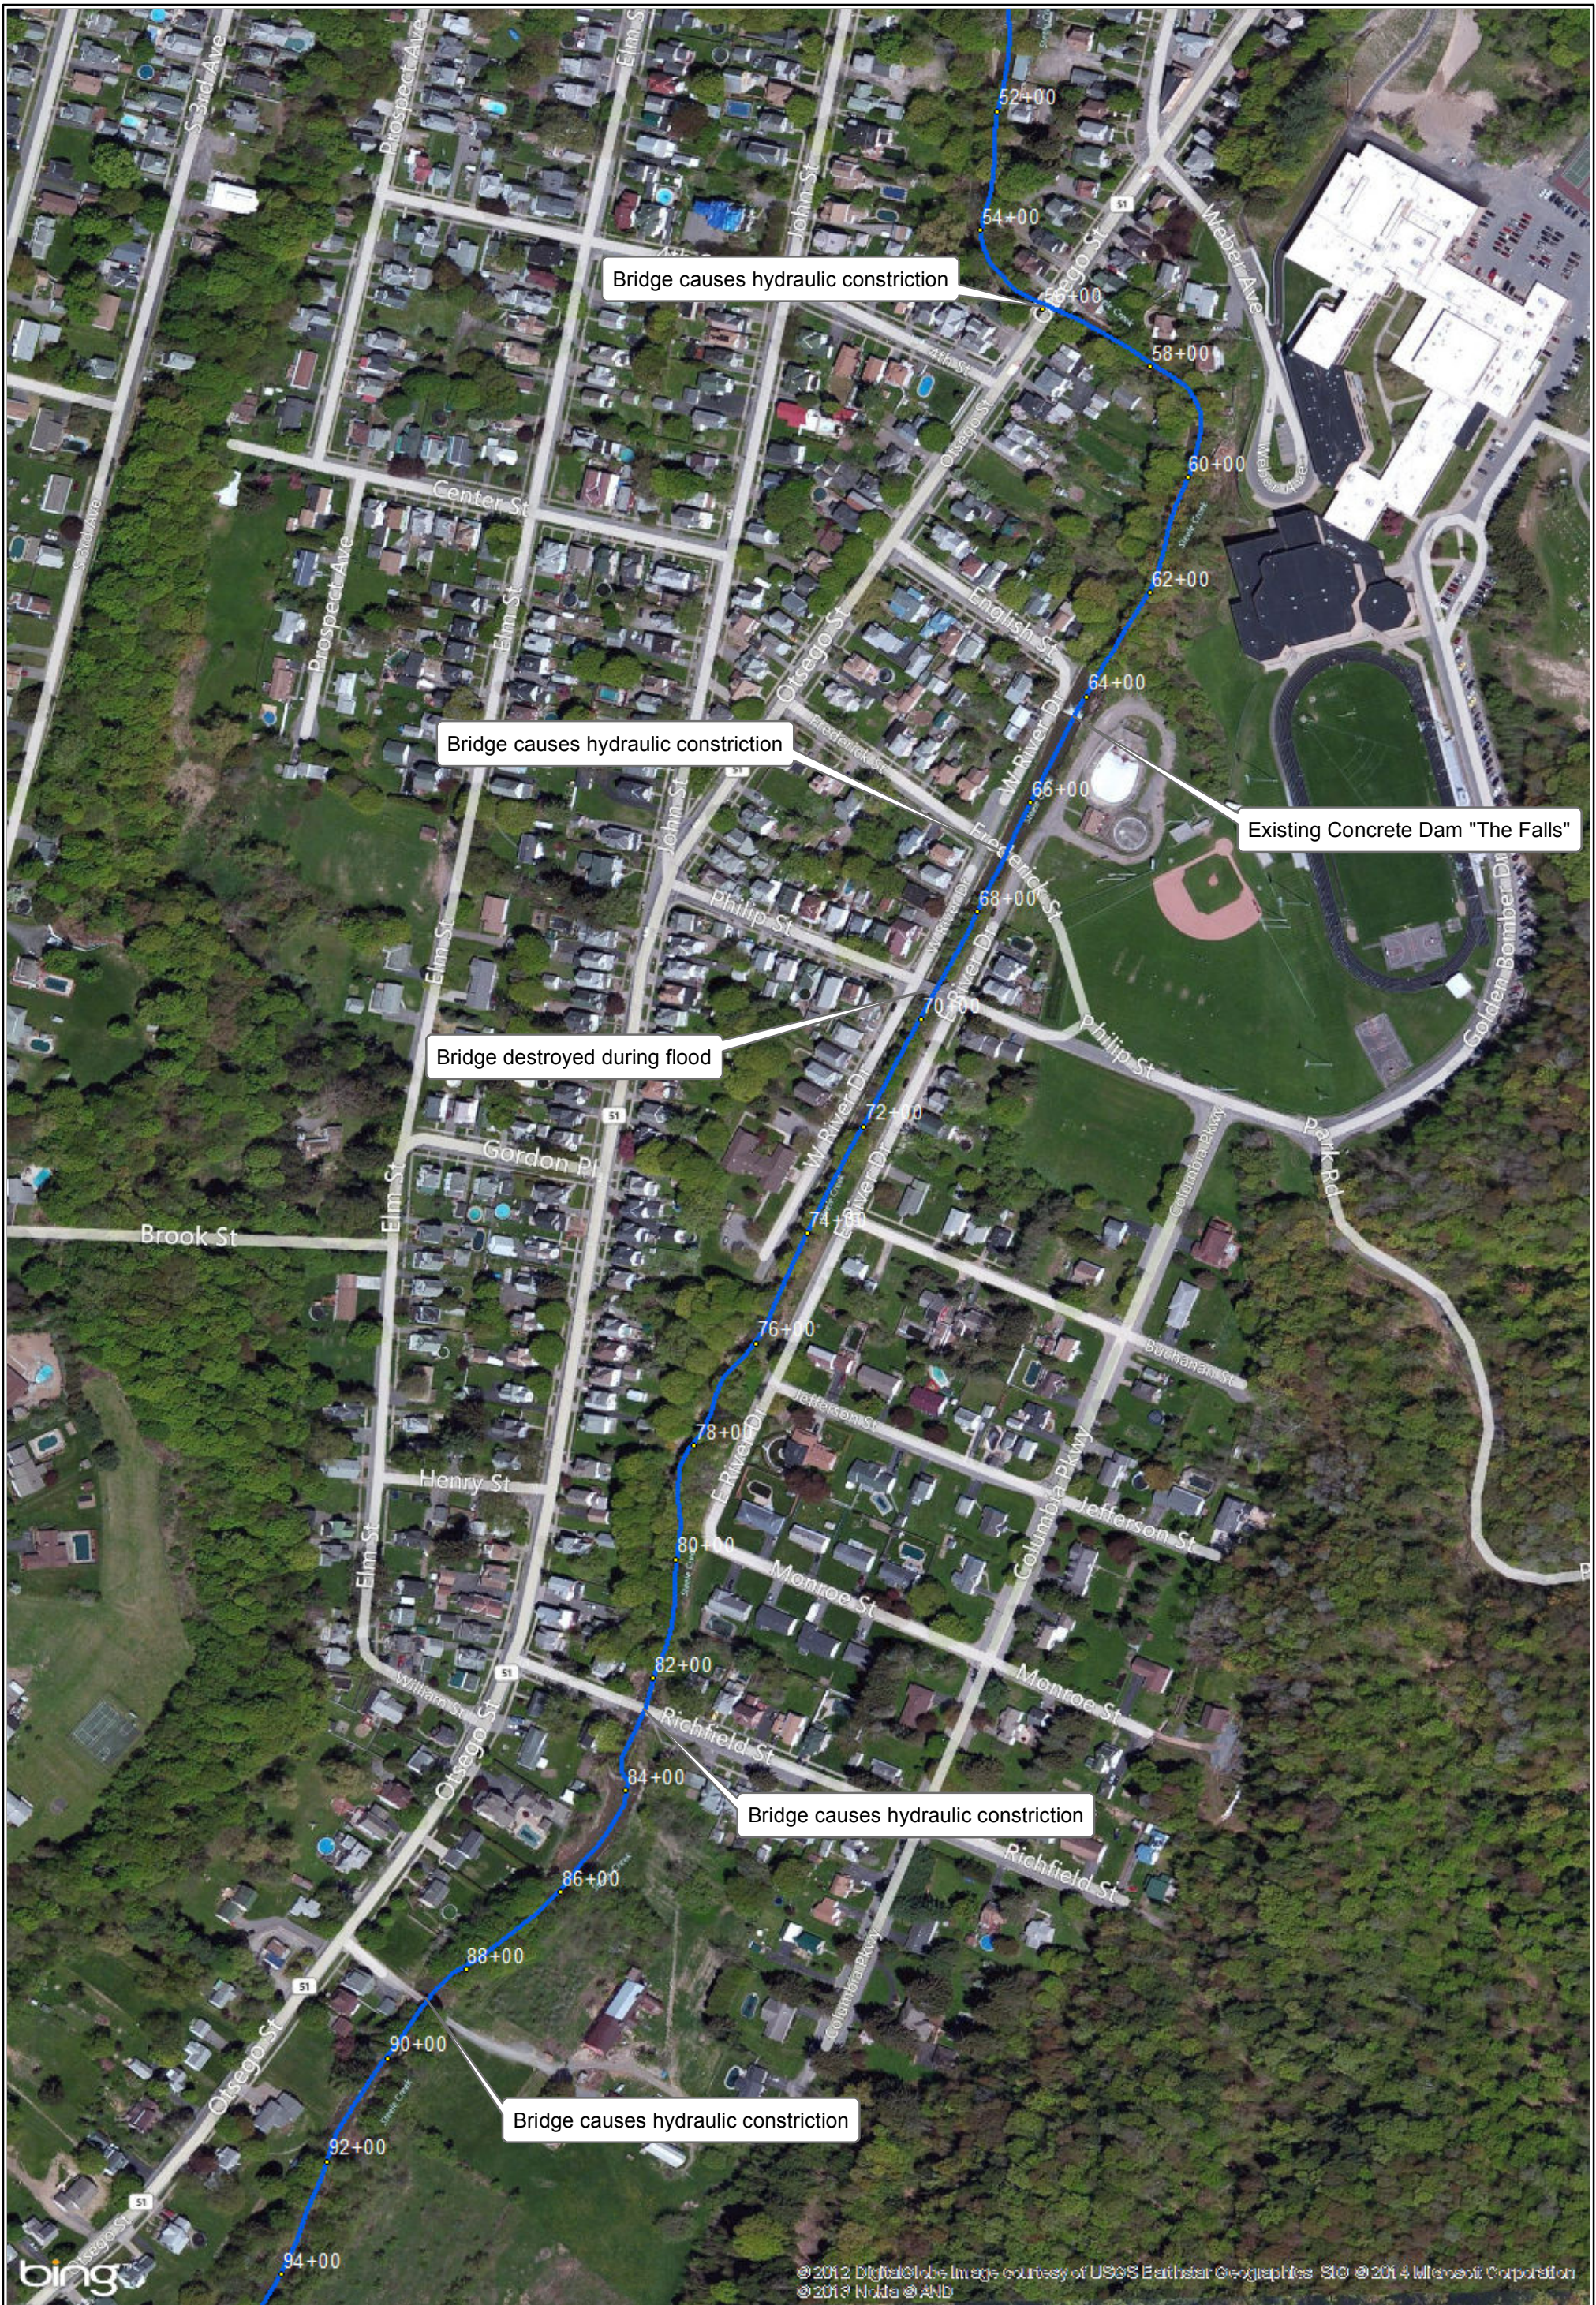
Figure 7: Steele Creek High Risk Area #2

Figure 7 is a location plan of High Risk Area #2. This area extends from STA 91+00 downstream to STA 56+00 and includes the Clapsaddle Farm Road bridge (STA 89+00, indicated on the FEMA flood profile as Whitney Street), the Richfield Street bridge (STA 82+75), the Frederick Street bridge (STA 67+00), the dam at STA 64+75 (known locally as "The Falls"), and the Otsego Street bridge (STA 56+00). The channel upstream of the dam is lined on the right bank by East River Drive and on the left bank by West River Drive. These two roads closely confine the channel, leaving no overbank area during flood events.

According to the FIRM and community officials, this area experiences extensive flooding. The flood profiles indicate that the Clapsaddle Farm Road bridge and the Otsego Street bridge are acting as severe hydraulic restrictions. The dam at STA 64+75 is also causing an increase in water surface elevations upstream of the dam.

The concrete run-of-river dam is approximately 13 feet high and 42 feet long. It does not appear to serve any modern day purpose. The dam has accumulated sediment behind it to the elevation of the crest, which has raised the bed of the upstream channel closer to that of the adjacent floodplain. Figure 8 shows a profile of Steele Creek near the dam and illustrates how the aggraded channel upstream has almost reached the elevation of the adjacent floodplain. This makes it very easy for flood flows to overtop the banks and flow into the residential areas along the left bank of Steele Creek to the west of the dam. Figure 8 also illustrates how the Otsego Street bridge acts to back up flows.

Dam removal will provide the most significant flood reduction in this reach. However, removal and replacement of undersized bridges would be required to fully mitigate flooding. Alternative 2-1 is recommended as a comprehensive approach to flood mitigation. This would remove the dam and replace the undersized bridges while increasing the size of the channel and removing the accumulated sediment from behind the existing dam. If only limited funding can be obtained, flood mitigation could be staged over time, which is essentially Alternative 2-2 and Alternative 2-3.

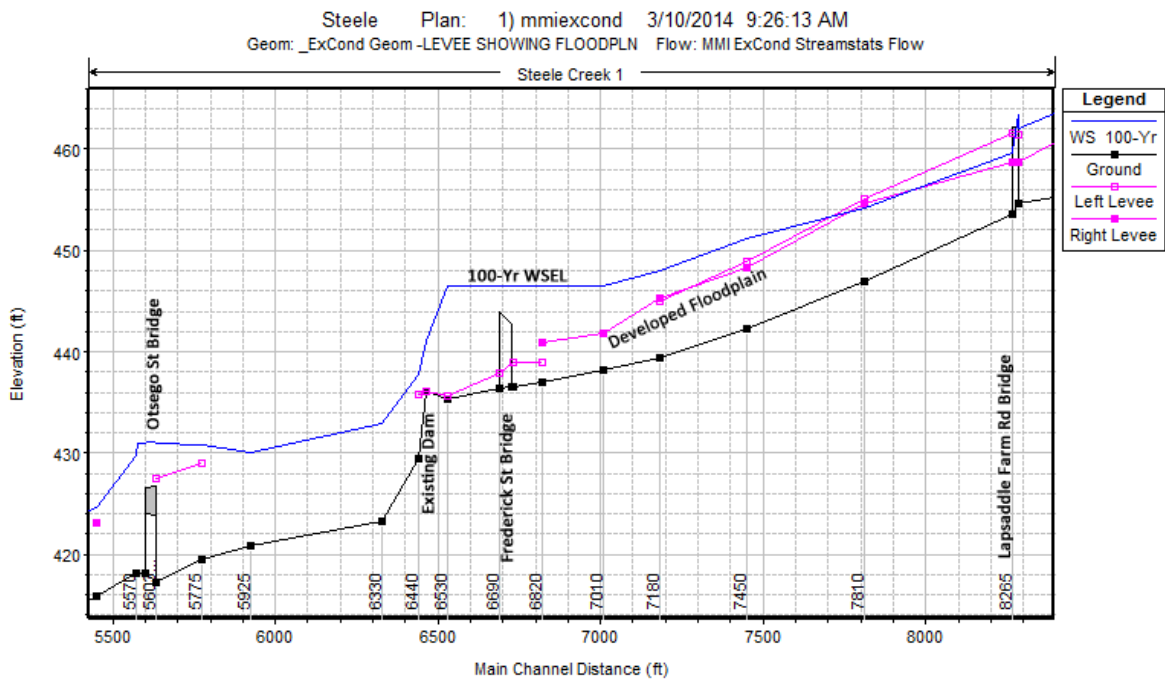
FIGURE 8
Hydraulic Modeling Results - Steele Creek Profile
STA 55+00 to STA 84+00

Hydraulic modeling indicates that removal of the dam will help to reduce the frequency and severity of flooding but will not eliminate it entirely. Three undersized bridges in the immediate vicinity of the dam overtop under current conditions, exacerbating flooding. The channel through this reach is undersized to convey flood flows due to the close proximity of the roads along both banks as well as historic filling and development in the floodplain.

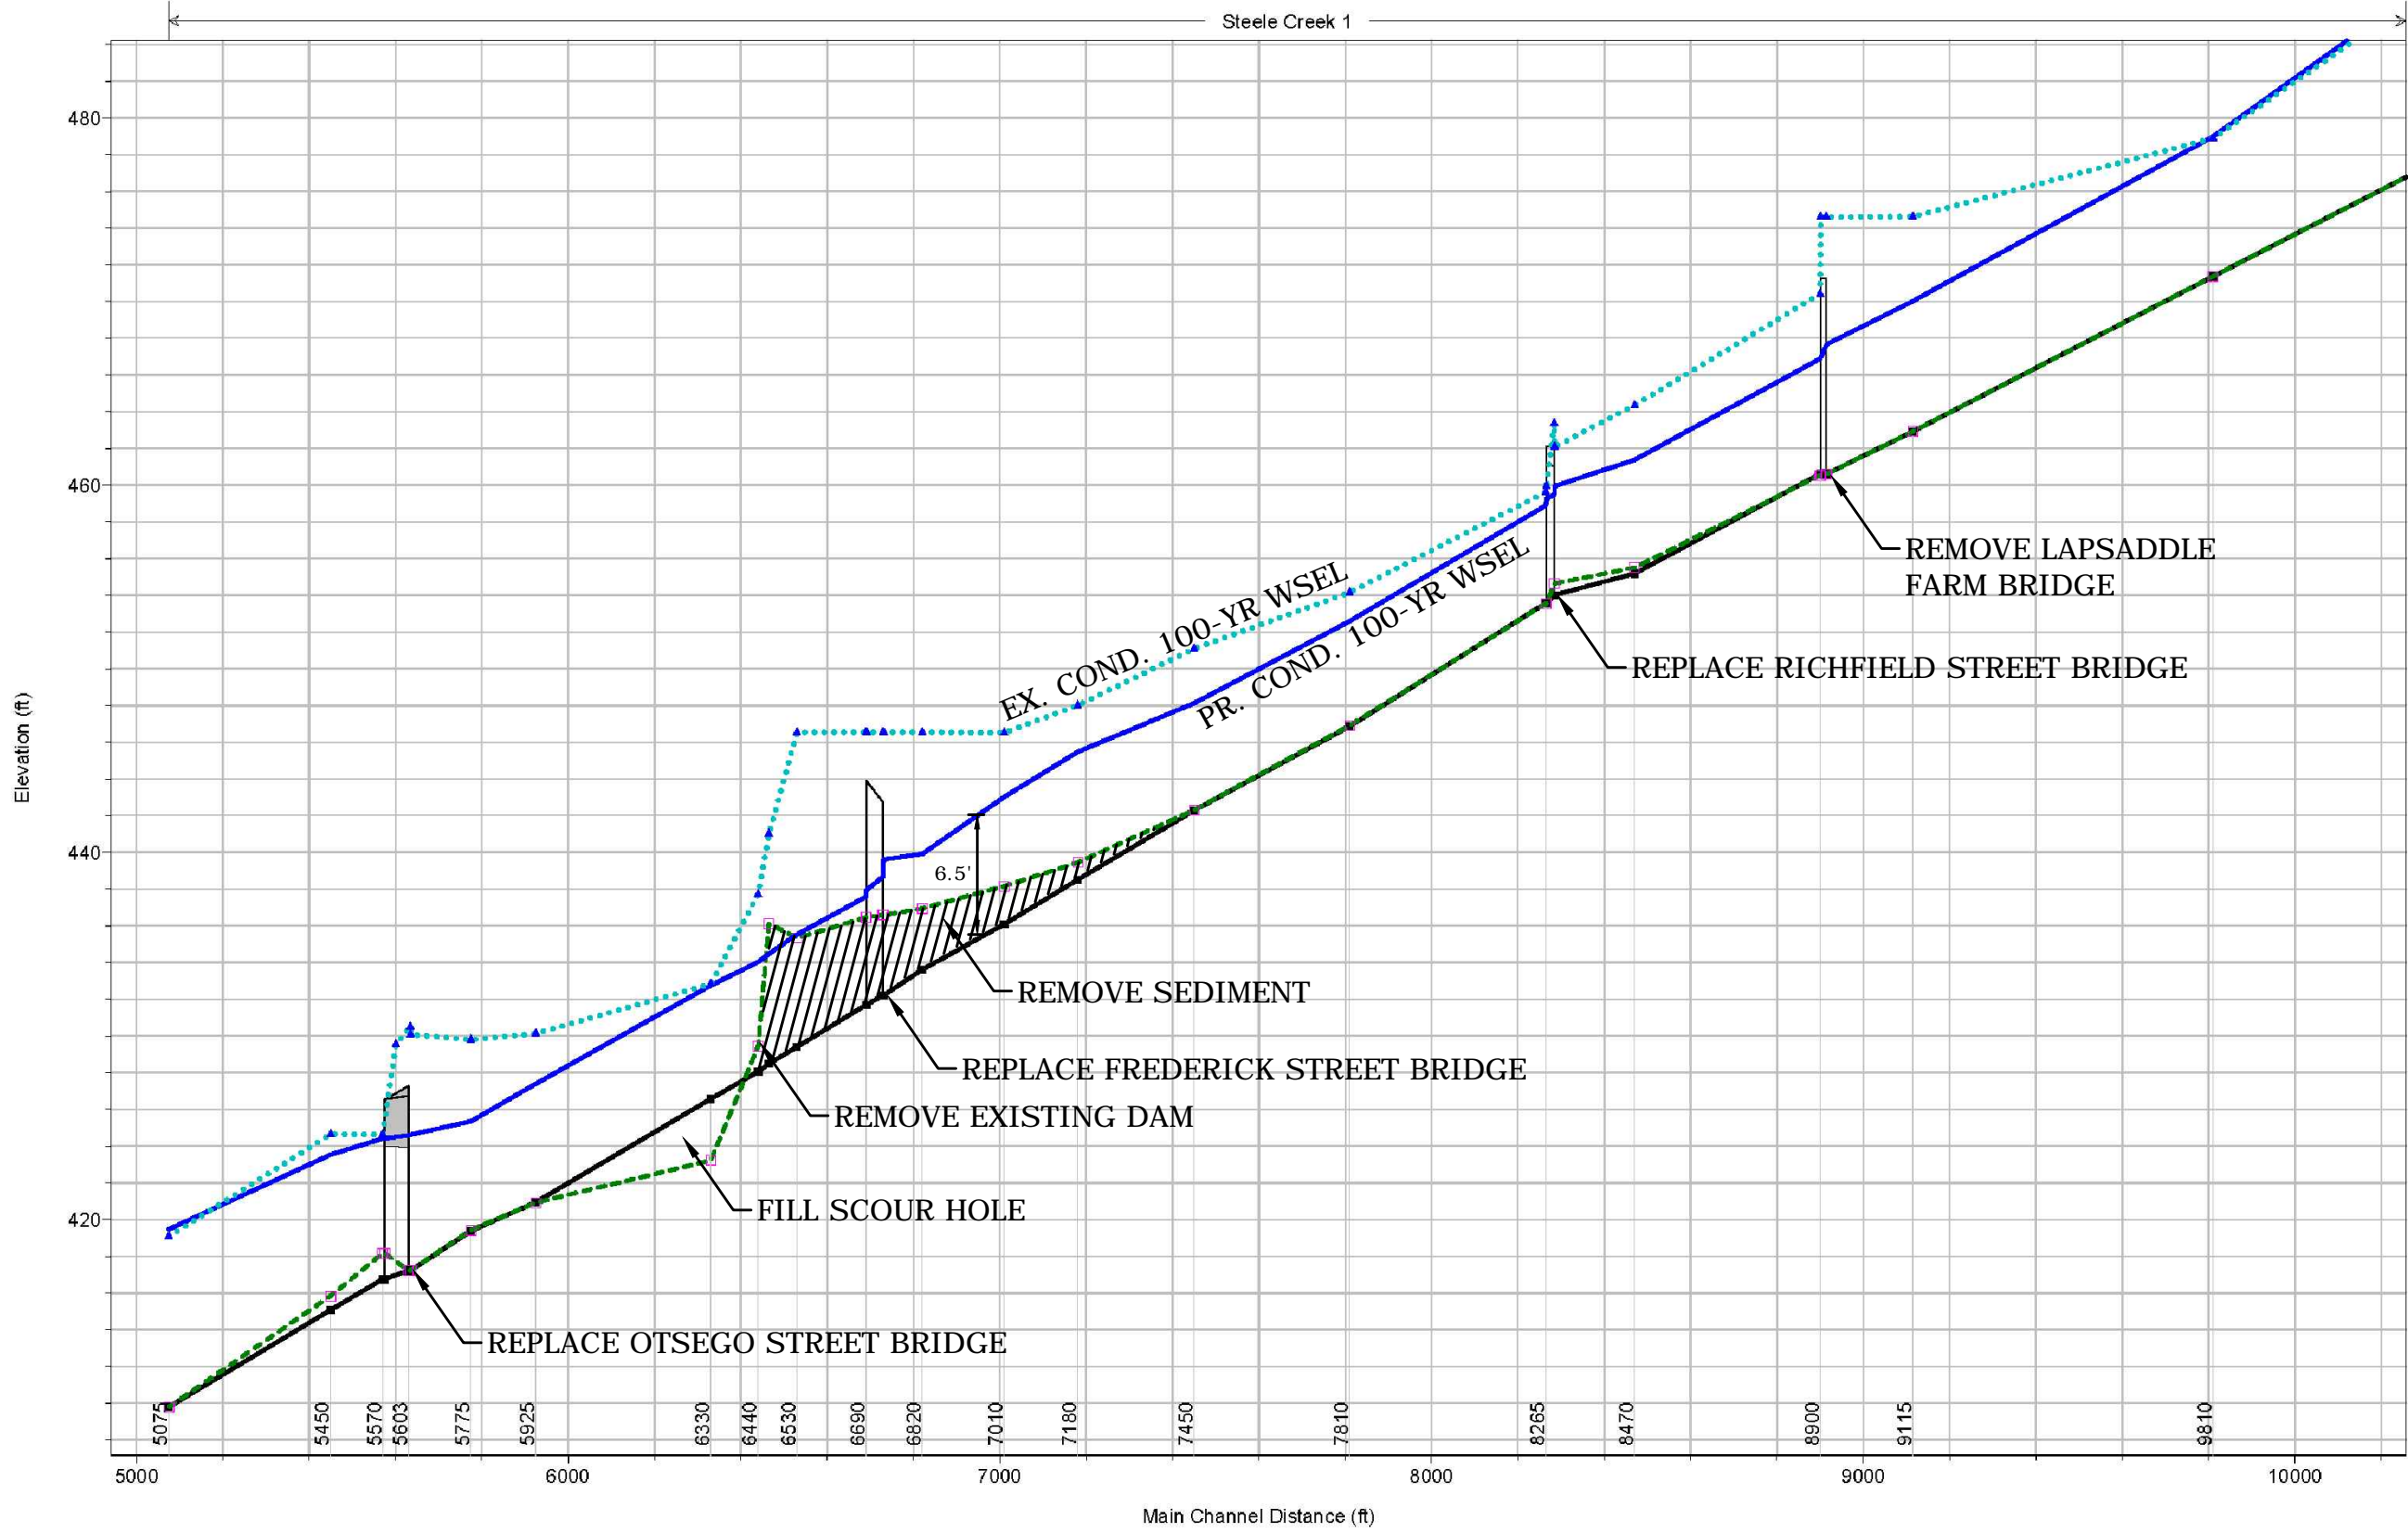
Hydraulic Modeling Analysis - Steele Creek Profile
 WATER BASIN ASSESSMENT
 AND FLOOD HAZARD MITIGATION ALTERNATIVES
 STEELE CREEK
 ILION, NEW YORK

Figure 9 presents a profile of this reach under conditions proposed in Alternative 2-1, including the modeled hydraulic benefits of the improvements.

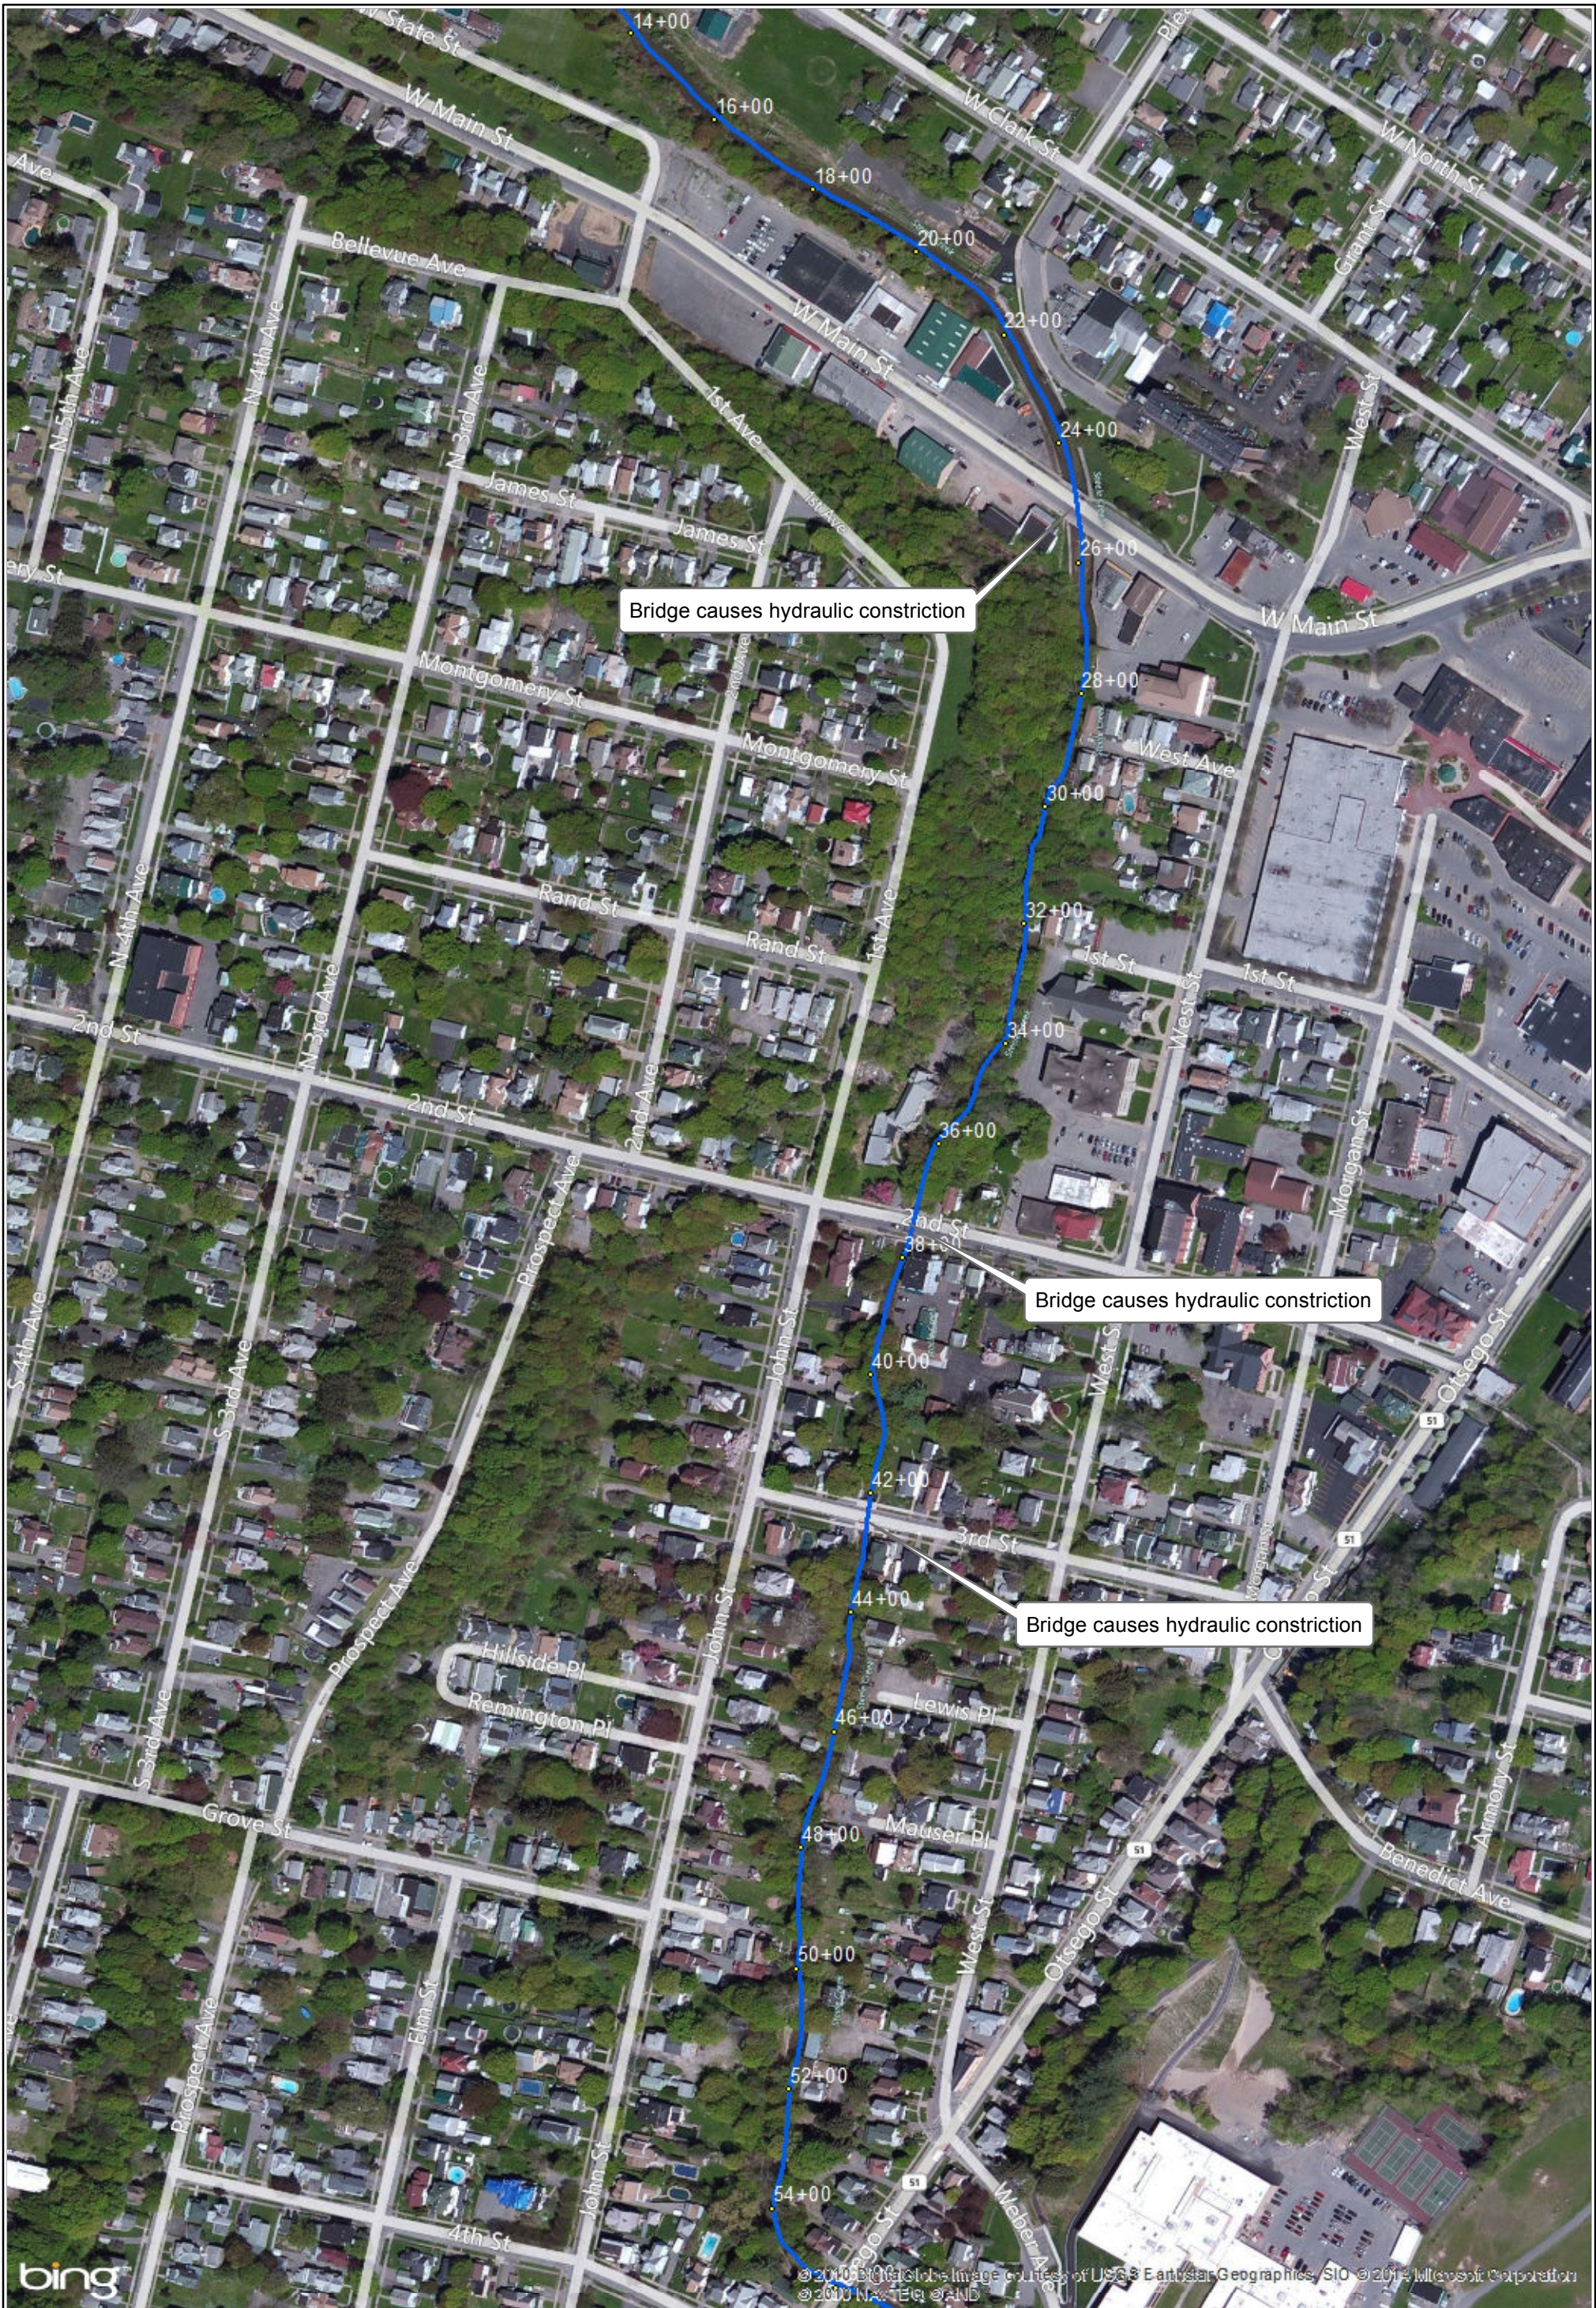
Figure 10: Steele Creek High Risk Area #3

Assessment of the available FEMA data indicates that the Second and Third Street bridges are among the most severely undersized bridges along Steele Creek. Community officials indicate that the Third Street bridge was replaced as a result of the 2006 storm and its size increased. However, the development constraints on both banks restricted further channel expansion. Field inspection of the channel along this reach indicates that it is too narrow in relation to regional geometry bankfull estimates and also too small to convey flood flows. Its banks are high and steep, and development has been extended to the edge of the banks throughout this reach, reducing the conveyance of the creek. Hydraulic capacity is reduced further by sediment deposition in the reach, and a sediment management plan may be necessary for future deposition in the channel.

FEMA modeling in this reach indicates that the bridges at West Main Street, Second Street, and Third Street are all severely undersized. These bridges should be slated for replacement as funding allows and should be assessed individually for proper sizing. These bridges are likely to require at least 100-foot span bridges or greater.

It may be cost prohibitive to expect that the bridges and associated channel widening described in Alternatives 3-1 and 3-2 can be completed at one time, but each of the undersized bridges should be considered for replacement as funding allows. The associated channel widening and floodplain restoration may be difficult due to the number of private property impacts, but a long-term implementation plan is recommended to complete this work.

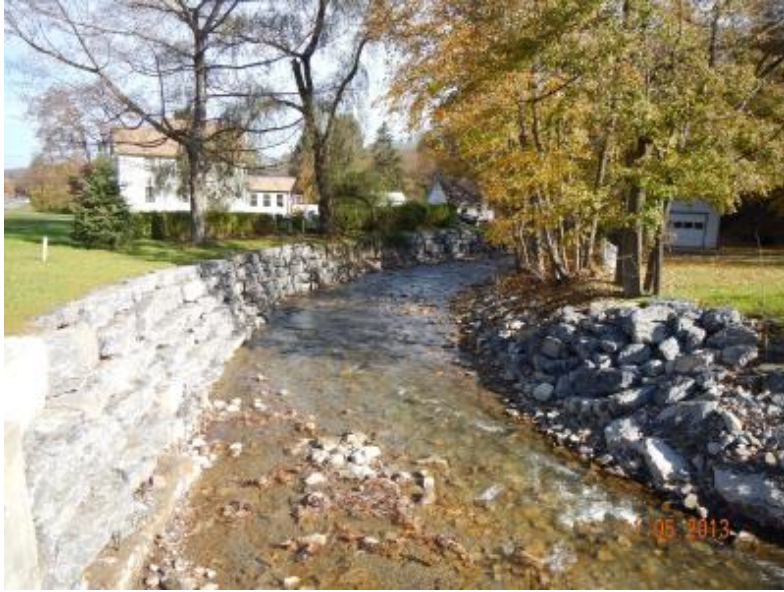
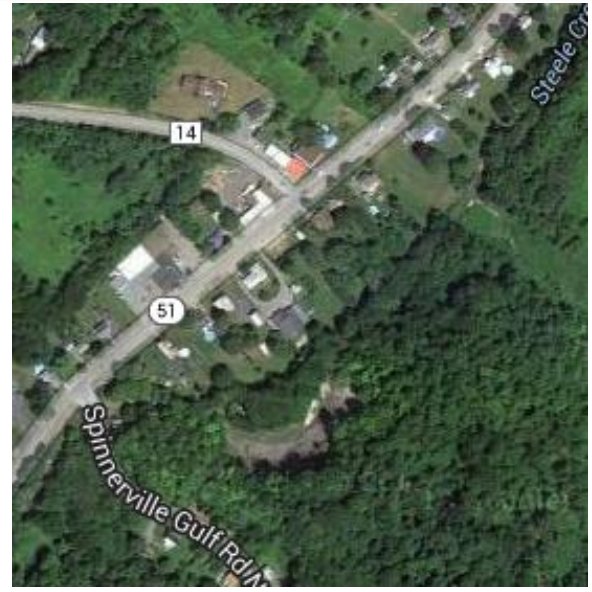
High-Risk Area #1 – Spinnerville Gulf Confluence

Site Description: From the end of the Ilion Gorge upstream of Spinnerville Gulf Road (STA 117+00) to 300 feet downstream of a gas and high voltage electricity crossing (STA 95+00), sediment aggradation reduces channel capacity, which has caused overtopping and flooded a local veterinarian's office.

- Channel needs to be adequately sized to convey a bankfull width of 50 feet, and an adequate floodplain bench should be provided, where possible.
- Sediment aggradation causing water to overtop the banks may have to be periodically removed. A sediment management plan should be developed and implemented.

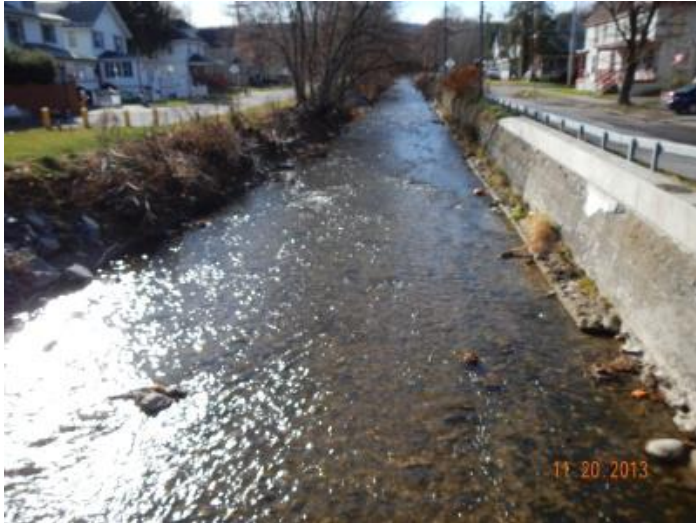
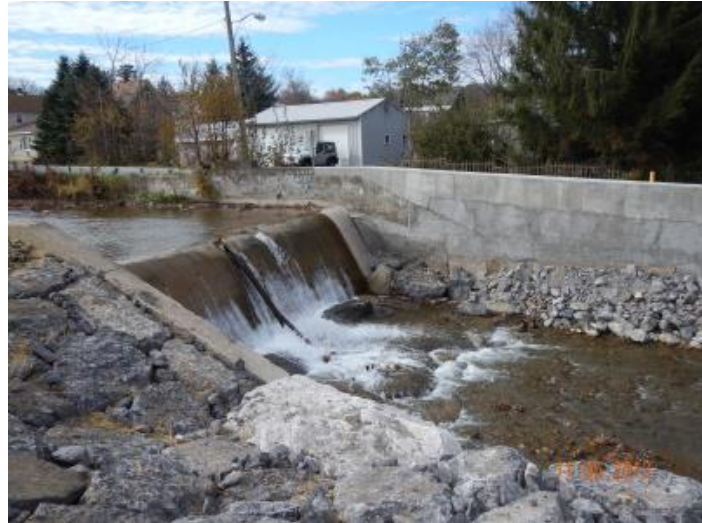
High-Risk Area #2 – Undersized Bridge Crossings and “The Falls”

Site Description: Beginning upstream of Lapsaddle Farm Road bridge (STA 91+00) to the Otsego Street bridge (STA 56+00), several undersized bridges and an existing dam at STA 64+75 known as “The Falls” cause flooding in the area. Bridges in this reach include Richfield Street Bridge (STA 82+75) and Frederick Street Bridge (STA 67+00).

- Replace undersized bridge crossings that act as hydraulic constrictions and replace with larger spans (if appropriate).
- Remove existing concrete dam.
- Widen channel to minimum bankfull dimensions and create floodplain bench.

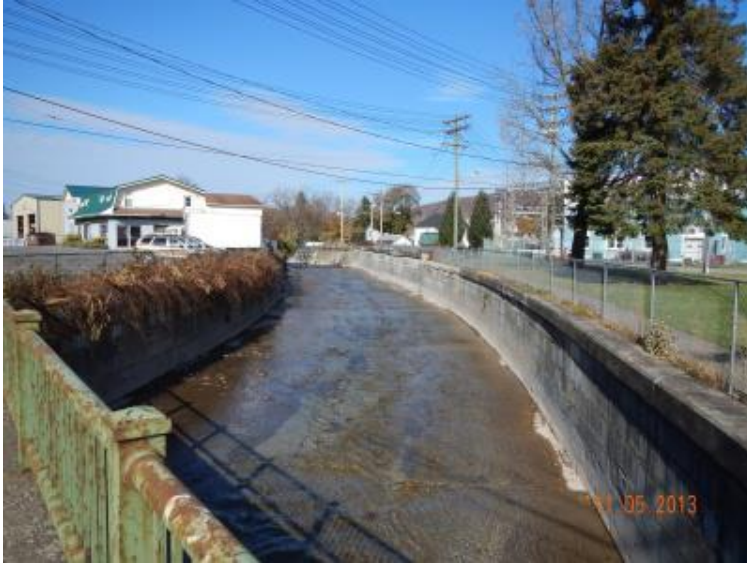
High-Risk Area #3 – Concrete Lined Sections of Channel

Site Description: From just downstream of the Otsego Street bridge (STA 51+00) to just downstream of the West Main Street bridge (STA 14+00), the channel is concrete lined at various sections creating confined as well as high velocity flows. A number of undersized bridges and an undersized channel cause flooding in this reach. The surrounding area is highly commercialized with residential dwellings along both sides of the creek, threatened by overtopping of the concrete channel.

- Replace undersized bridge crossings that act as hydraulic constrictions and replace with larger spans (if appropriate).
- Remove concrete lining and create naturalized, appropriately sized channel to minimum bankfull dimensions and create floodplain bench.

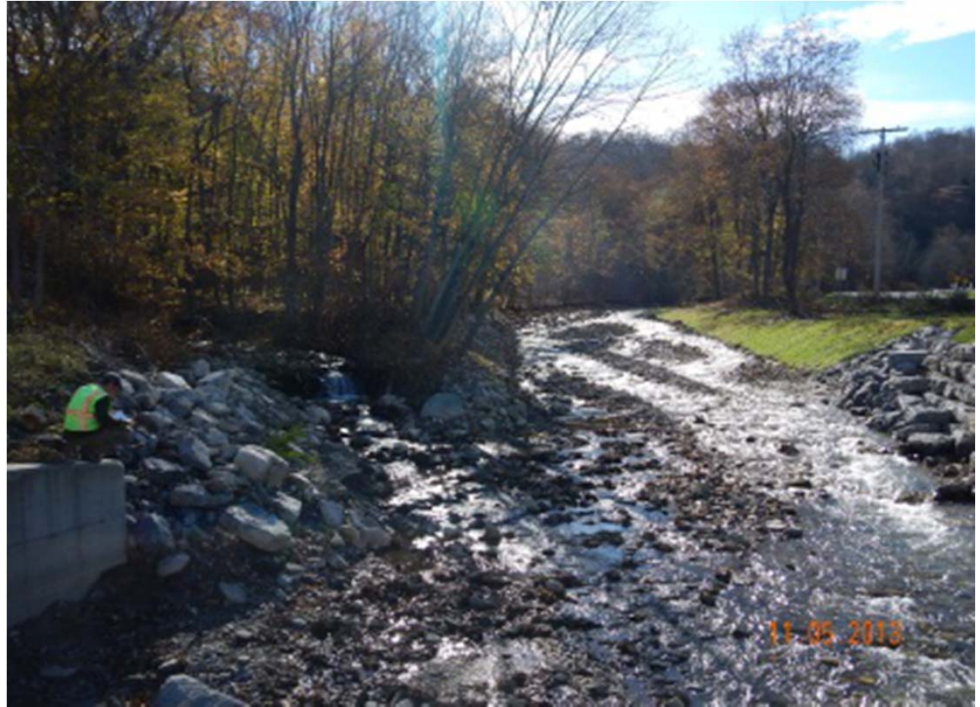
Photo taken from Spinnerville Gulf Road crossing, station 110+00, upstream depicting the most severe sediment deposition zone.

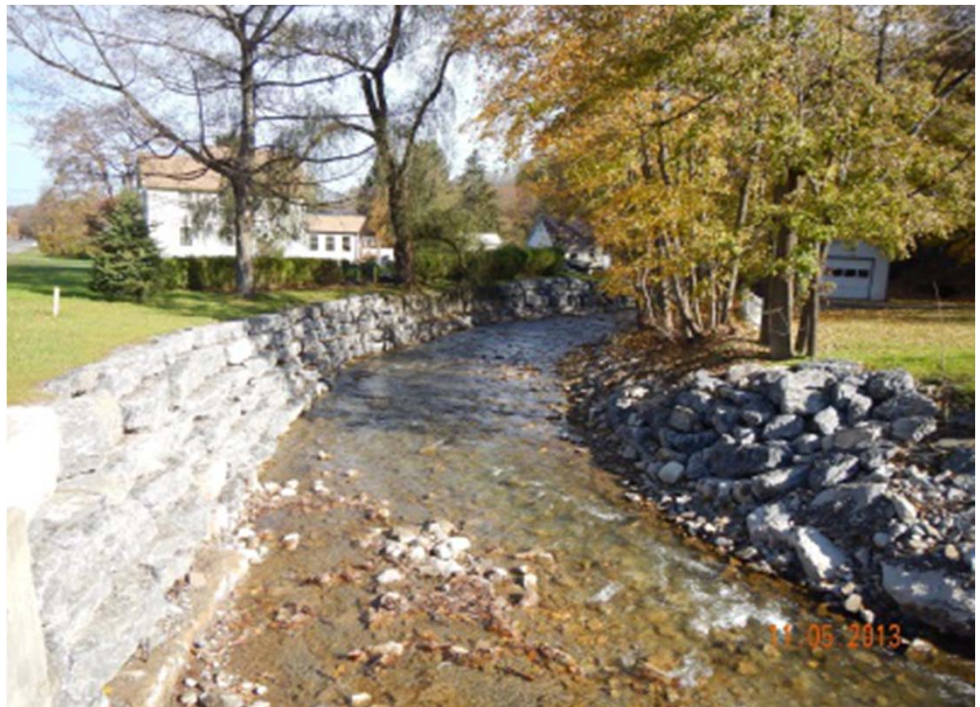
2

Looking downstream from the Spinnerville Gulf Road crossing is a stone reventment wall preventing erosion of residential properties.

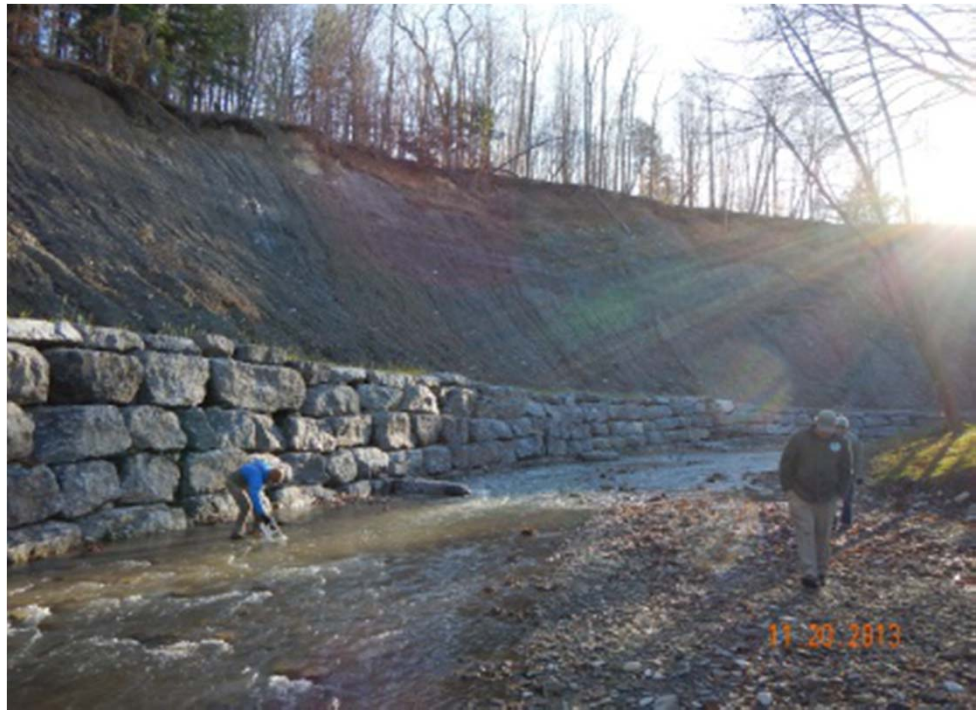
3

Another section of stone wall put in place after the 2013 flooding events in order to prevent further undercutting of this bank. This cut bank is located between stations 104+00 and 108+00.

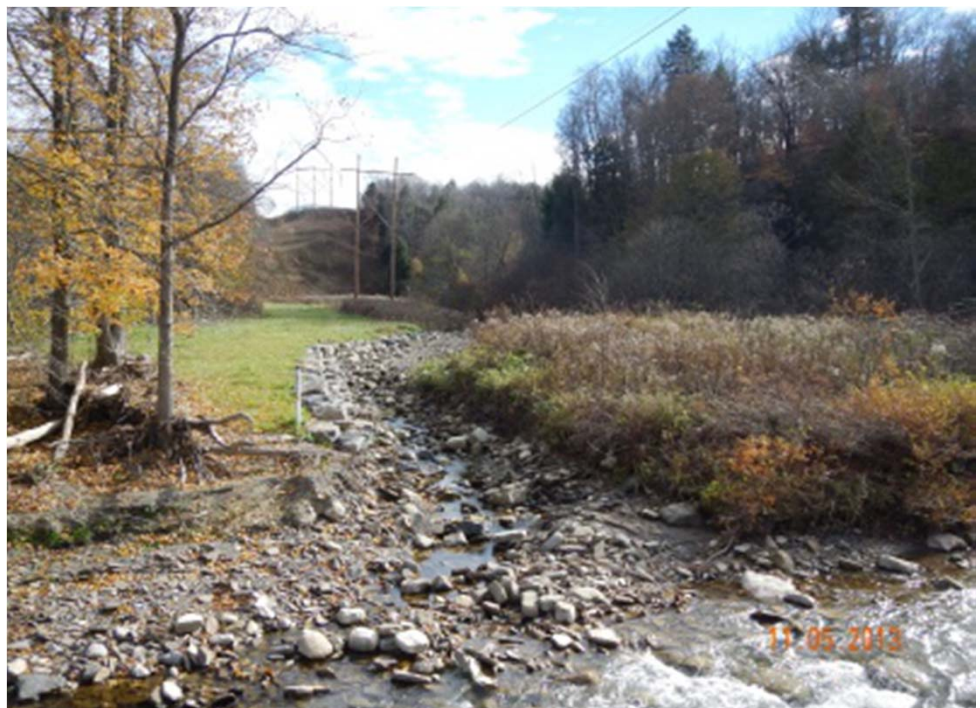
4

Small tributary enters into Steele Creek at station 98+00 and is causing bank erosion on the far side of the river, threatening the gas line.
