EMERGENCY TRANSPORTATION INFRASTRUCTURE RECOVERY
WATER BASIN ASSESSMENT
AND FLOOD HAZARD MITIGATION ALTERNATIVES

STEELE CREEK
HERKIMER COUNTY, NEW YORK

April 2014

MMI #5231-01

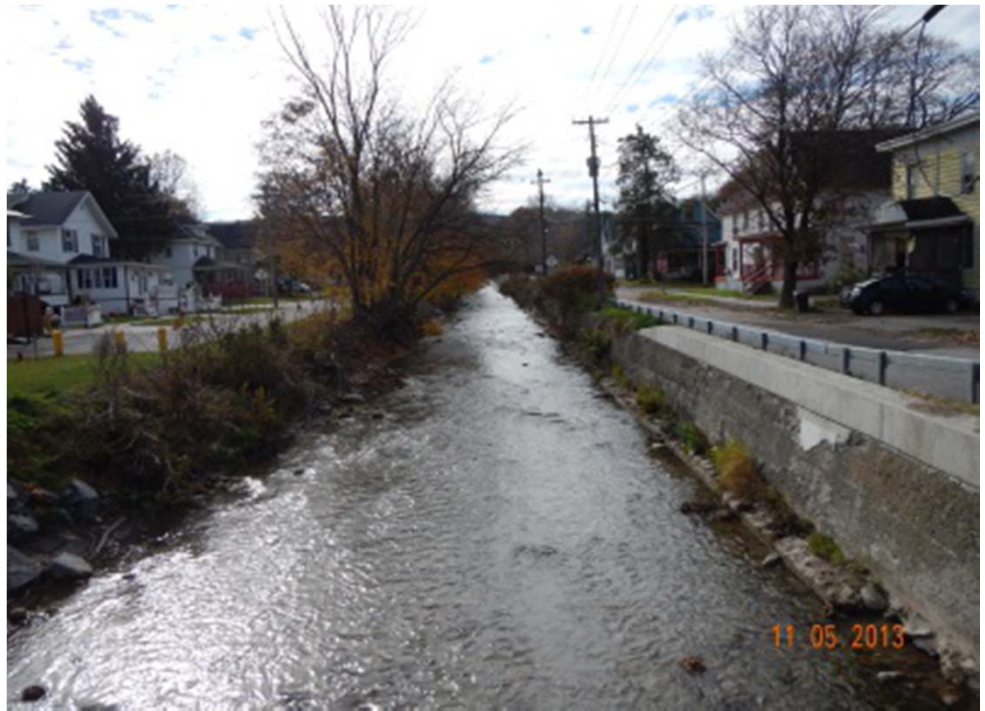
5

Photo taken from newly built Frederick Street bridge looking upstream to where the Philip Street bridge existed before being washed out in the 2013 floods. This straight stretch of river extends over a third of a mile from station 80+00 downstream to station 60+00.

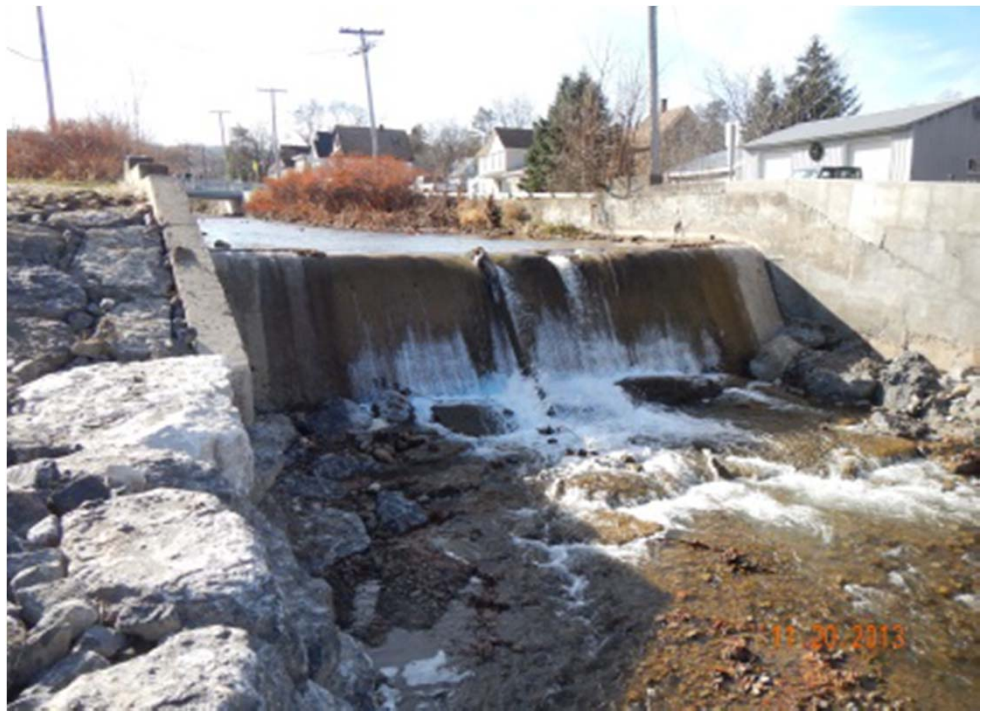
6

Dam located along E River Drive at station 64+75 with sporadic concrete channel banks, just downstream of Frederick Street bridge crossing.

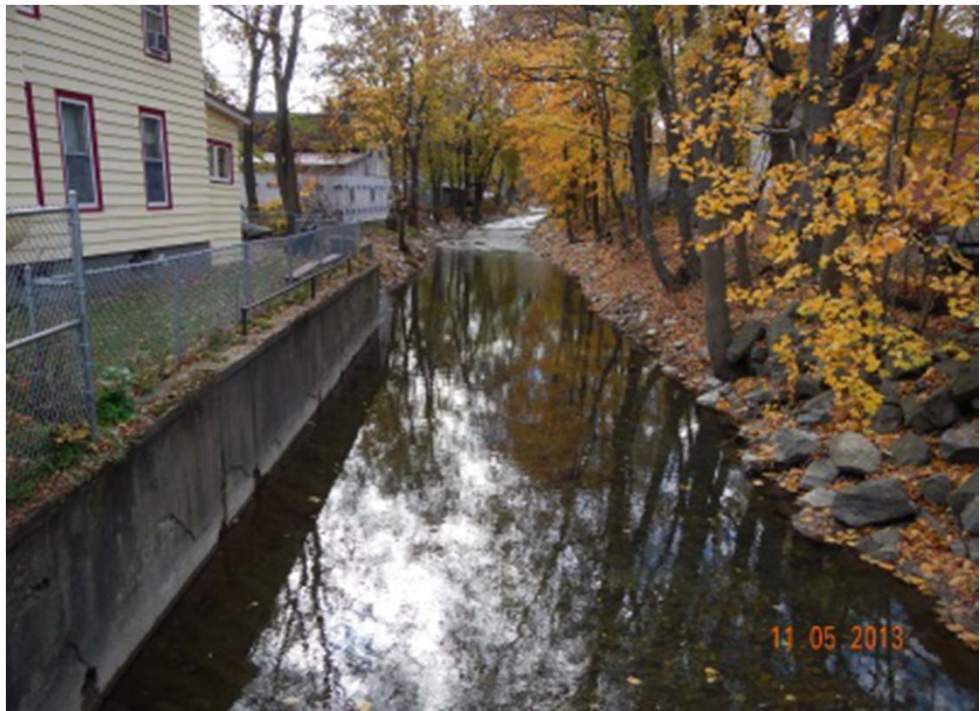
Looking upstream from the Third Street crossing at station 42+50, the channel banks are lined with discontinuous concrete walls. This is one of the many areas that becomes ponded under high flows due to the hydraulic constriction from the bridge.

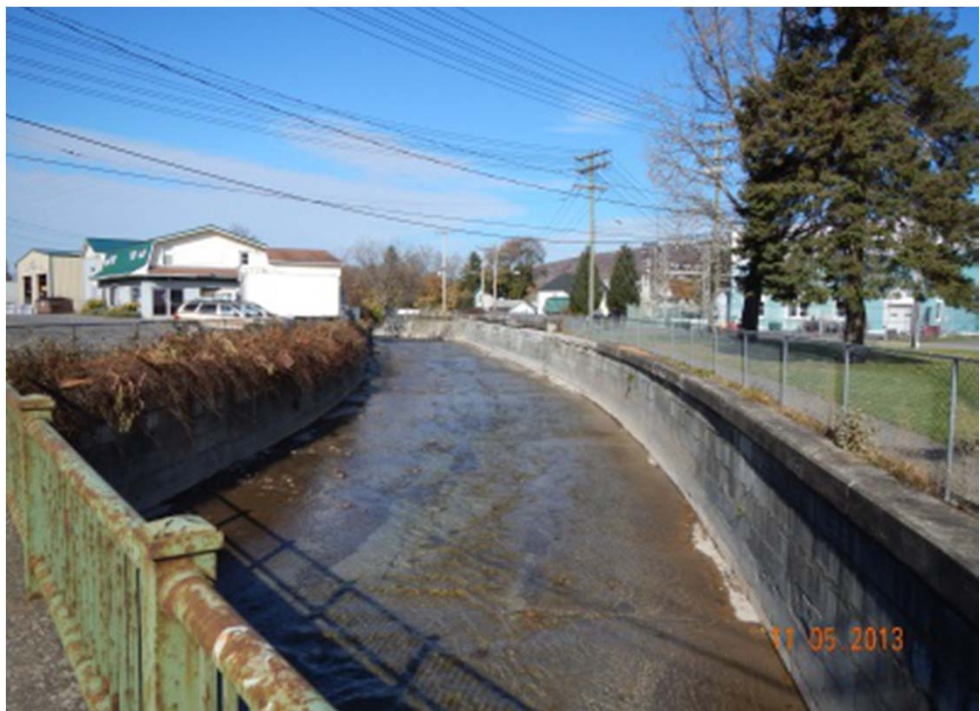
8

A concrete lined section of Steele Creek beginning just upstream of the Main Street bridge at station 27+00 to downstream station 22+00.
