**EMERGENCY TRANSPORTATION INFRASTRUCTURE RECOVERY**  
**WATER BASIN ASSESSMENT**  
**AND FLOOD HAZARD MITIGATION ALTERNATIVES**

**NOWADAGA CREEK**  
**HERKIMER COUNTY, NEW YORK**

April 2014

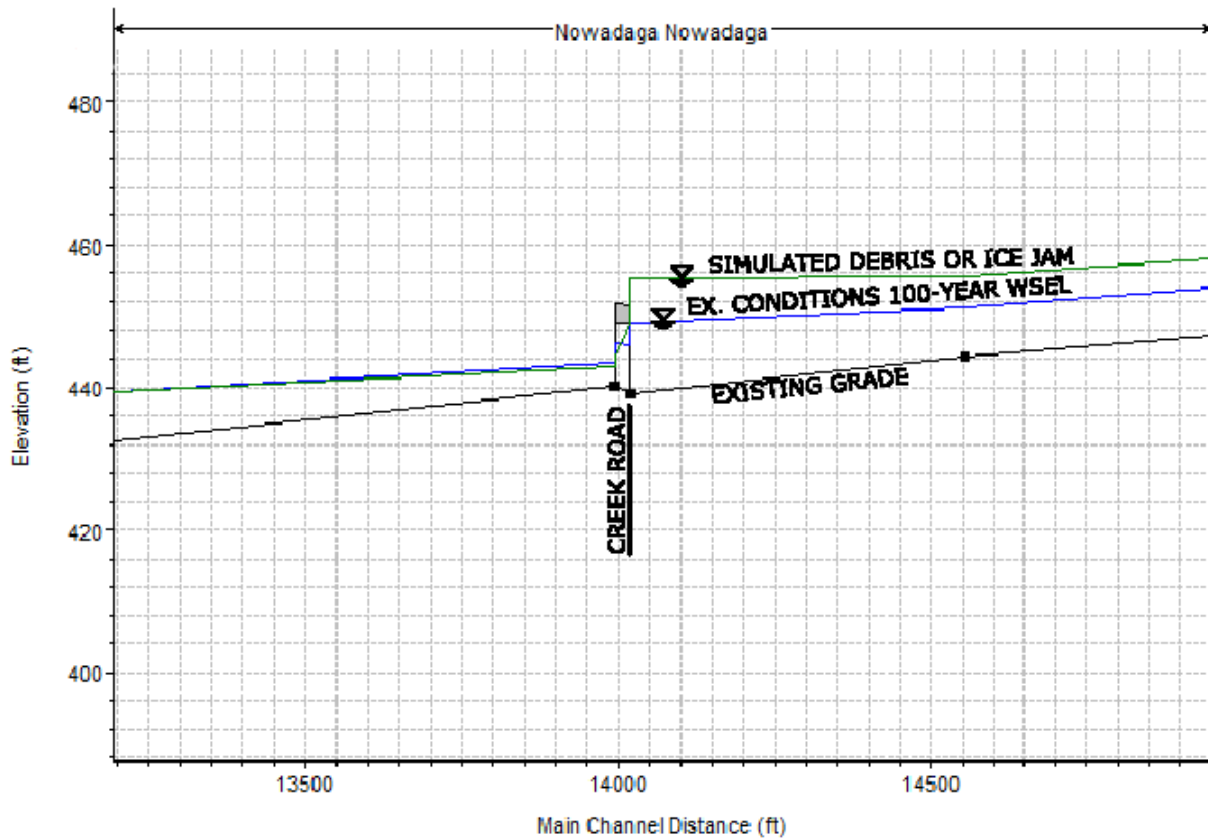
**FIGURE 6**  
**Modeling Results of Debris Jam Near STA 142+00**

Modeling results showing a water surface elevation profile of the 100-year flood event with and without a simulated debris jam are presented in Figure 6. The blue line shows modeled water surface elevations for existing conditions. The flow of water in this diagram is from right to left. The line jumps up moving from downstream to upstream (left to right across the diagram), indicating the bridge acts as a hydraulic constriction. When a debris jam is simulated, as shown by the green line, the hydraulic constriction is greater, causing water to overtop the bridge.

The bridge is visibly in poor condition and is poorly aligned with the creek. Its large piers make it highly prone to debris jams. Full replacement of this bridge with a new bridge that is better aligned with the creek would reduce debris jams and alleviate the hydraulic constriction. Hydraulic modeling shows that eliminating the center pier from the design will be sufficient to remove the hydraulic constriction. As such, the existing bridge width of 68 feet (measured from skew) or non-skew width of approximately 96 feet appears adequate. Detailed modeling should be conducted during design to confirm the final span dimension.

Replacement of the bridge at Creek Road near STA 142+00 with a single (approximate 96-foot) span structure is recommended. This will reduce flooding of the house located on the left bank. When the rail-to-trail bridge near STA 14+25 is due for replacement, it should be appropriately sized, with consideration given to high flows, debris accumulation, and ice jamming. Similar to the structure at Creek Road, a single span structure of approximately 96-feet is recommended. Until such time as the bridge is replaced, floodproofing of nearby homes on a case-by-case basis is recommended.

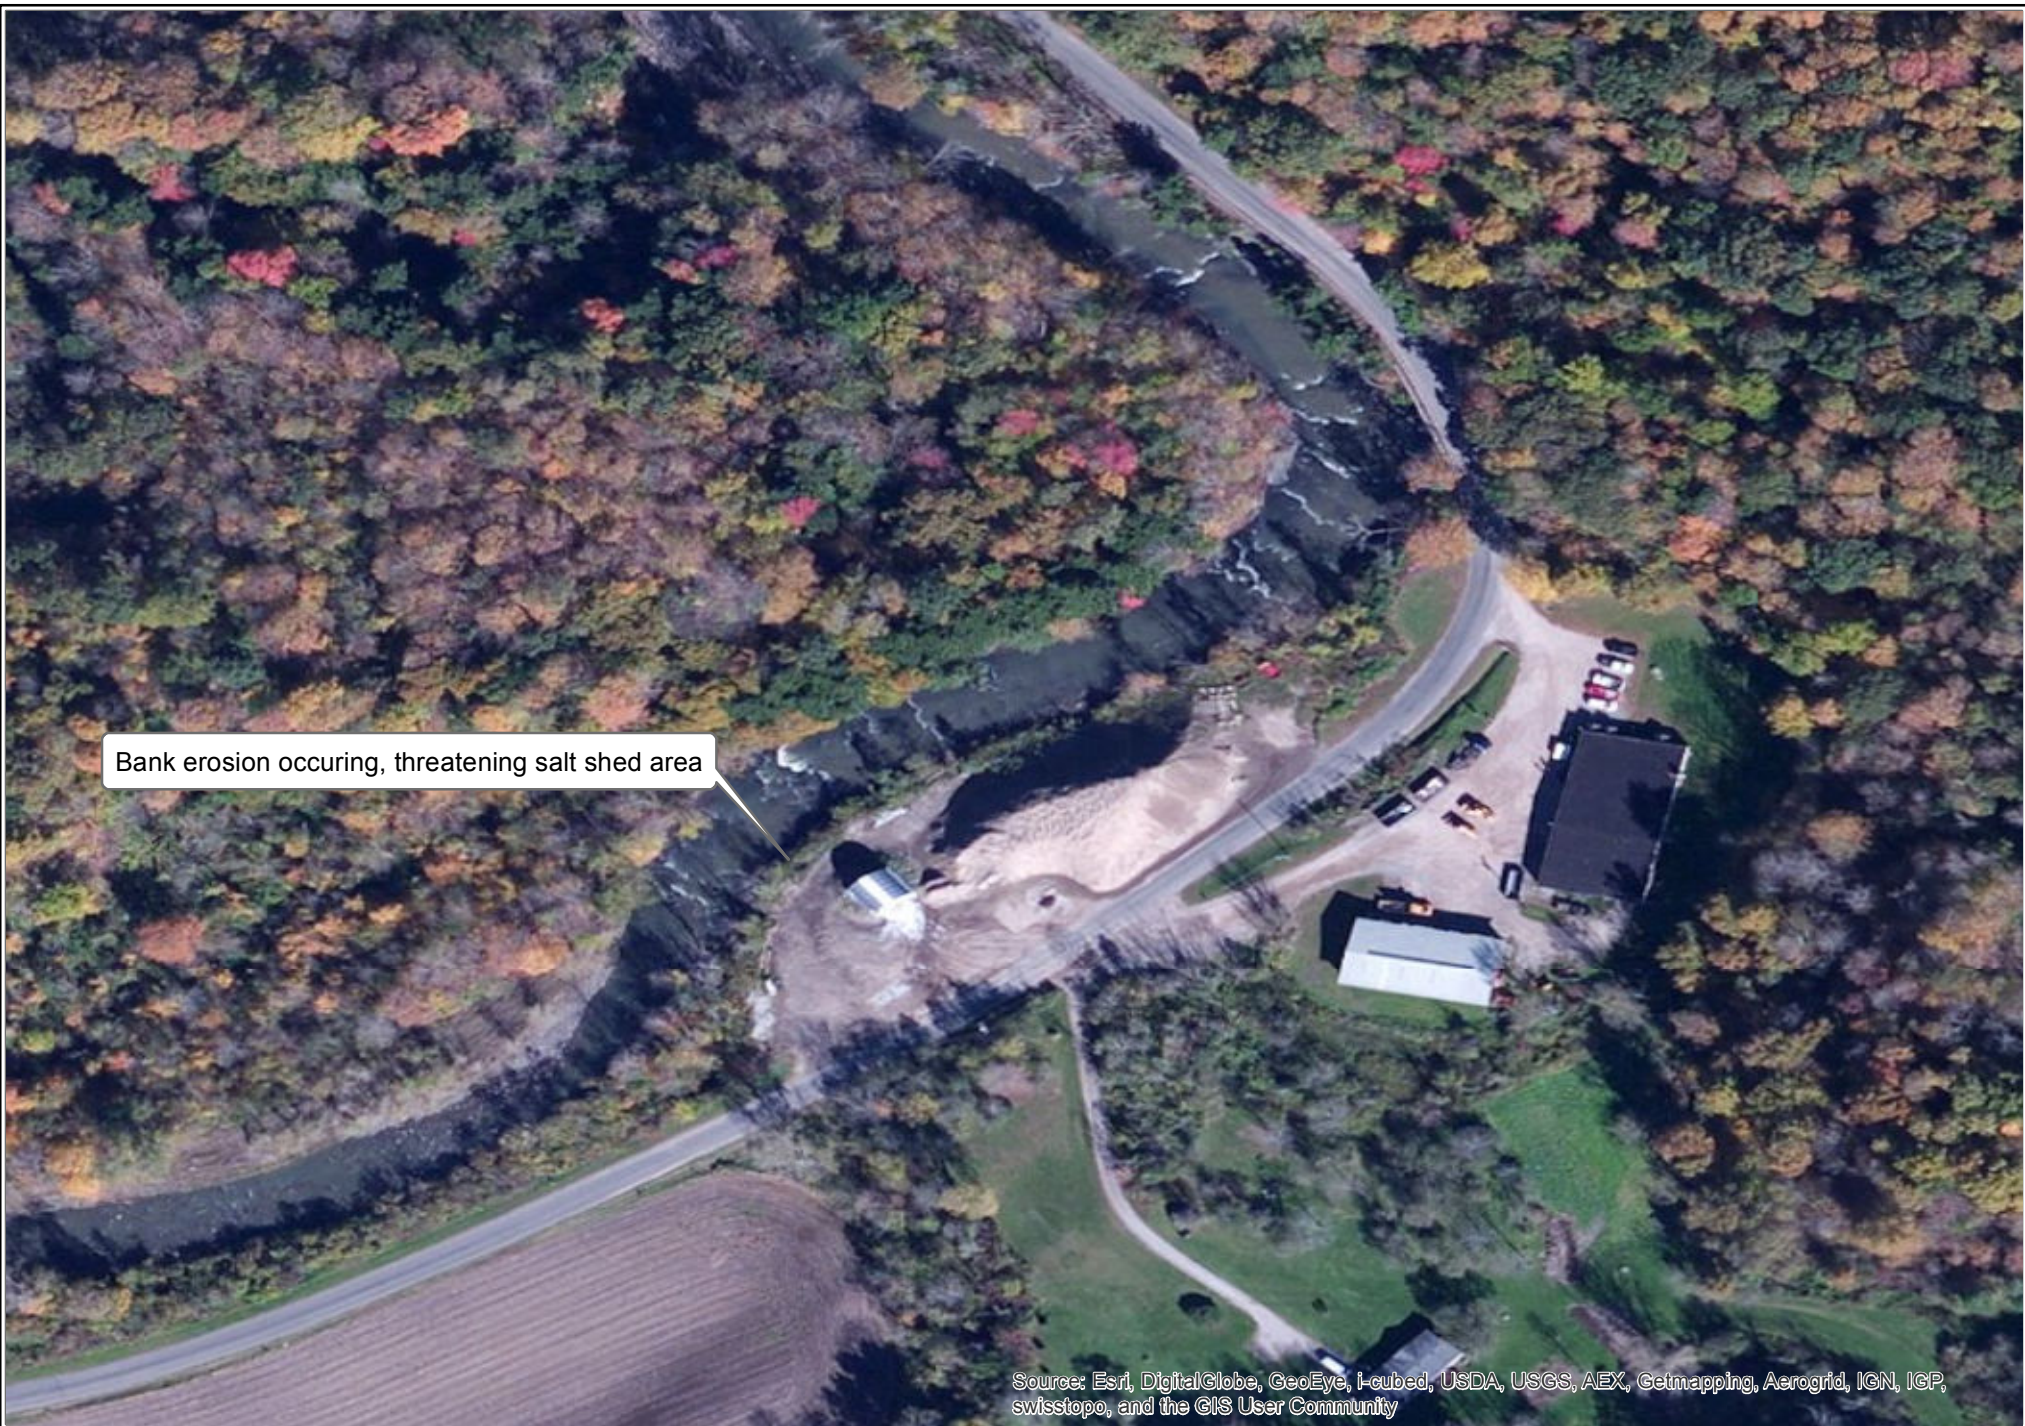
The location of the salt storage shed and other stockpiled materials in an area of apparent fill within the natural floodplain of the river leaves the shed, stockpiled material, and filled stream bank prone to undermining. Moving the shed and stockpiled materials to a different location further away from the creek would prevent the loss of these materials. A logical relocation site is across Creek Road in the area of the town garage.

Bank erosion occurring, threatening salt shed area

Alternative 3-1 is recommended.

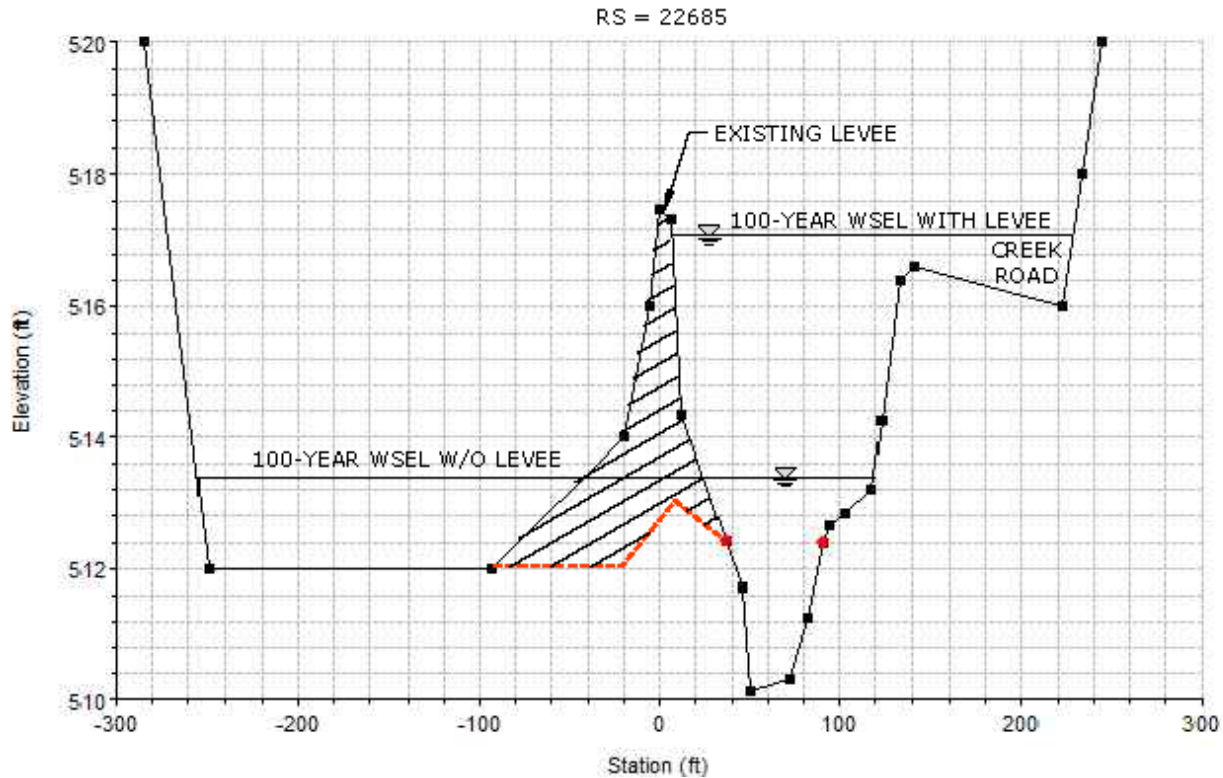
**FIGURE 10**  
**Modeling Results of Levee in the Vicinity of STA 228+00 to STA 223+00**

Figure 9 is a location plan of High Risk Area #4. Immediately downstream of Tibbitts Road on the left bank, a levee has been constructed by a local homeowner in the vicinity of STA 223+00 to STA 228+00. The levee isolates the creek from its natural floodplain on the inside of a sharp left bend. Hydraulic modeling indicates that while the levee may protect the home and yard from flooding it also causes an increase in water surface elevation along Creek Road and will contribute to flooding of the road and possibly adjacent homes during significant flood events. The levee also acts to constrict flows and increases flow velocities, contributing to erosion.

Alternative 4-1 is recommended to reconnect Nowadaga Creek to its floodplain and reduce flooding along Creek Road.

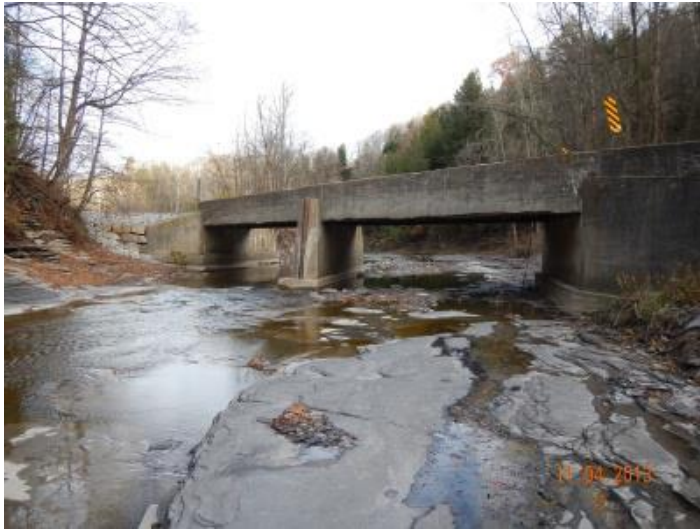
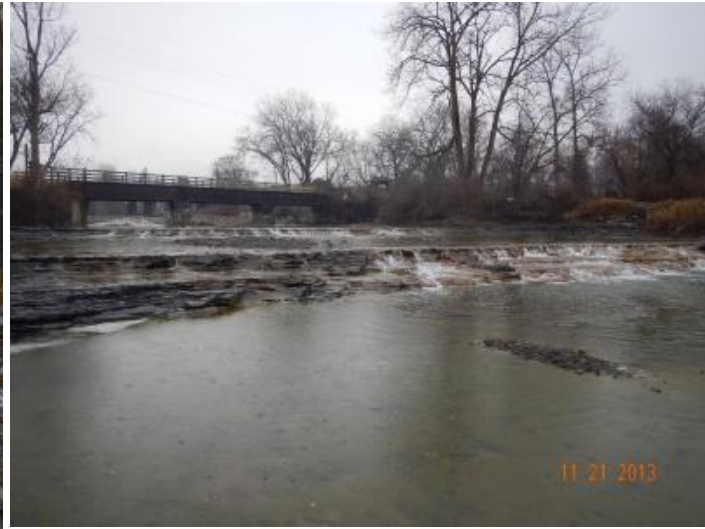
**Site Description:** Several bridge crossings along Nowadaga Creek are undersized and cause hydraulic restriction during low frequency flooding events. At the upstream end is the Creek Road Crossing (STA 142+00, Left Picture) and downstream is the rail-to-trail bridge at (STA 14+25, Right Picture).

- Replace the Creek Road Crossing with a new bridge that is better aligned with the creek and sized to reduce debris jams and alleviate the hydraulic constriction.
- When the rail-to-trail bridge is due for replacement, it should be appropriately sized, with consideration given to high flows, debris accumulation, and ice jamming. Until such time as the bridge is replaced, flood-proofing of nearby homes on a case-by-case basis is recommended.

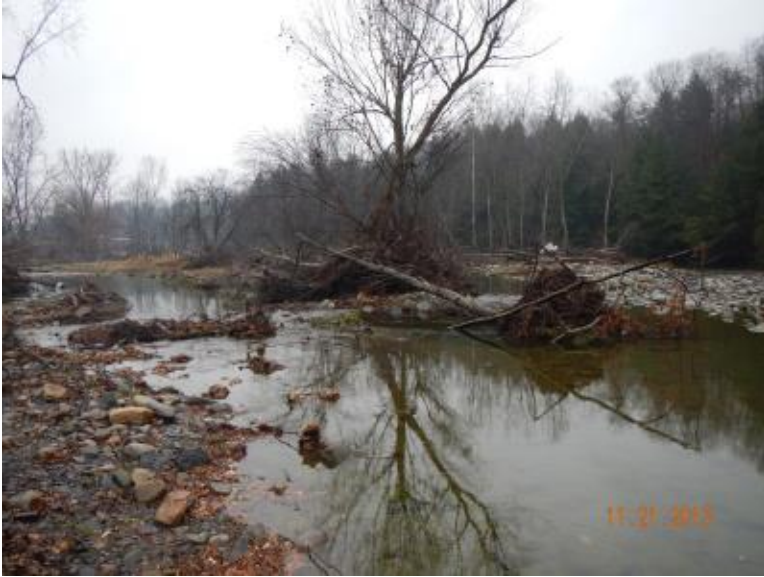
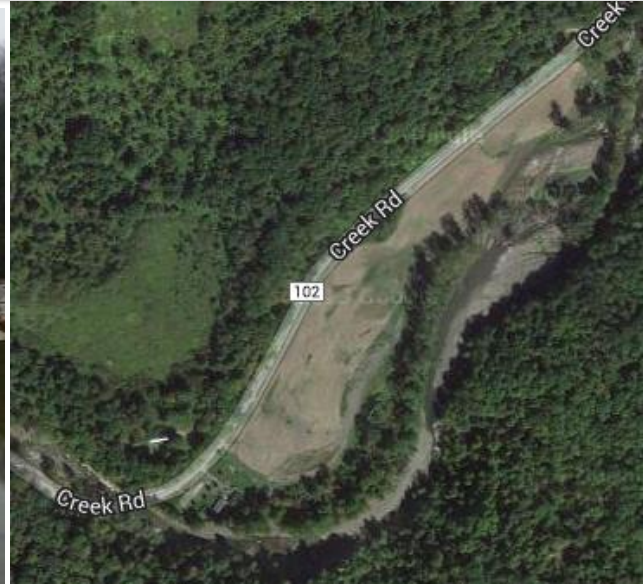
**Site Description:** Between STA 142+00 and 103+00, the channel within this reach is highly unstable and present is heavy deposition, channel avulsion and bank erosion.

- Stabilize the bank along approximately 200 feet of the channel to reduce sediment loading that is contributing to the downstream channel avulsion.
- Clear the sediment and woody debris from the channel to allow it to return to its previous location and allow the landowner to make use of the agricultural field. The channel should not be extensively dredged.

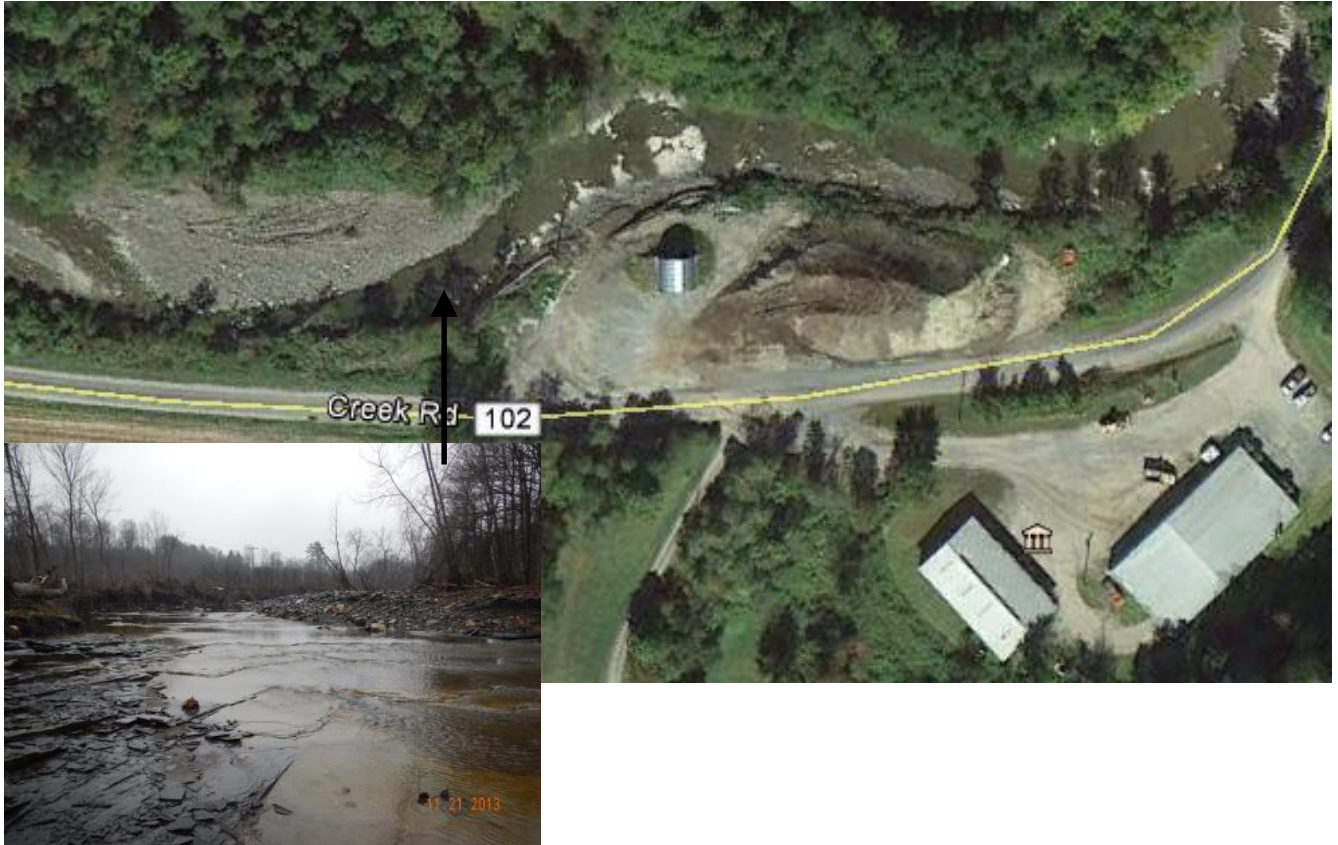
**Site Description:** Bank erosion is occurring the vicinity of the Danube Department of Public Works Garage, from STA 180+00 to STA 176+00, threatening the salt storage shed and other stockpiled materials.

- Move the shed and stockpiled materials to a different location further away from the creek.
- Stabilize the toe of bank and re-establishment a floodplain on the right bank to mitigate ongoing erosion.

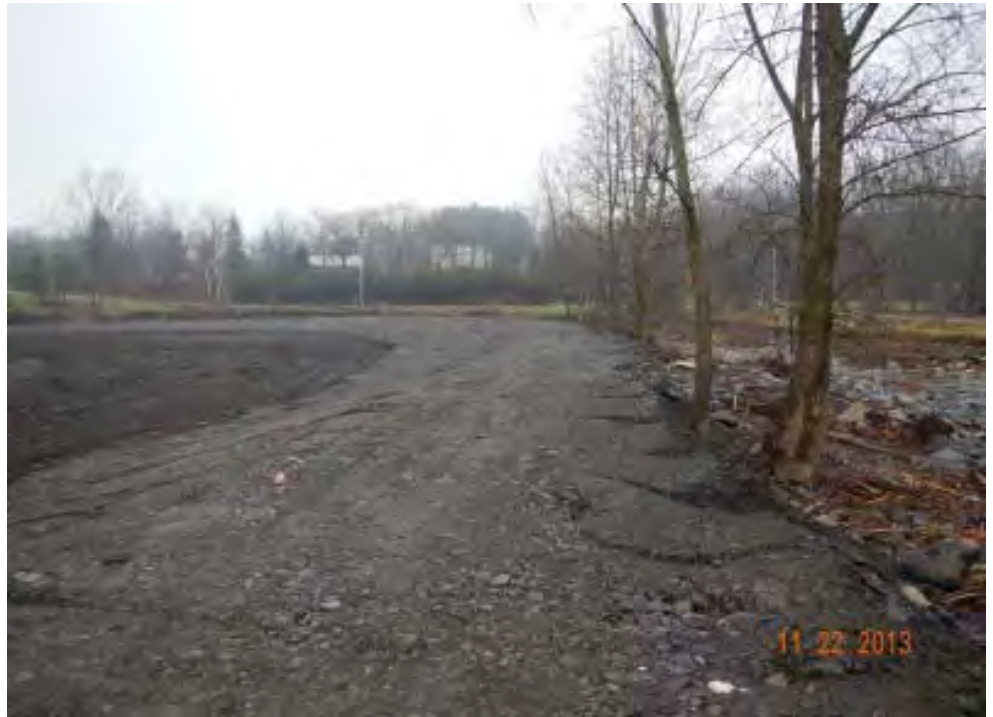
Located at approximate STA 224+00 is a constructed berm along the banks of the creek aimed at confining flow to the main channel.

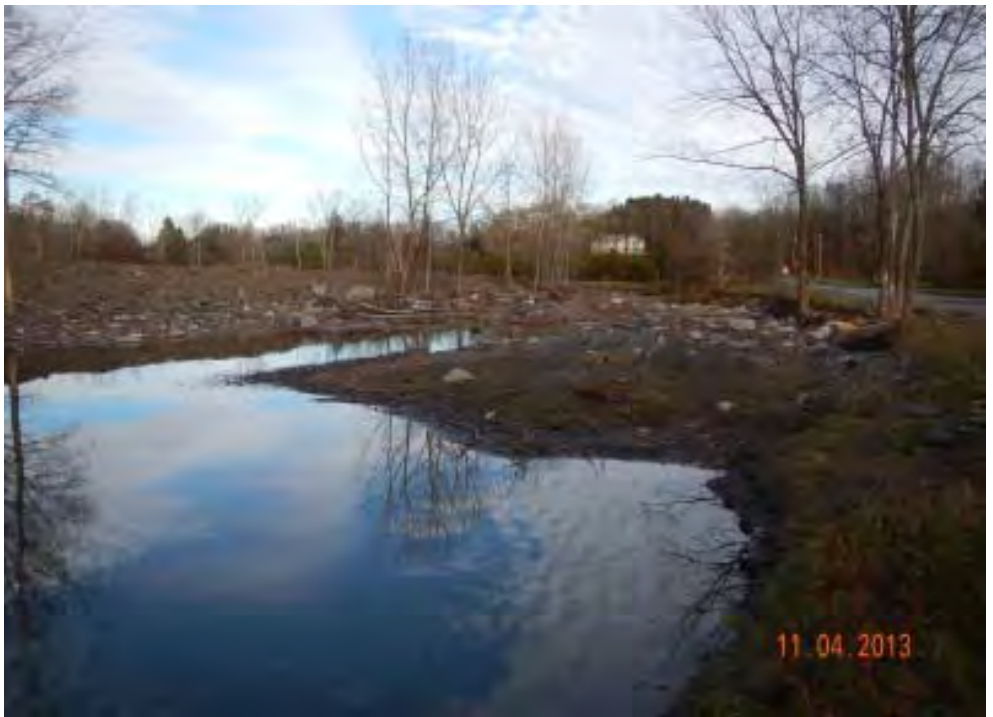
**2**

Looking from the opposite bank of the river as above, this depicts the higher elevation of the berm relative to the height of the road.

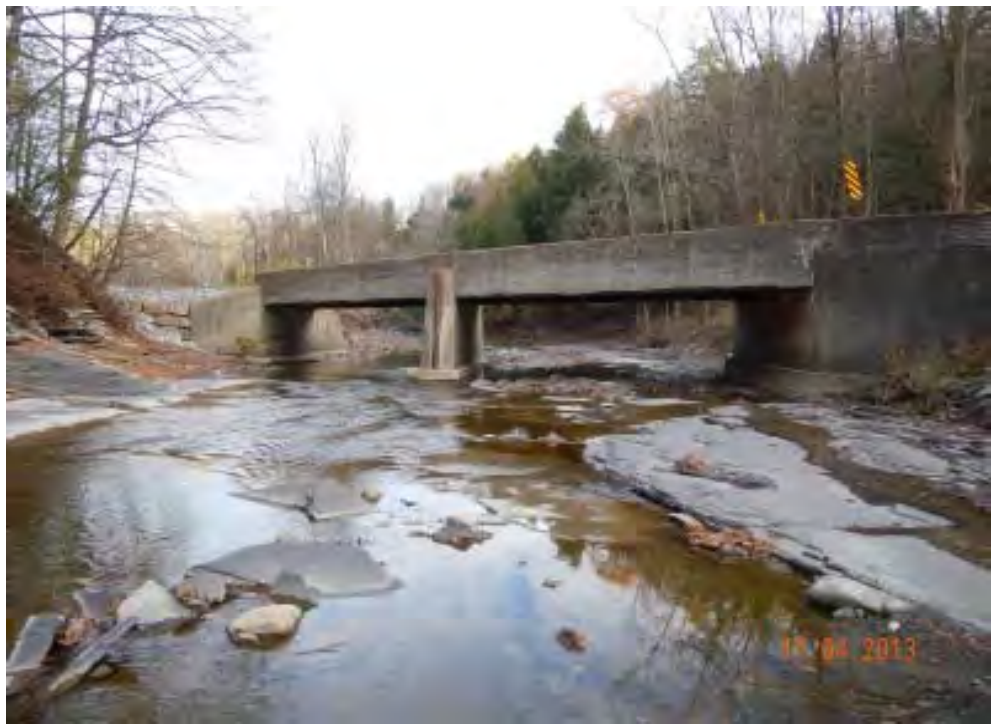
**3**

The Creek Road Bridge crossing at STA 142+00 has a history of ice and debris jamming that restrict floodwaters and causes water to overtop the road.

3. Replace the Bridge at Creek Road Crossing Near STA 142+00 – Replacement of the bridge at Creek Road near STA 142+00 is recommended. This will reduce flooding of the house located on the left bank. The bridge is visibly in poor condition and is poorly aligned with the creek. Its large piers make it highly prone to debris jams. Full replacement of this bridge with a new single span bridge of similar span (approximately 96 feet) but without piers and that is better aligned with the creek will reduce debris jams and alleviate the hydraulic constriction. If piers are required to support the new structure, additional hydraulic analysis should be undertaken to develop a solution that is not prone to ice and debris jams and that does not create a hydraulic constriction.

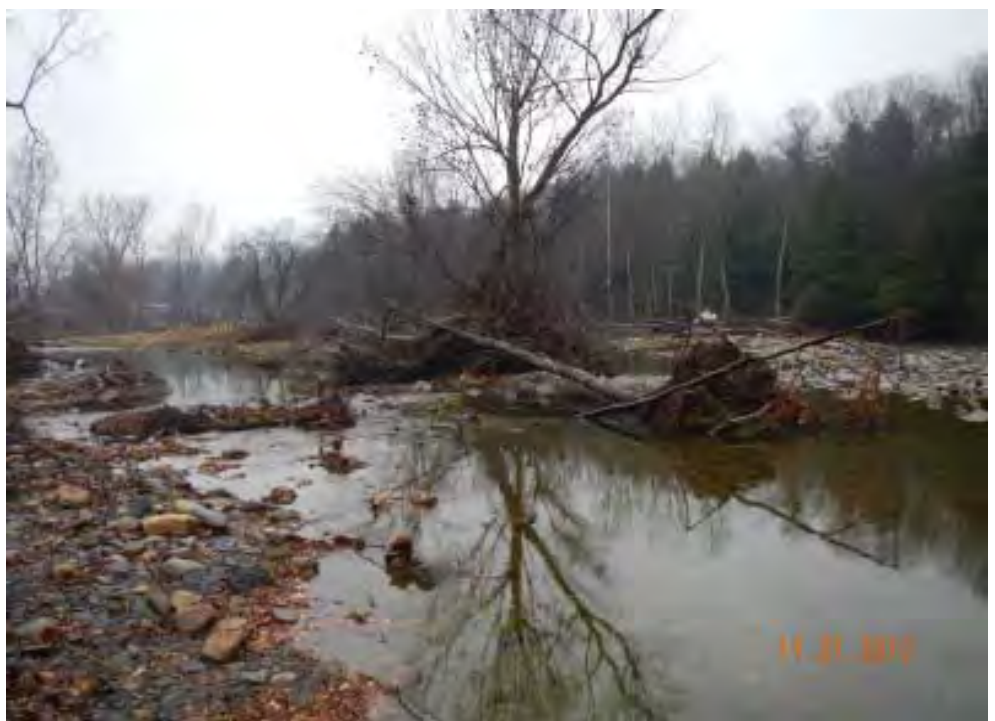
**4**

The channel has become unstable between STA 126+00 and 112+00, where the channel is braiding and impacting adjacent agricultural land.

5. Repair of Channel Avulsion in the Vicinity of STA 122+00 – A substantial avulsion has formed in the vicinity of STA 122+00, where the channel has relocated through an agricultural field. Clearing sediment and woody debris from the channel would allow it to return to its previous location and would allow the landowner to make use of the agricultural field. The channel should not be extensively dredged.

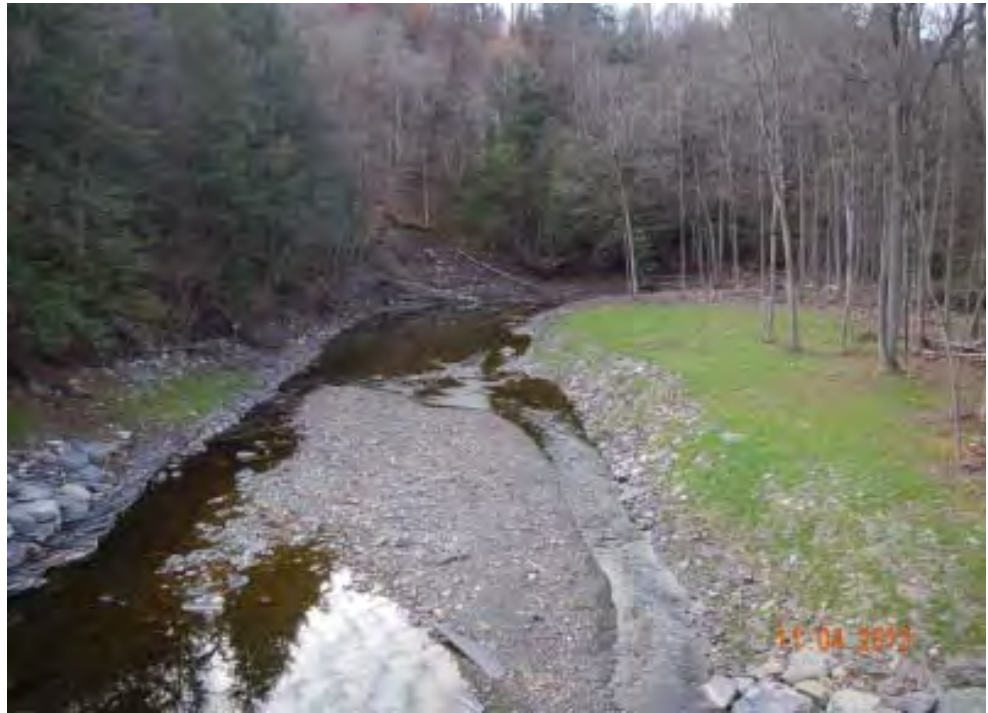
**5**

Looking downstream from the Creek Road crossing at STA 99+00, a sediment bar has aggradated mid-channel and a small bank failure can be seen downstream.

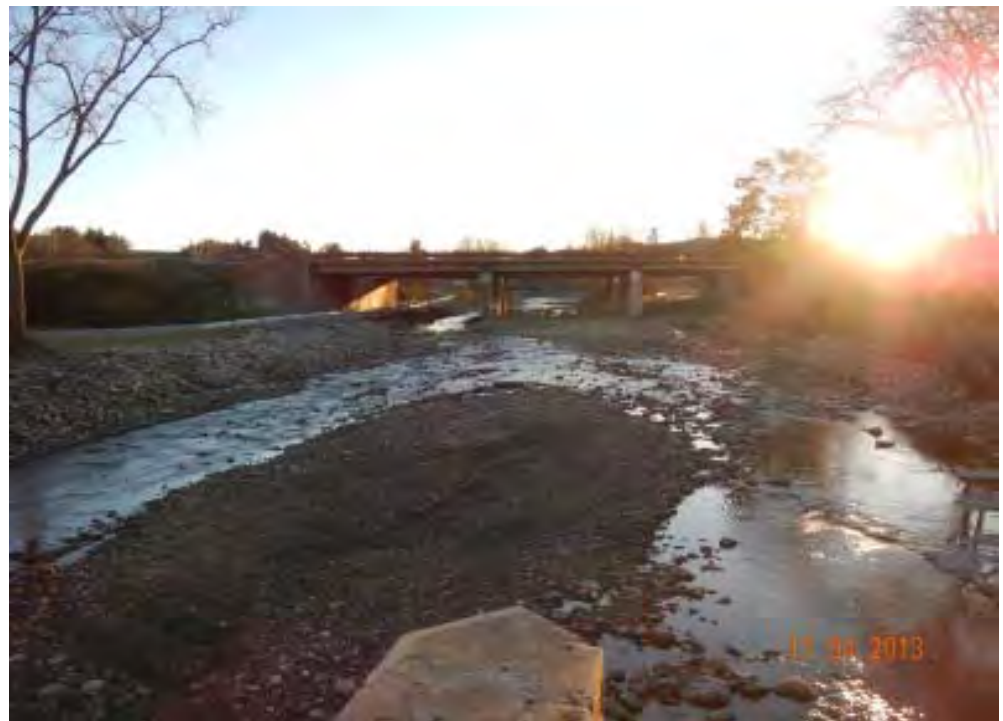
**6**

In the lower stretch of Nowadaga Creek, the river channel significantly widens, inducing heavy deposition of sediments.
