EMERGENCY TRANSPORTATION INFRASTRUCTURE RECOVERY
WATER BASIN ASSESSMENT
AND FLOOD HAZARD MITIGATION ALTERNATIVES

BELLINGER BROOK AT THE VILLAGE OF HERKIMER
HERKIMER COUNTY, NEW YORK

April 2014

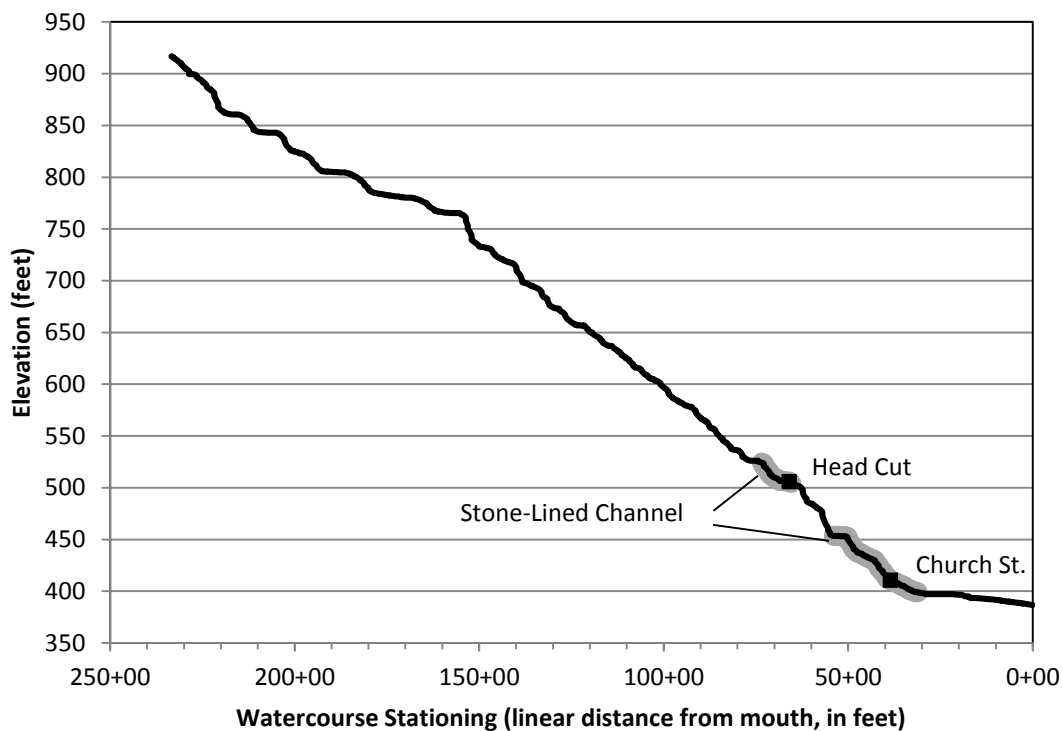
**FIGURE 4
Bellinger Brook Channel Profile**

Figure 4 presents a profile of Bellinger Brook, showing its elevation versus linear distance from the mouth of the watercourse, as well as the locations of the headcut, the Church Street bridge, and the stone-lined channel. The brook drops a total of 530 vertical feet over its 4.4-mile length, from an elevation of 916 feet above sea level at its headwaters to 386 feet at its outlet to the Mohawk River.

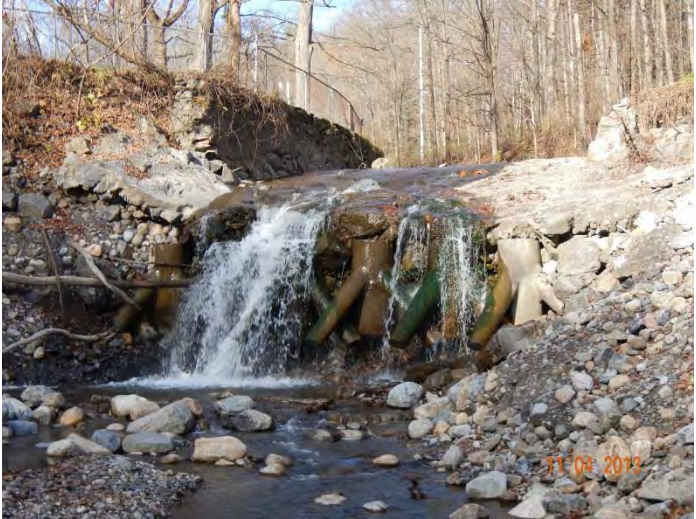
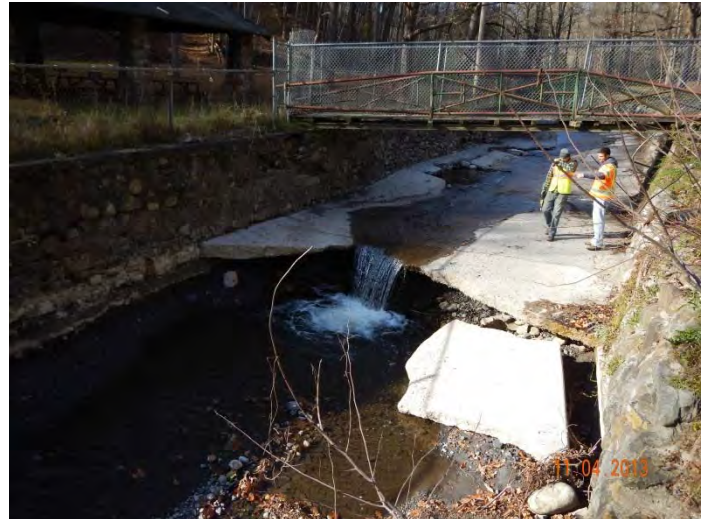
High-Risk Area #1 – Head Cut in Brookwood Park

Site Description: Located in Brookwood Park, this site includes a deteriorating grade control structure and a large (11-foot' high) head cut extending downstream approximately 275 feet. The head cut is contributing to downstream sediment loads and causing channel instability. The concrete-bottomed channel just upstream of the deteriorating grade control structure is being undermined.

- Place appropriately sized rock fill against the head cut and armor with large stone and/or sheet pile grade control structures.
- Stabilize the deteriorating concrete channel upstream of the grade control structure.

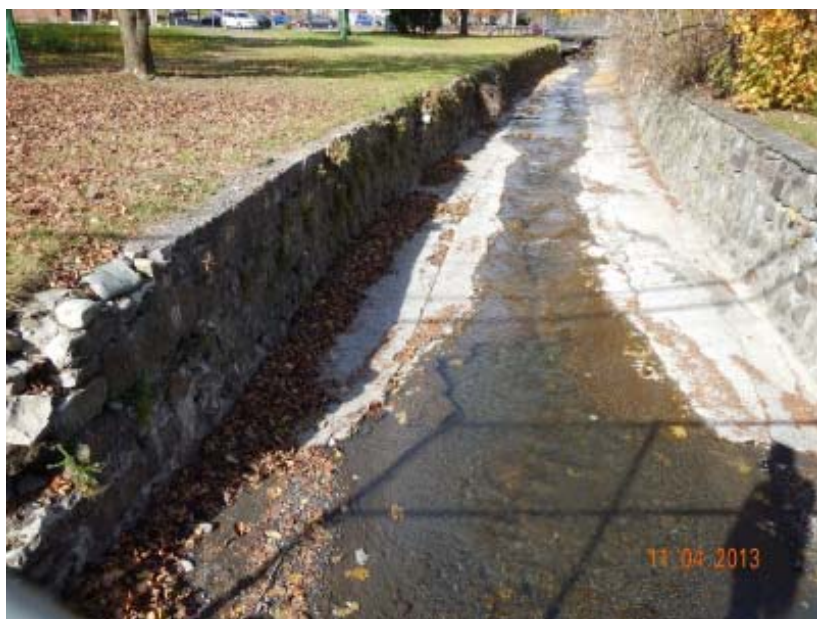
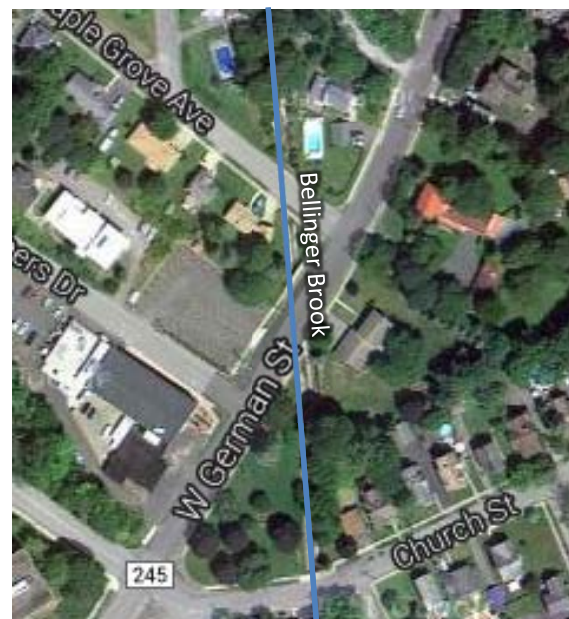
High-Risk Area #2 – Concrete Lined Channel

Site Description: Beginning at station 46+00 downstream to station 31+00, is a concrete lined channel that routes Bellinger Brook through the developed town of Herkimer. The channel is deteriorated at many points and highly constricts floodwaters, with no floodplain to accommodate flood flows.

- Modify the channel to a multi-stage compound channel, including an inner 25-foot wide by two-foot deep bankfull channel with a minimum of 10 feet of floodplain bench on both sides.
- Acquire easements and several high risk residential properties near Maple Grove Avenue, West German Street, and Church Street to accommodate the larger stream corridor.

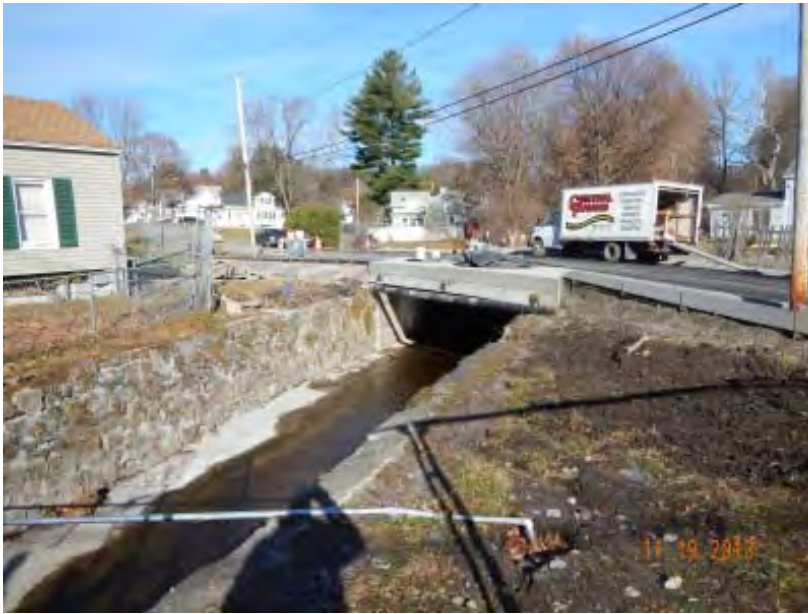
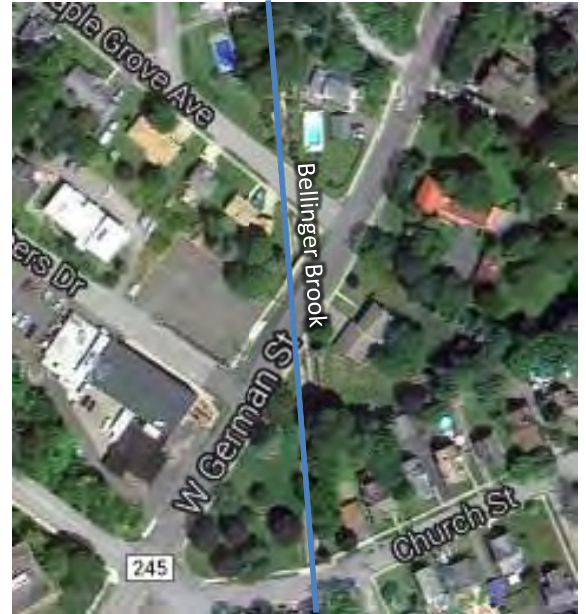
High-Risk Area #2 – Undersized Bridges

Site Description: Bridge crossings at Maple Grove Avenue, West German Street, and Church Street severely constrict hydraulic flows, are subject to ice jams and debris clogging, and are a major factor in area-wide flooding.

- Remove the Maple Grove Avenue Bridge and convert the road to a cul-de-sac.
- Replace the West German and Church Street bridges with new 45-foot minimum span bridges.

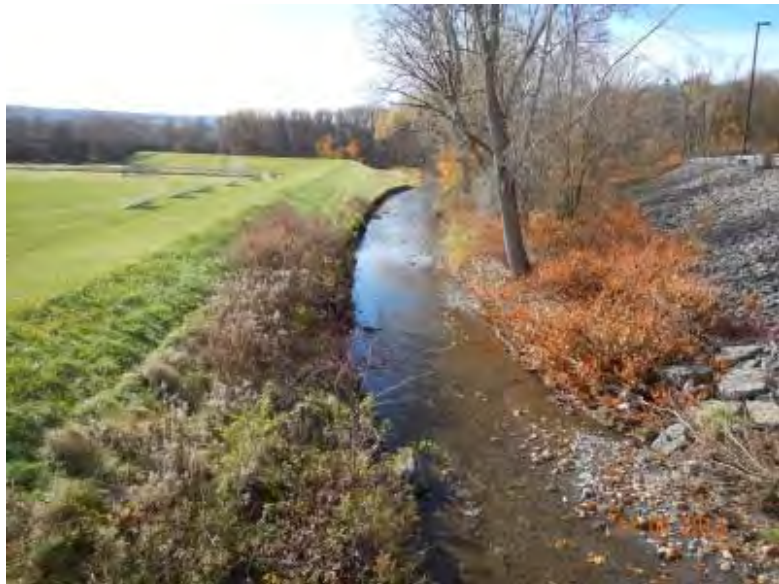
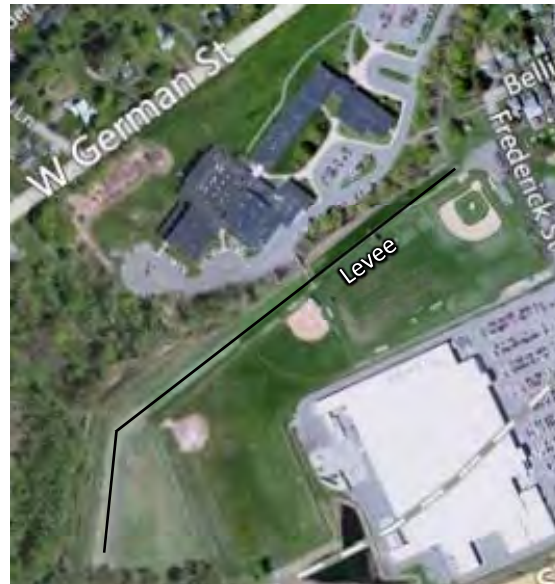
High-Risk Area #3 – Leveed Channel at High School

Site Description: Located just south of Herkimer High School along the athletic fields is a man made levee designed to contain flows of Bellinger Brook. The levee runs from station 32+00 downstream to station 16+00 and shows signs of linear erosion at some sections along the channel. Two pedestrian bridges span the river just upstream of the levee and midway, creating a hydraulic constriction at the upstream point.

- Replace the pedestrian bridge near the Herkimer Junior/Senior High School with a larger structure with one of approximate 60-foot span.
- Repair and armor the levee to stabilize erosion and protect against future erosion.

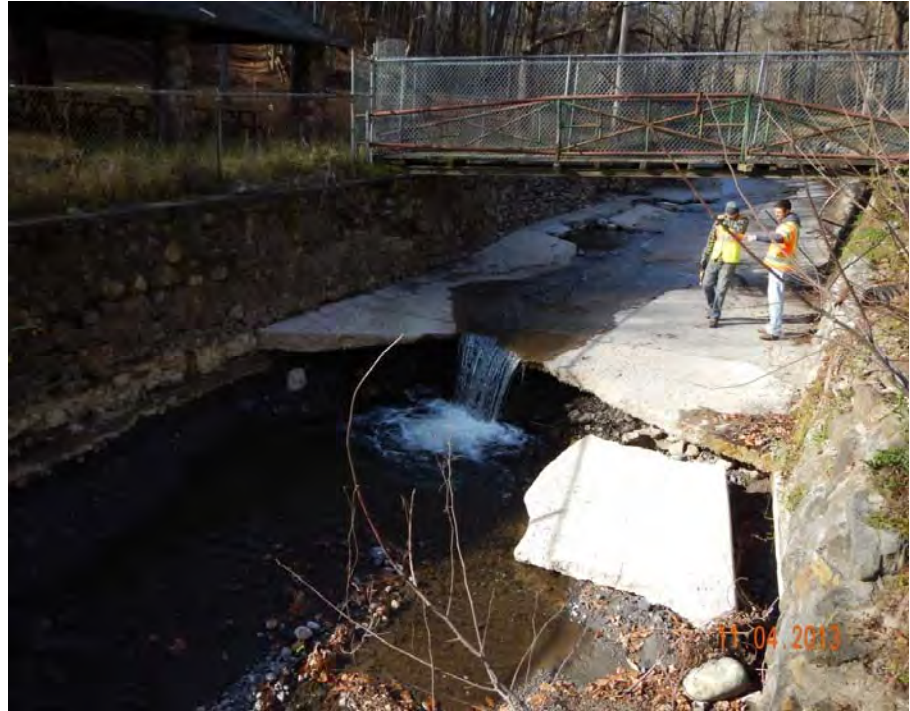
Upper concrete channel lining failure located approximately 200 feet upstream of large head cut.

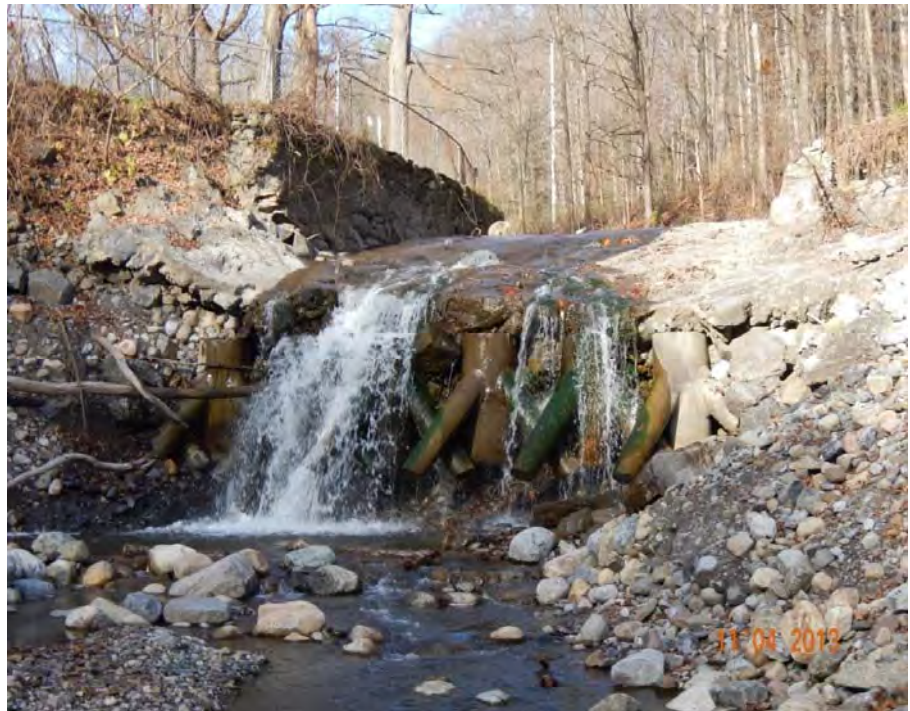
2

A large erosional headcut has formed in Bellinger Brook and has been arrested in place by a concrete "jack" grade control structure near STA 65+75, just downstream of the Brookwood Park pavilion. The headcut is a point of severe instability, a progressive major source of sediment, and at high risk of becoming more severe if not repaired.

Head cut and grade control structure failure at Brookwood Park.

Alternative 1-1 is recommended as the preferred alternative due to the effectiveness of arresting the headcut and the ability to prevent future erosion. If a limited amount of time and funding exist, Alternative 1-2 may be considered.

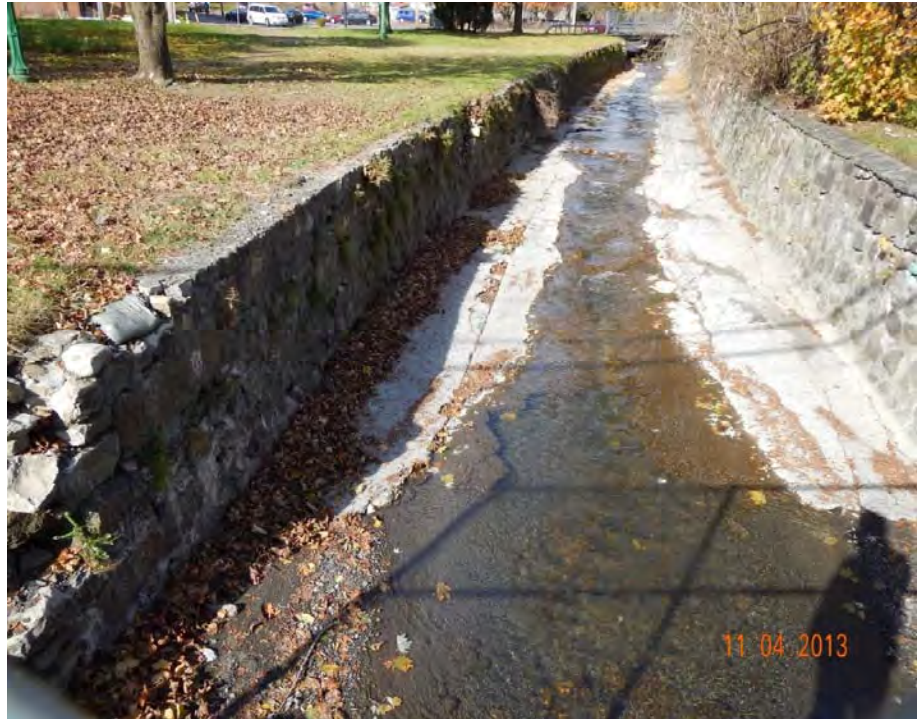
3

Concrete lined channel
between Church Street and
W German Street
crossings

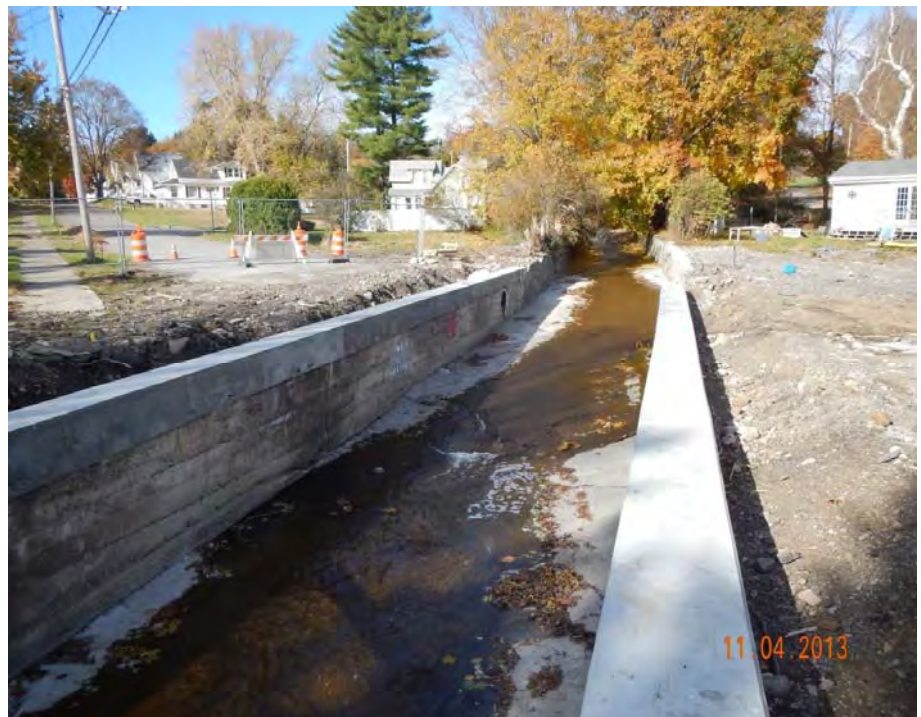
4

Reconstructed section of
concrete lined channel
where Maple Grove Ave
had been washed out in the
summer of 2013 flooding
events.

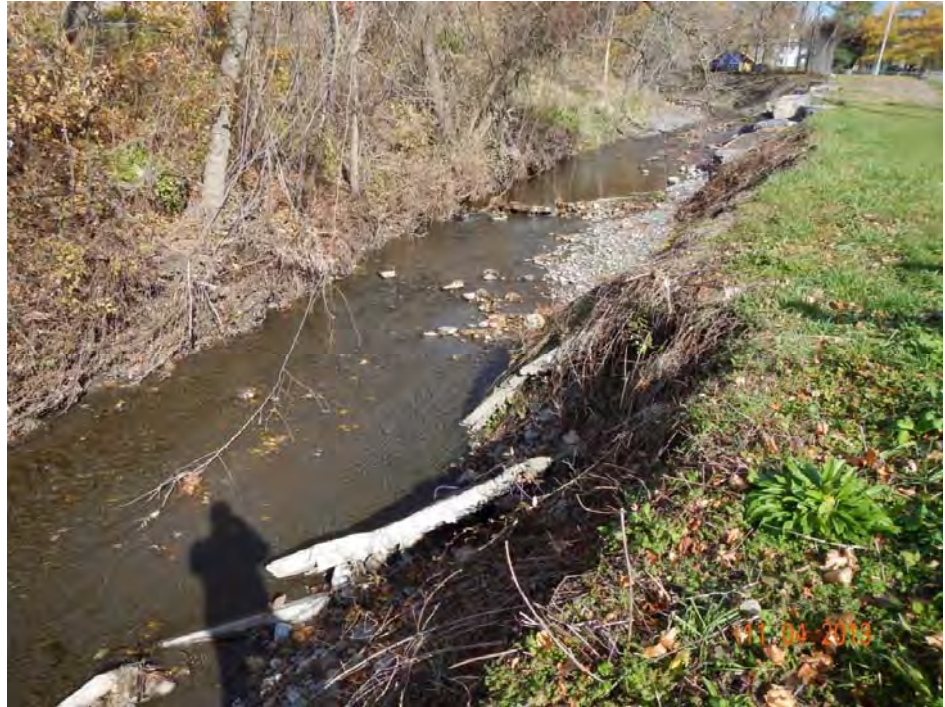
5

Straight run between the high school and ball fields detained by a levee on the left bank. Note the degrading along the leveed bank.

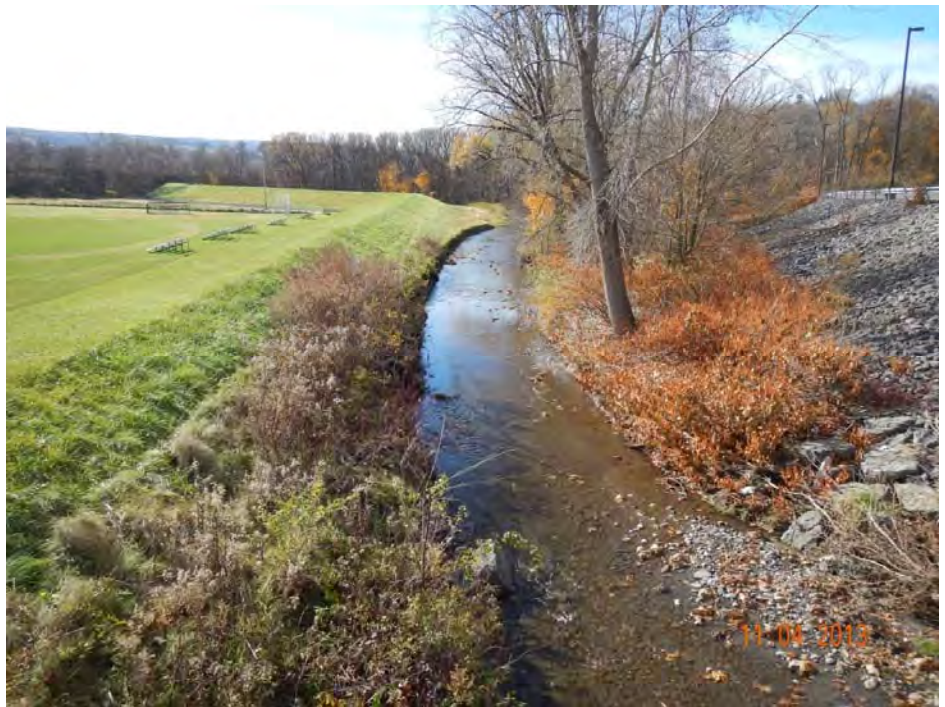
6

Looking downstream of photo 5, the levee can be seen along the left bank
