EMERGENCY TRANSPORTATION INFRASTRUCTURE RECOVERY WATER BASIN ASSESSMENT AND FLOOD HAZARD MITIGATION ALTERNATIVES

BIG CREEK ONEIDA COUNTY, NEW YORK

April 2014

MMI #5231-01

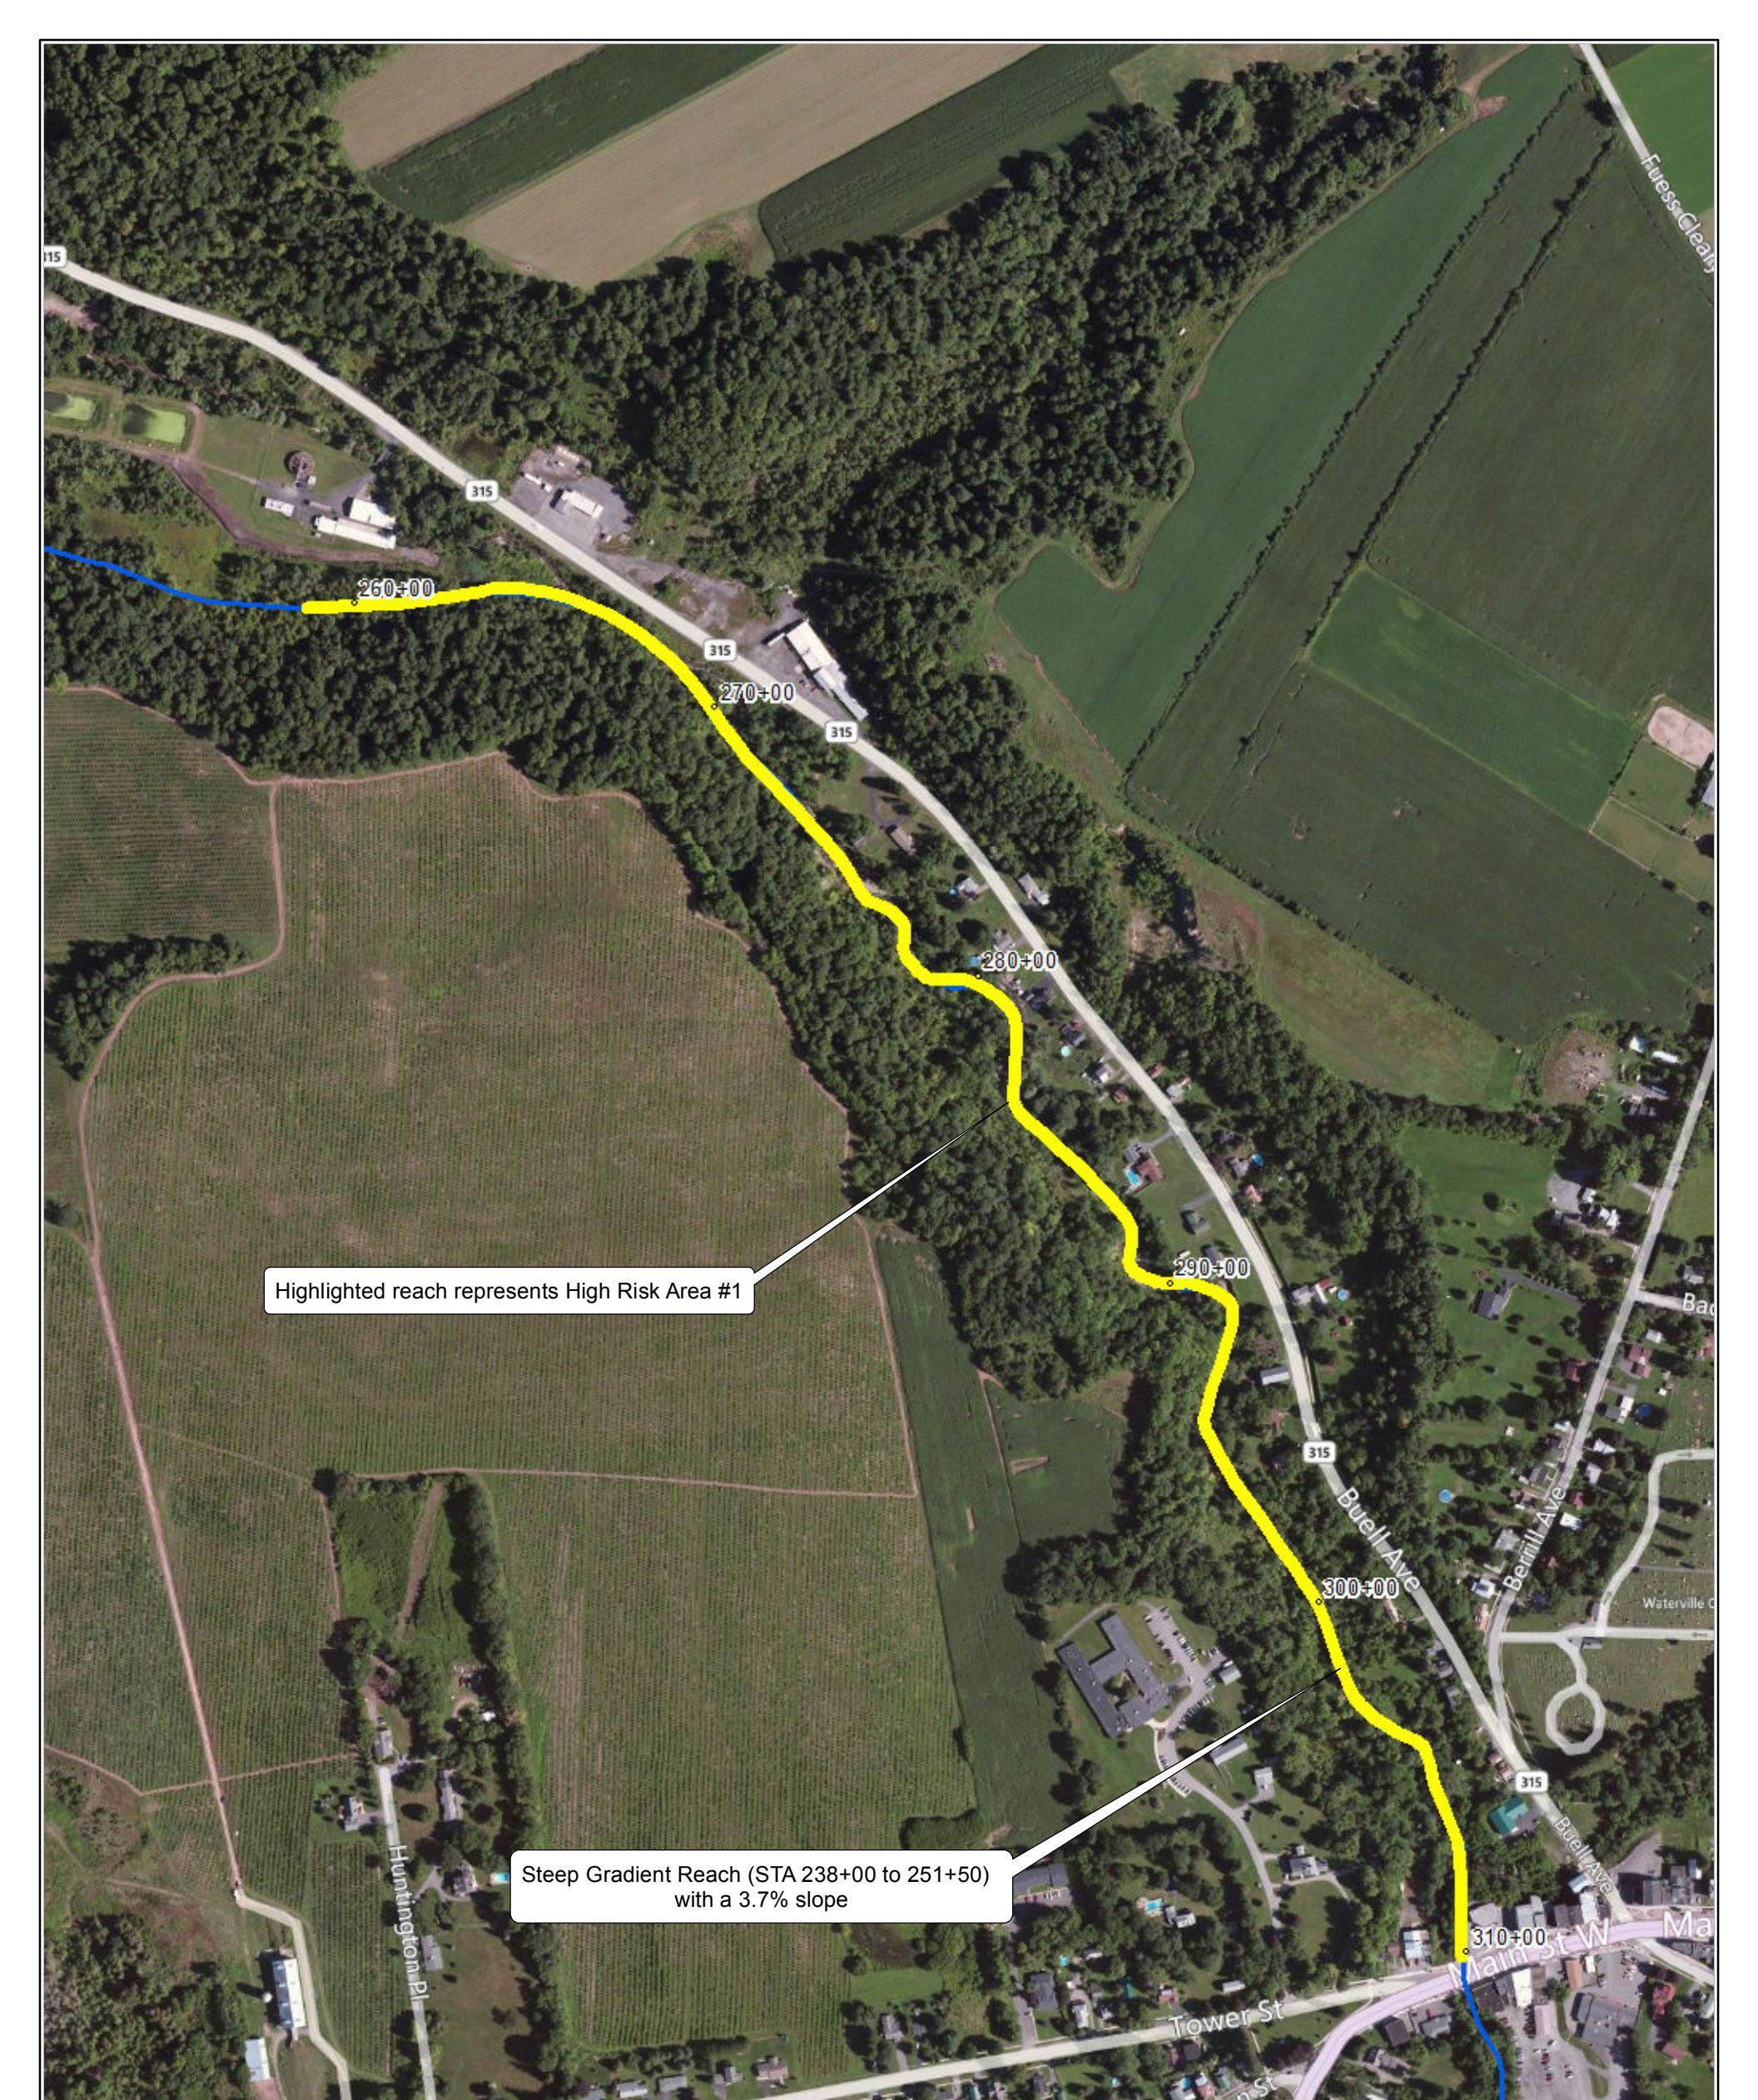
Figure 11 is a location plan of High Risk Area #1. This area includes Big Creek downstream of Waterville as it flows along Route 315 from Waterville (STA 310+00) to the wastewater treatment plant (STA 260+00). Within this section, floodwaters have overtopped the banks and caused bank erosion and failures. This reach of Big Creek becomes steeper, including a quarter-mile section that drops 50 feet, with a slope of 3.7 percent. The eroding banks and bank failures contribute to sediment loads in the stream and have caused trees to become uprooted and fall into the creek, resulting in a high volume of woody debris in the channel.

From STA 307+00 downstream to STA 274+00, the right creek bank is lined with houses, several of them located very close to the creek. During recent flood events, several of these homes experienced flooded basements as well as flood-related structural damage. On the left, the creek is confined by a high slope, which is eroding at several locations and contributing sediments to the creek. Near STA 264+50, utility lines associated with the wastewater treatment plant are being threatened by erosion.

The fundamental issue within the middle segment of Big Creek is many small bank failures. While no single one of these failures is the major cause of sediment transport, collectively they contribute a significant amount of sediment loading in Big Creek. Once mobilized, this sediment restricts channel and bridge capacity and exacerbates flooding.

Alternative 1-1: Stream Repair and Management Program

A stream repair and management program for this reach of Big Creek could be developed and implemented to address the multiple bank failures and areas of erosion on a site-by-site basis using a combination of conventional and bioengineering techniques. Such a program

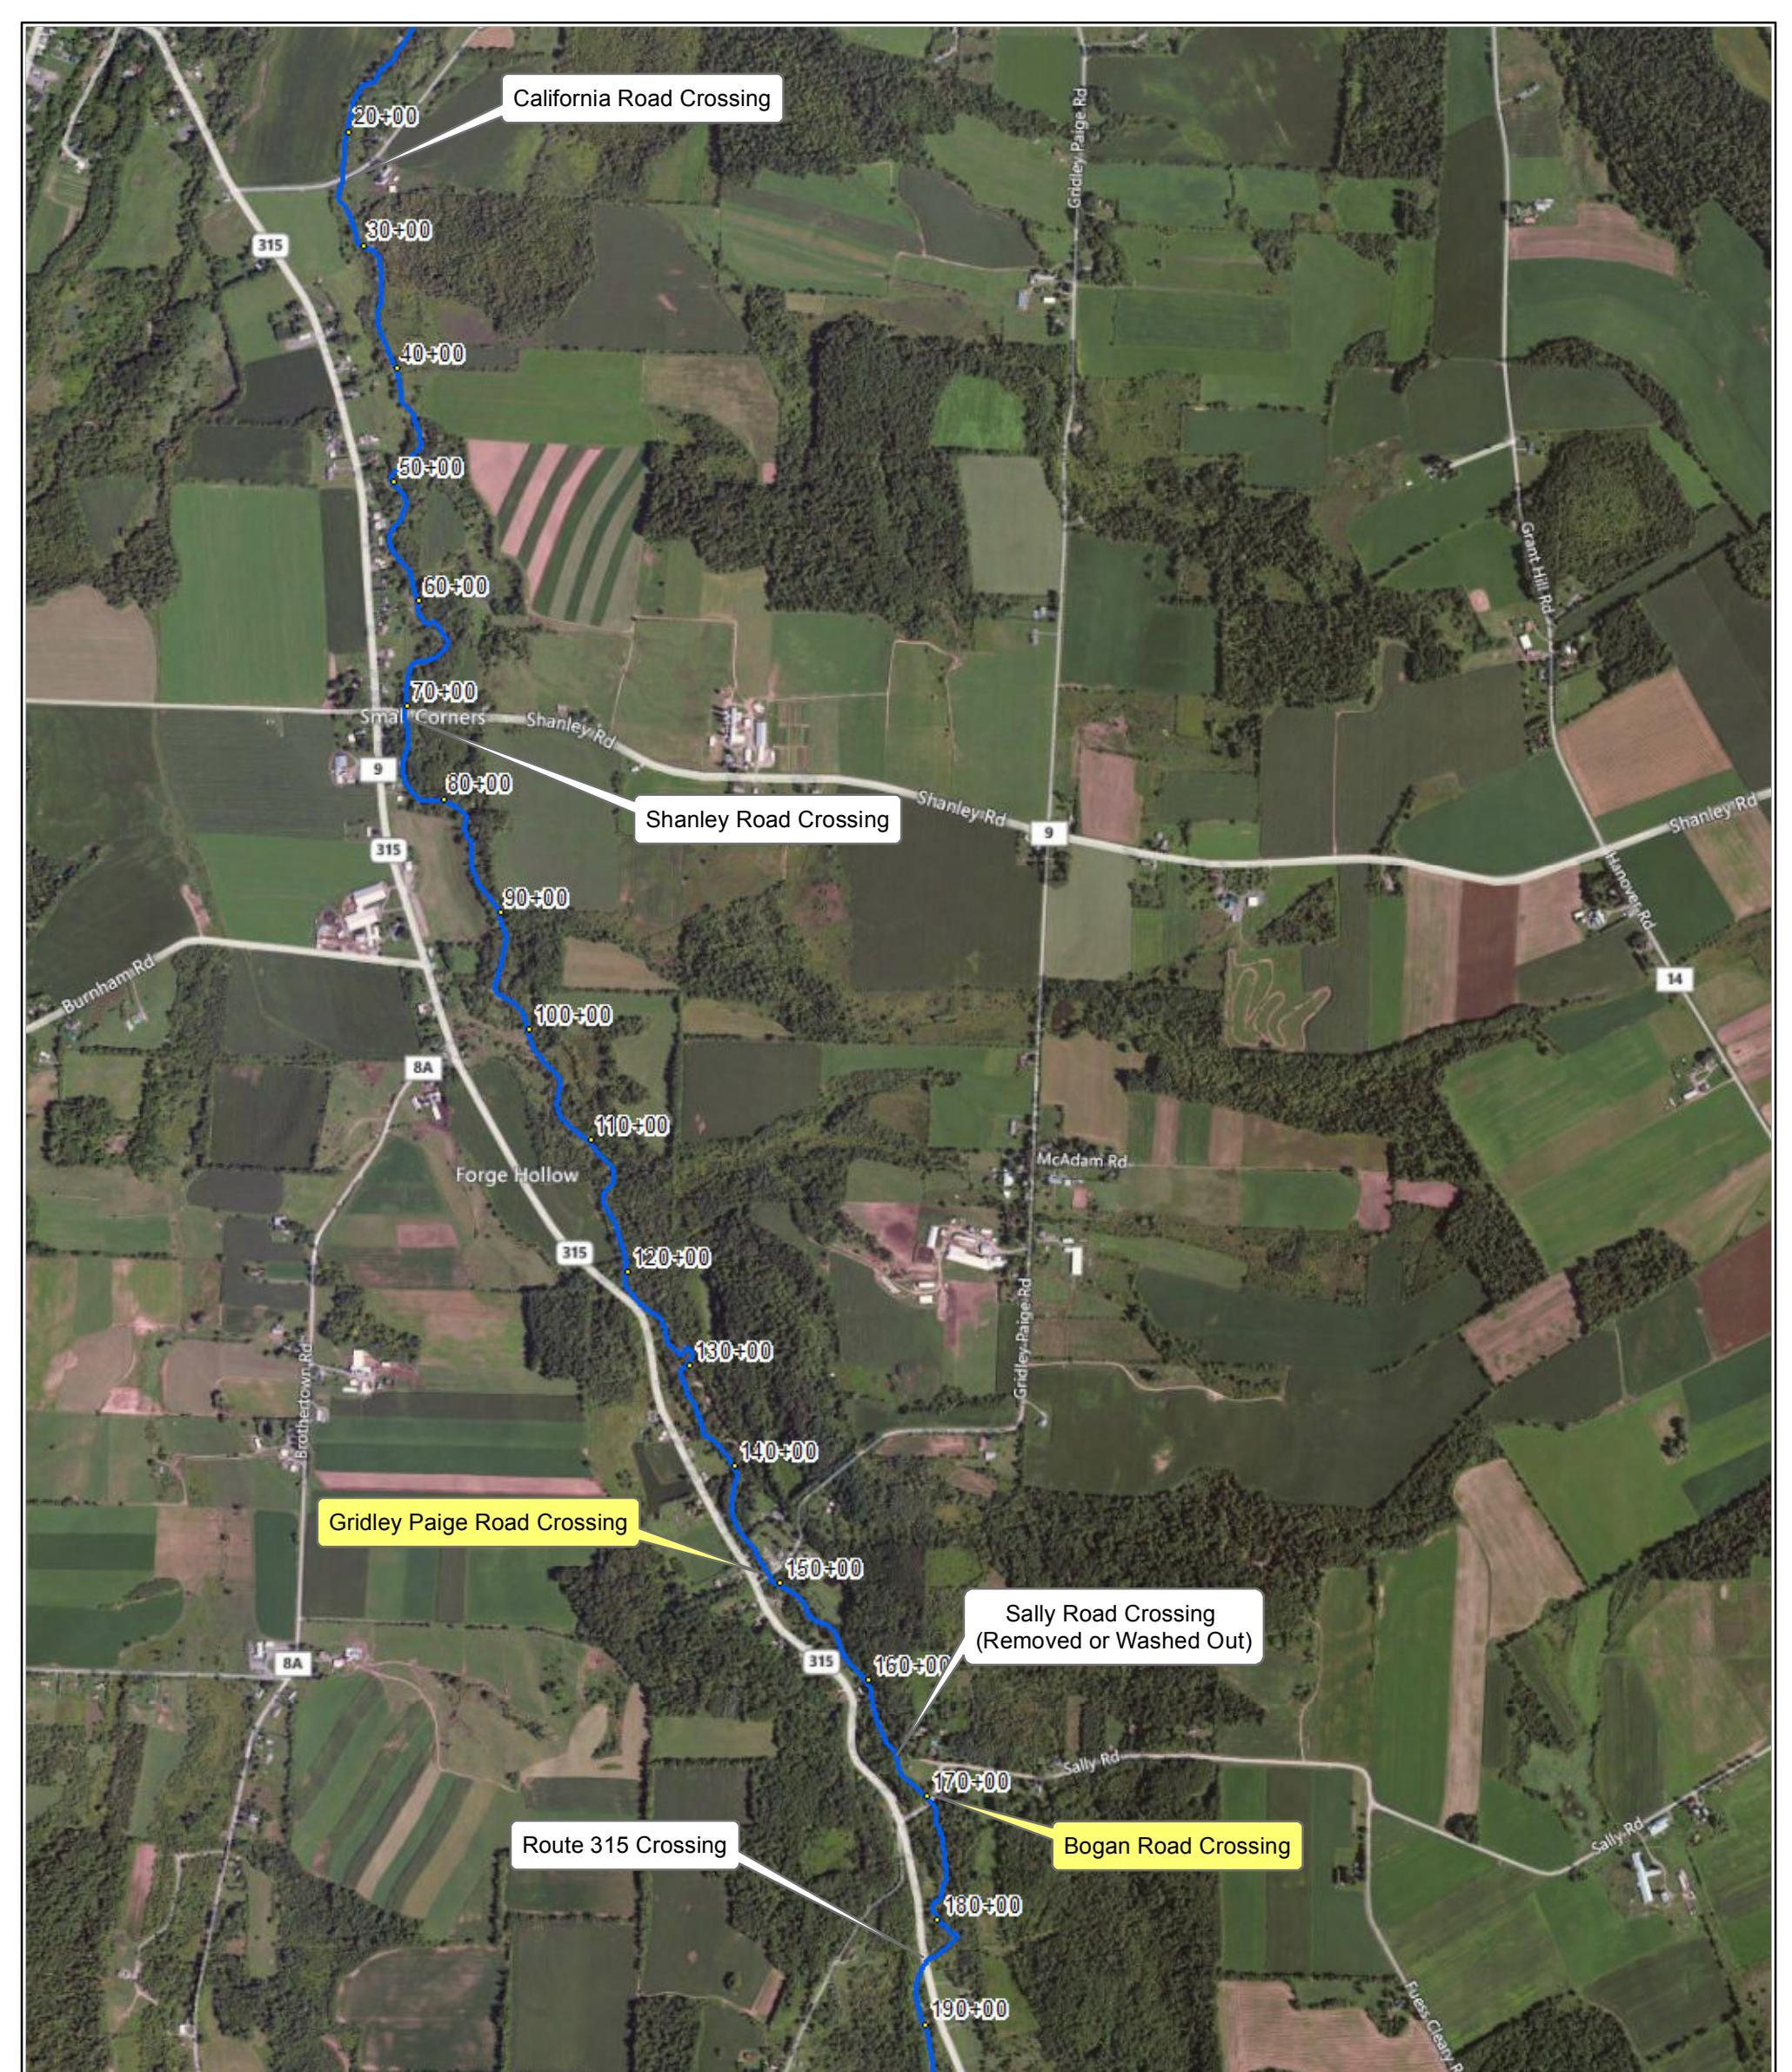
Figure 12 is a location plan of High Risk Area #2. A number of bridges and one culvert along Big Creek are undersized and should be evaluated for replacement as funding allows. The most severe constrictions are occurring at the Bogan Road culvert (STA 170+00) and Gridley Paige Road bridge (STA 148+50). The bridges at Route 315 (STA 185+25), Shanley Road (STA 71+00), and California Road (STA 24+00) are also undersized. All of these crossings, with the exception of California Road, fail to span the estimated bankfull width of Big Creek, indicating that they are undersized. According to FEMA profiles, all of these crossings create hydraulic constrictions.

Community officials report that the bridge at Route 315 (STA 185+25) has flooded, with resulting damage to the bridge and road. This bridge is undersized and is also poorly aligned with the creek.

It appears that at one time there were crossings at both Bogan Road and Sally Road. Based on aerial photos, it appears that the Sally Road bridge has been removed or was washed out. These crossings are in very close proximity to one another. To reduce the number of crossings over Big Creek, either the Bogan Road crossing or the Sally Road crossing should be replaced, but not both.

The Gridley Paige Road, Shanley Road, and California Road bridges are all undersized. Community officials report that the California Road bridge has flooded, with resulting damage to the bridge and road.

Specifically, when the crossings at Route 315 (STA 185+25), Bogan Road (STA 170+00), Sally Road (STA 162+00), and Gridley Paige Road (STA 148+50) are considered for replacement, they should be designed to span the creek's bankfull width and convey flood flows without causing hydraulic constriction. Due to their close proximity to one another, either the Bogan Road or the Sally Road crossing should be replaced, not both.

Alternatives 2-1 and 2-2 are recommended concurrently as bridge replacement funding allows, with the bridges identified in Alternative 2-1 being of higher priority.

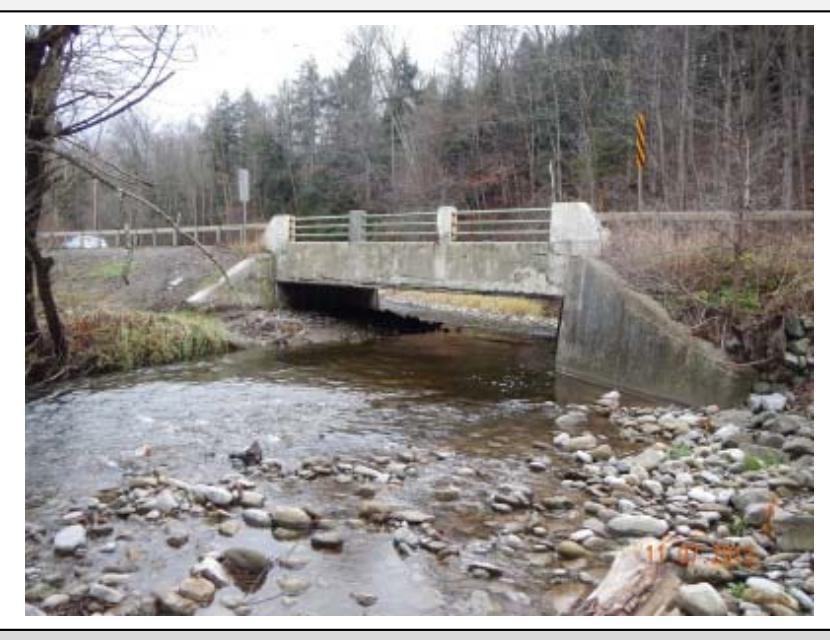
High-Risk Area #2 – High Priority Undersized Bridges

Site Description: Numerous undersized bridges are located within High Risk Area #2 including Route 315 (STA 185+25, shown in the photograph below), Bogan Road (STA 170+00), Sally Road (STA 162+00, has been washed out or removed), and Gridley Paige Road (STA 148+50).

• As these structures are scheduled for repair or replacement, modifications should be undertaken to increase their hydraulic capacity.

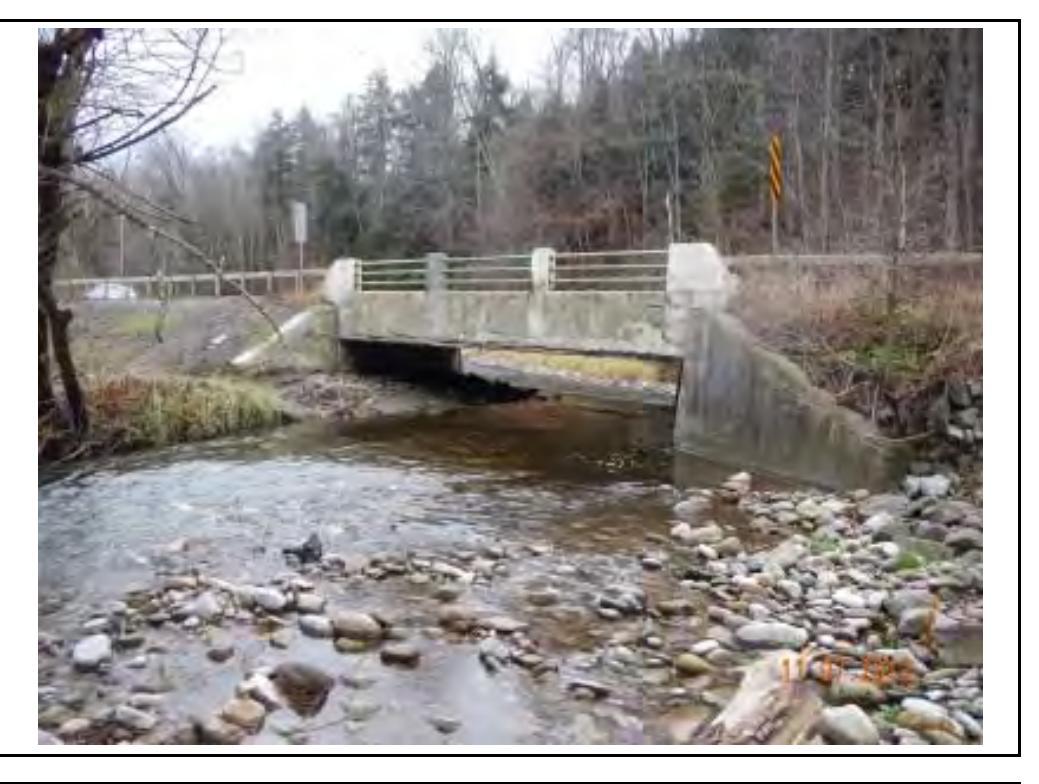
Depicting the Route 315 crossing at STA 184+00, this bridge is included in High Risk Area #2 due to its undersized crossing width and poor alignment to the creek.

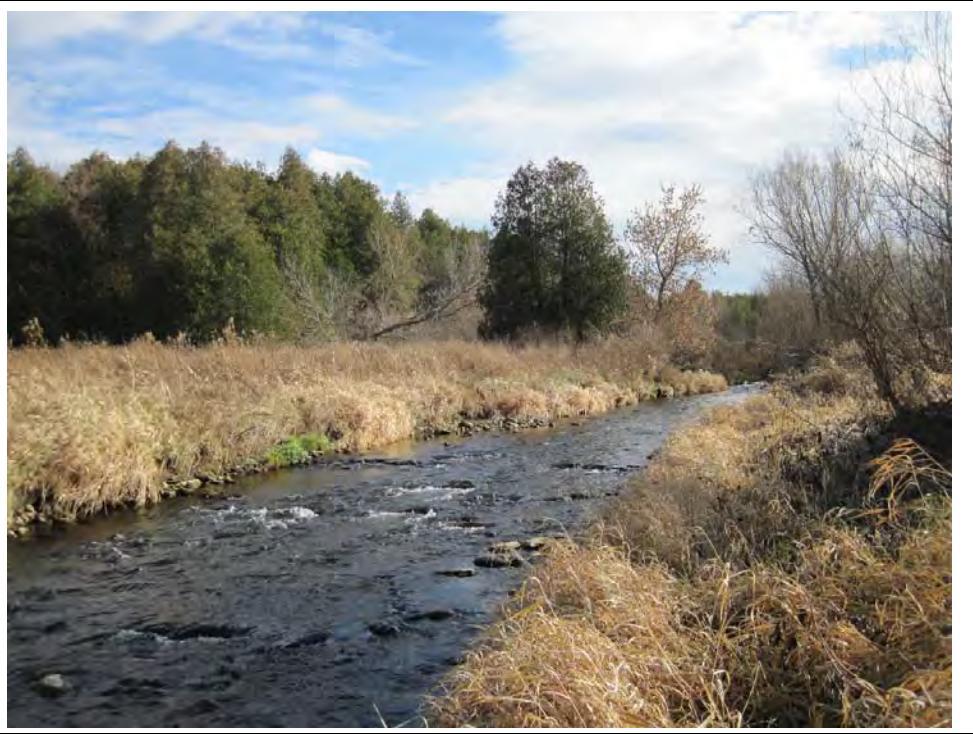
4

In the lower reach of Big Creek at STA 26+00, this image shows a naturalistic section of channel upstream of the California Road crossing.
