New Hartford, NY

Existing Conditions Scan

Mixed Use Corridor Segment

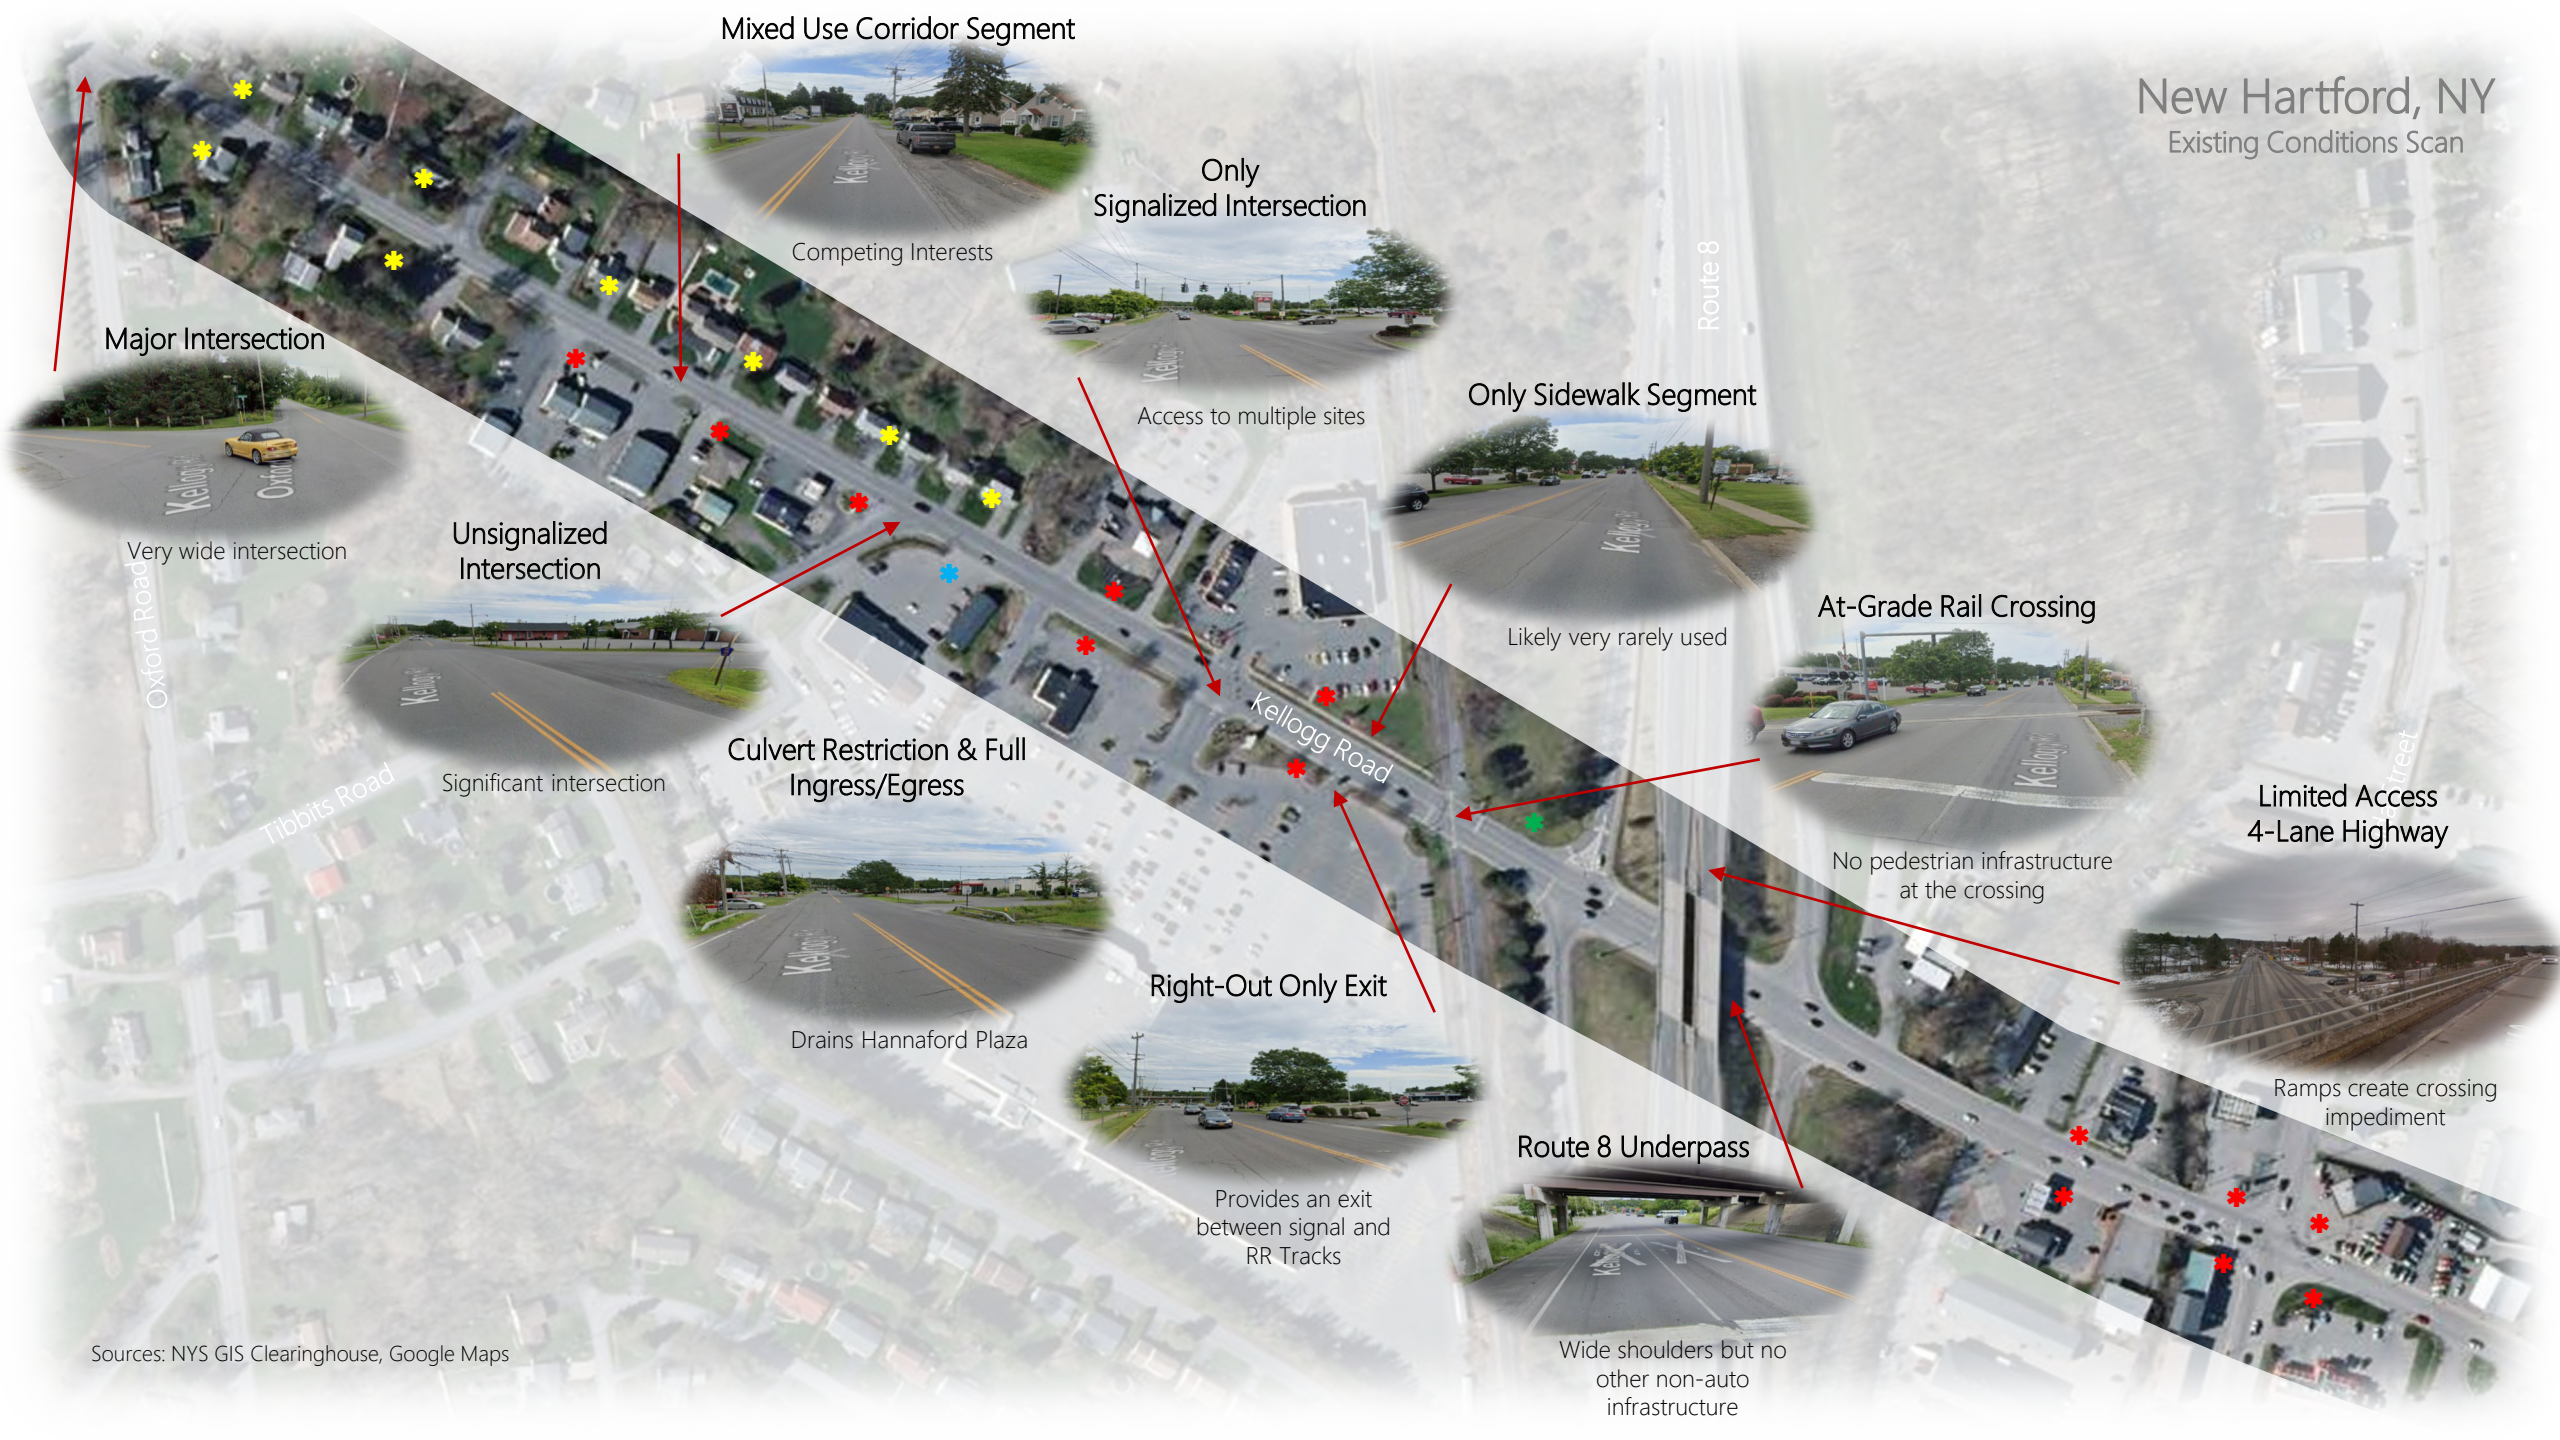
Only Signalized Intersection

Only Sidewalk Segment

At-Grade Rail Crossing

Limited Access 4-Lane Highway

Major Intersection

Unsignalized Intersection

Culvert Restriction & Full Ingress/Egress

Right-Out Only Exit

Route 8 Underpass

No pedestrian infrastructure at the crossing

Ramps create crossing impediment

Very wide intersection

Significant intersection

Drains Hannaford Plaza

Provides an exit between signal and RR Tracks

Wide shoulders but no other non-auto infrastructure

Likely very rarely used
