Streambank Stabilization Techniques using Natural Channel Design

Gian Dodici
US Fish & Wildlife service
Cortland, NY

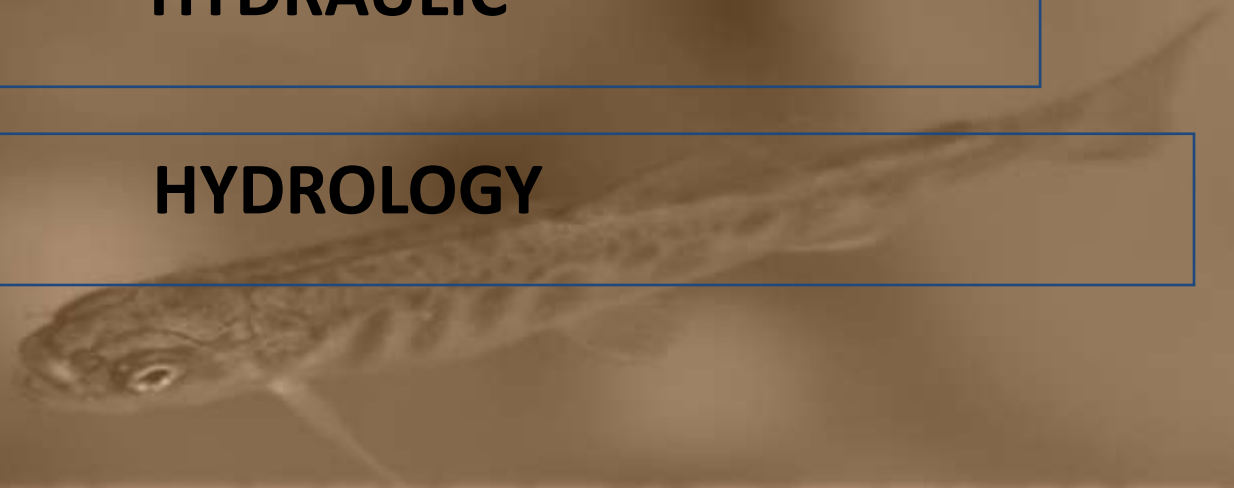
Stream Functions Pyramid

1. HYDROLOGY

- Transport of water from the watershed to the channel
 - Precipitation/ Runoff
 - Channel Forming Discharge
 - Flood Frequency
 - Flow Duration

2. HYDRAULIC

- Transport of water in the channel, on the floodplain and through sediments
 - Velocity
 - Shear Stress
 - Stream Power
 - Bank Height Ratio
 - Entrenchment Ratio
 - Rating Curves
 - Groundwater / Surface Water Exchange

3. GEOMORPHOLOGY

- Transport of wood and sediment to create diverse bedforms and dynamic equilibrium
 - **Sediment transport capacity**
 - Channel Evolution
 - **Streambank erosion rates**
 - Riffle & Pool spacing
 - Depth variability
 - Substrate distribution
 - **Large Woody Debris Transport & Storage**
 - Riparian Vegetation density & composition

4. PHYSIOCHEMICAL

- Temperature and Oxygen regulation; processing of organic matter and nutrients
 - Dissolved Oxygen
 - **Temperature Regulation**
 - pH
 - Conductivity
 - Nutrient processing
 - Organic processing
 - Turbidity

5. BIOLOGY

- Biodiversity and Life Histories of aquatic and riparian life
 - **Primary and Secondary production**
 - Macroinvertebrate communities
 - Fish communities
 - Riparian Communities
