EMERGENCY TRANSPORTATION INFRASTRUCTURE RECOVERY
WATER BASIN ASSESSMENT
AND FLOOD HAZARD MITIGATION ALTERNATIVES

STEELE CREEK
HERKIMER COUNTY, NEW YORK

April 2014

MMI #5231-01

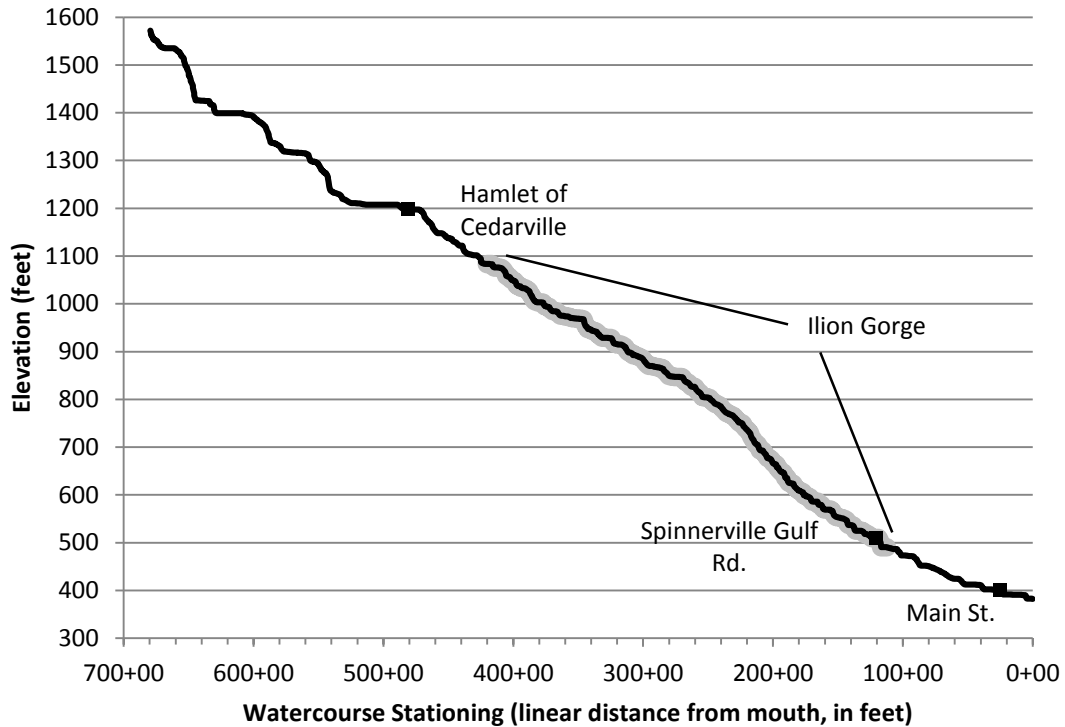
**Figure 4
Steele Creek Profile**

Figure 4 is a profile of Steele Creek, showing the watercourse elevation versus the linear distance from the mouth of the watercourse. Steele Creek has an average slope of 1.75 percent over its length of 12.9 miles. The creek has a fairly uniform slope, dropping a total of 1,190 vertical feet over its entire length, from an elevation of 1,572 feet above sea level at its headwaters upstream of Cedarville, to an elevation of 382 feet at its outlet at the Mohawk River. The creek flattens somewhat after it passes under Spinnerville Gulf Road (STA 113+50) and flows through the more densely populated village of Ilion, beneath the Main Street bridge (STA 25+50) to its outlet at the Mohawk River (STA 0+00). The average slope of this lower portion of Steele Creek is 1 percent.

Steeper stream reaches such as seen in upper Steele Creek have more energy than lower gradient reaches and, as a result, have higher velocities and can carry more sediment. These mobilized sediments are deposited in lower gradient reaches lower in the watershed, where they clog the channel and reduce hydraulic capacity, exacerbating flooding.

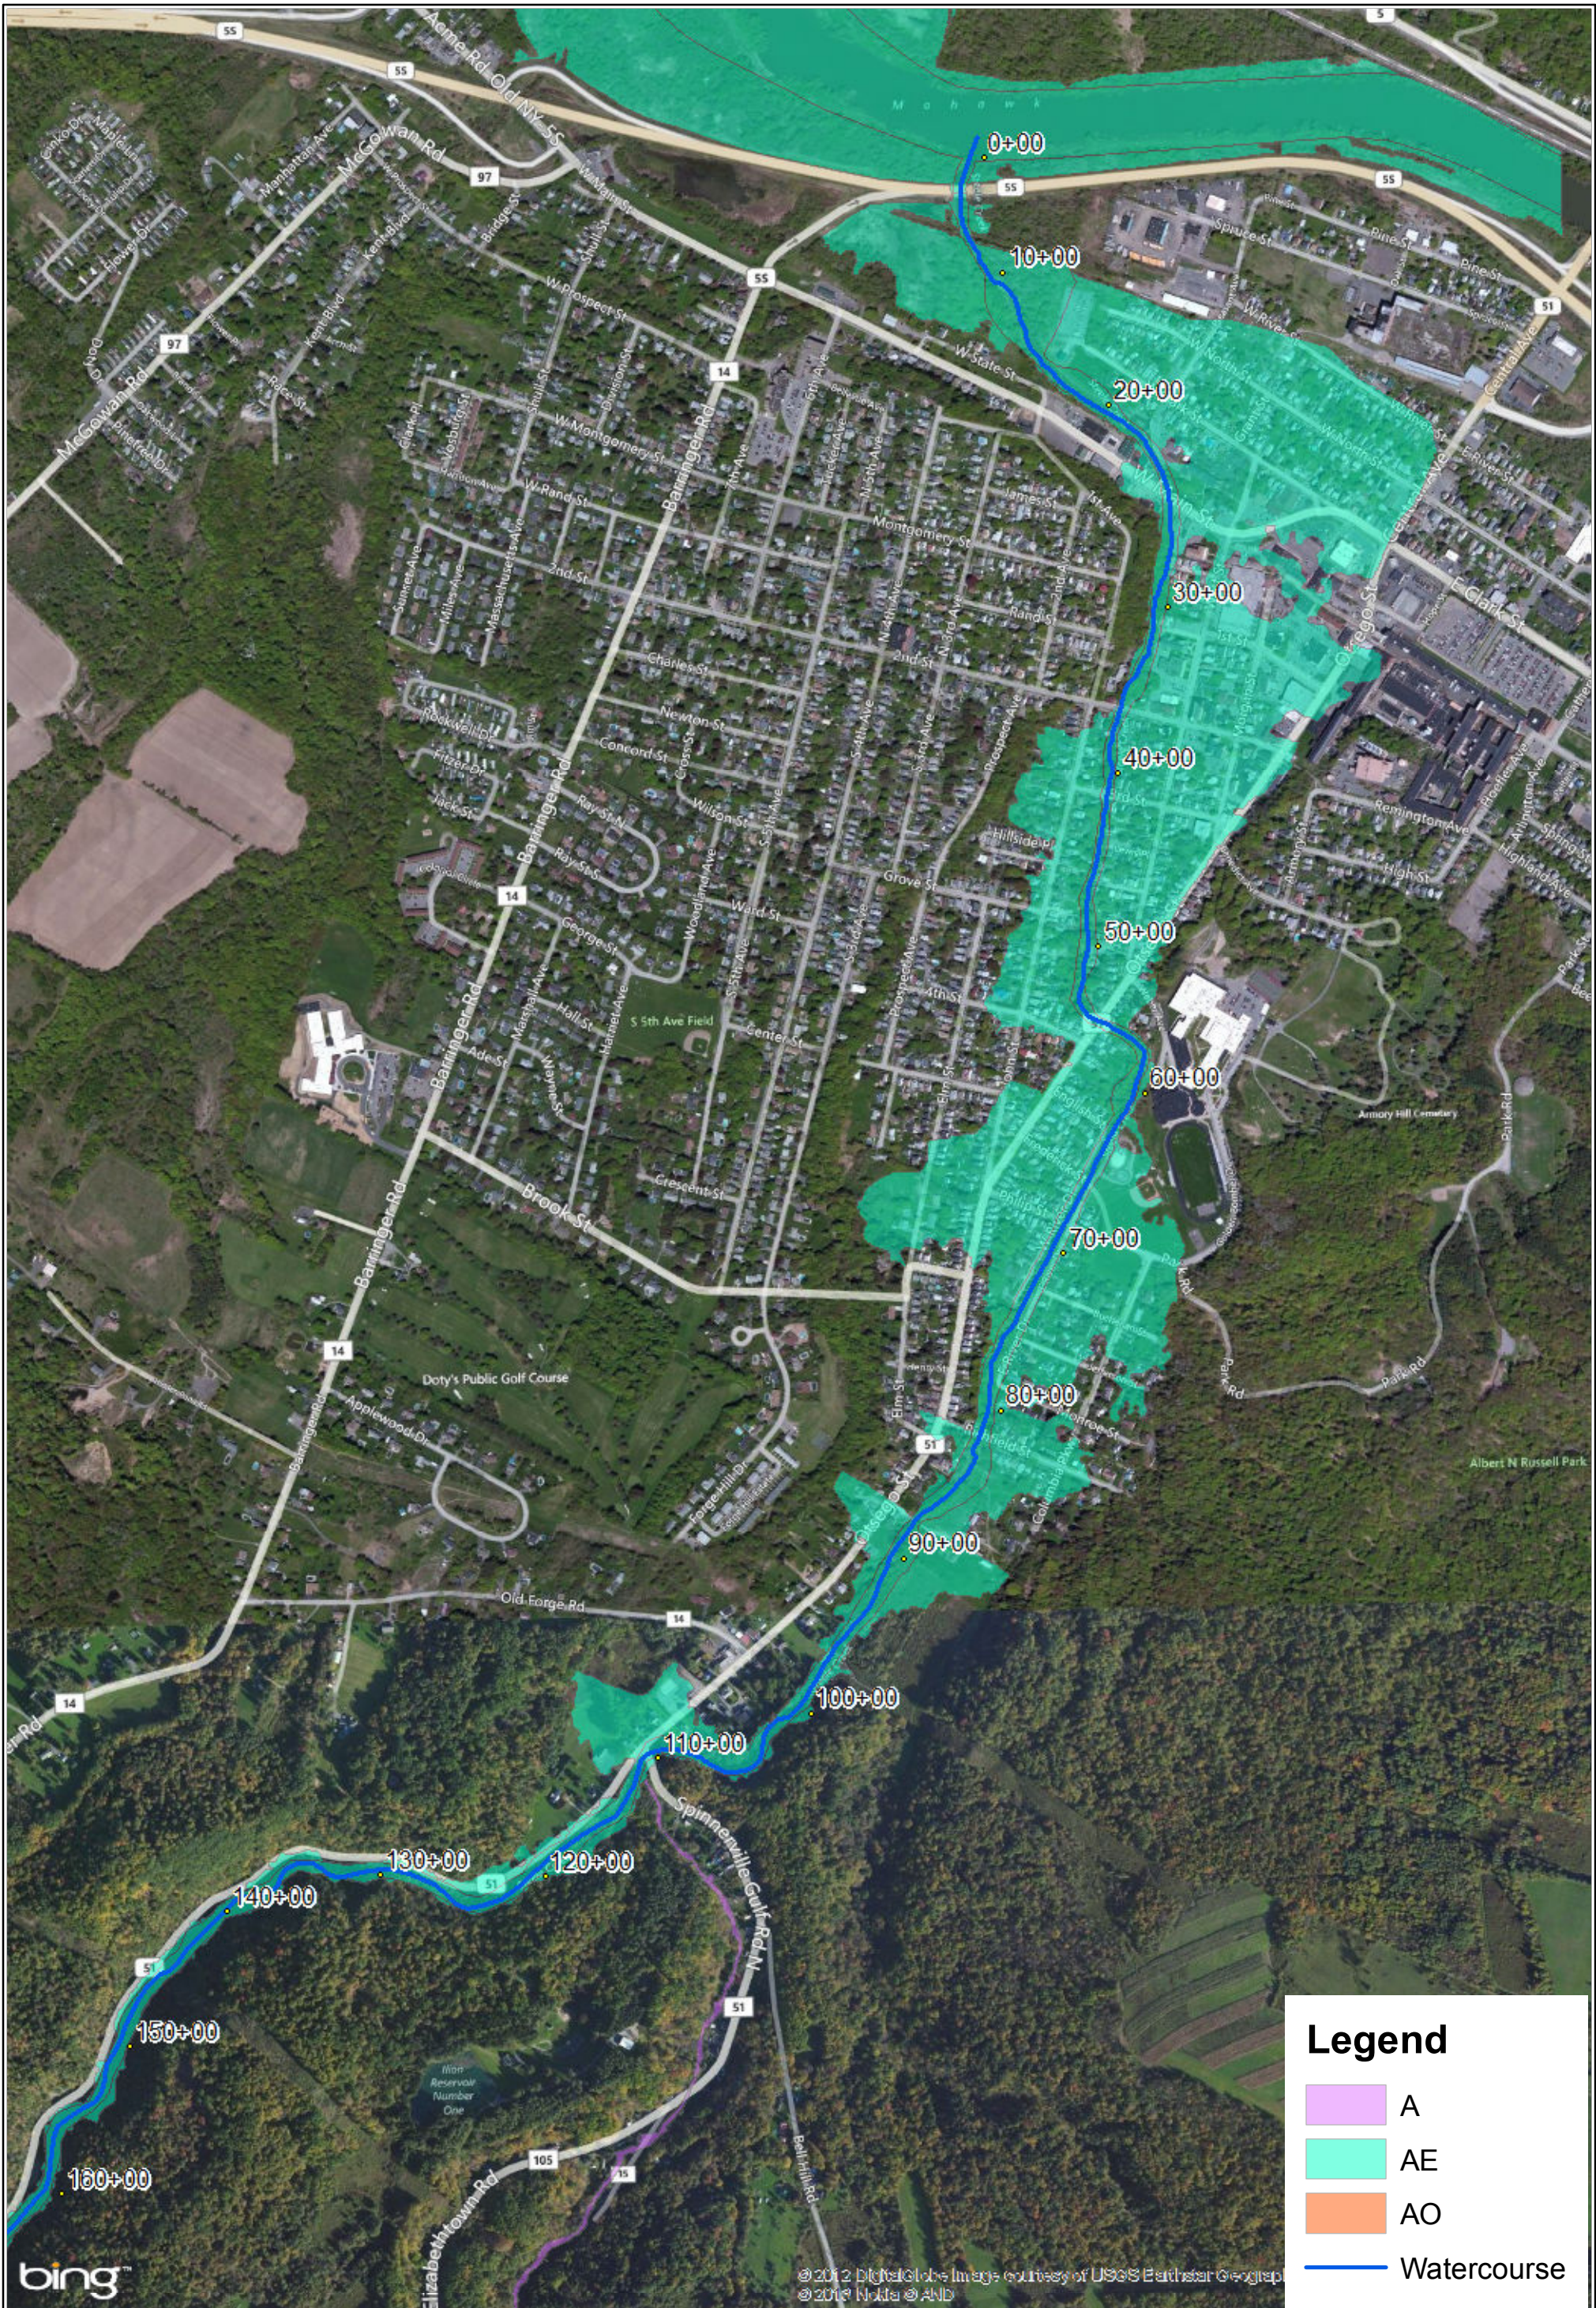
Figure 5: Steele Creek FEMA Floodzones

FEMA flood insurance maps are available for Steele Creek (Figure 5). The maps highlight the extensive nature of flooding that occurs in the village of Ilion during a 100-year frequency flood event. The FEMA flood maps indicate that the most extensive area of flooding occurs from upstream of Clapsaddle Farm Road (STA 89+00), downstream to the outlet of Steele Creek (STA 0+00), with an extensive area of downtown Ilion inundated by floodwaters.
