**EMERGENCY TRANSPORTATION INFRASTRUCTURE RECOVERY**  
**WATER BASIN ASSESSMENT**  
**AND FLOOD HAZARD MITIGATION ALTERNATIVES**

**NOWADAGA CREEK**  
**HERKIMER COUNTY, NEW YORK**

April 2014

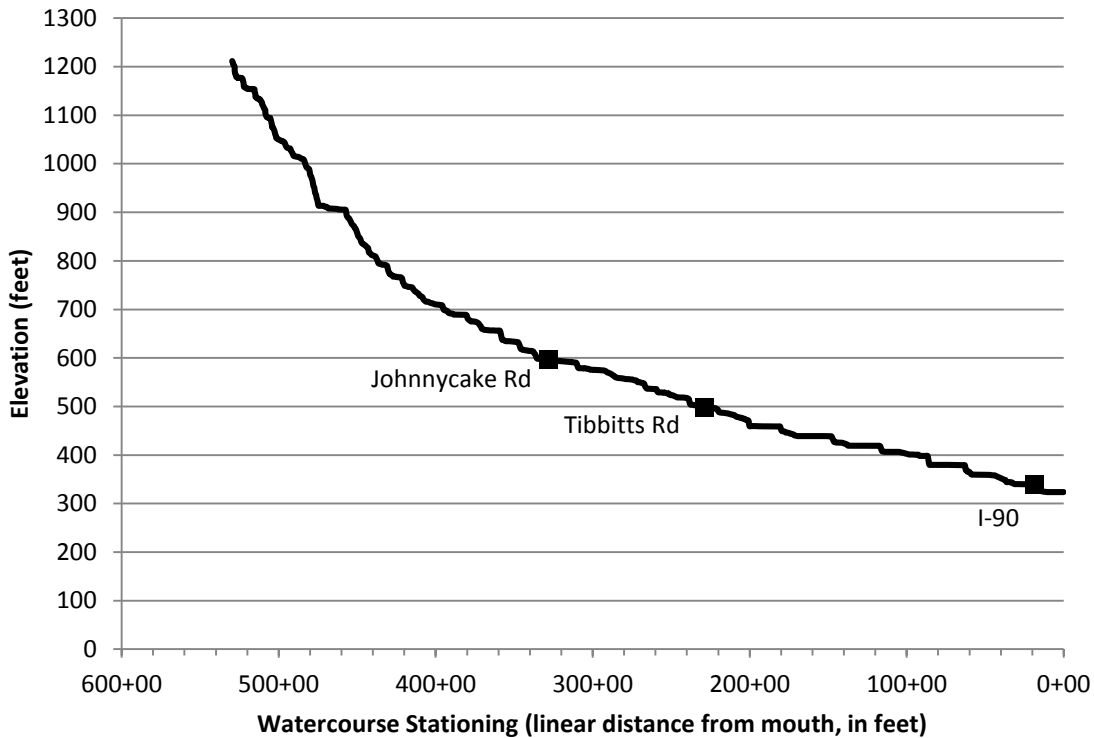
**Figure 4**  
**Nowadaga Creek Profile**

Figure 4 is a profile of Nowadaga Creek, showing the watercourse elevation versus the linear distance from the mouth of the watercourse.

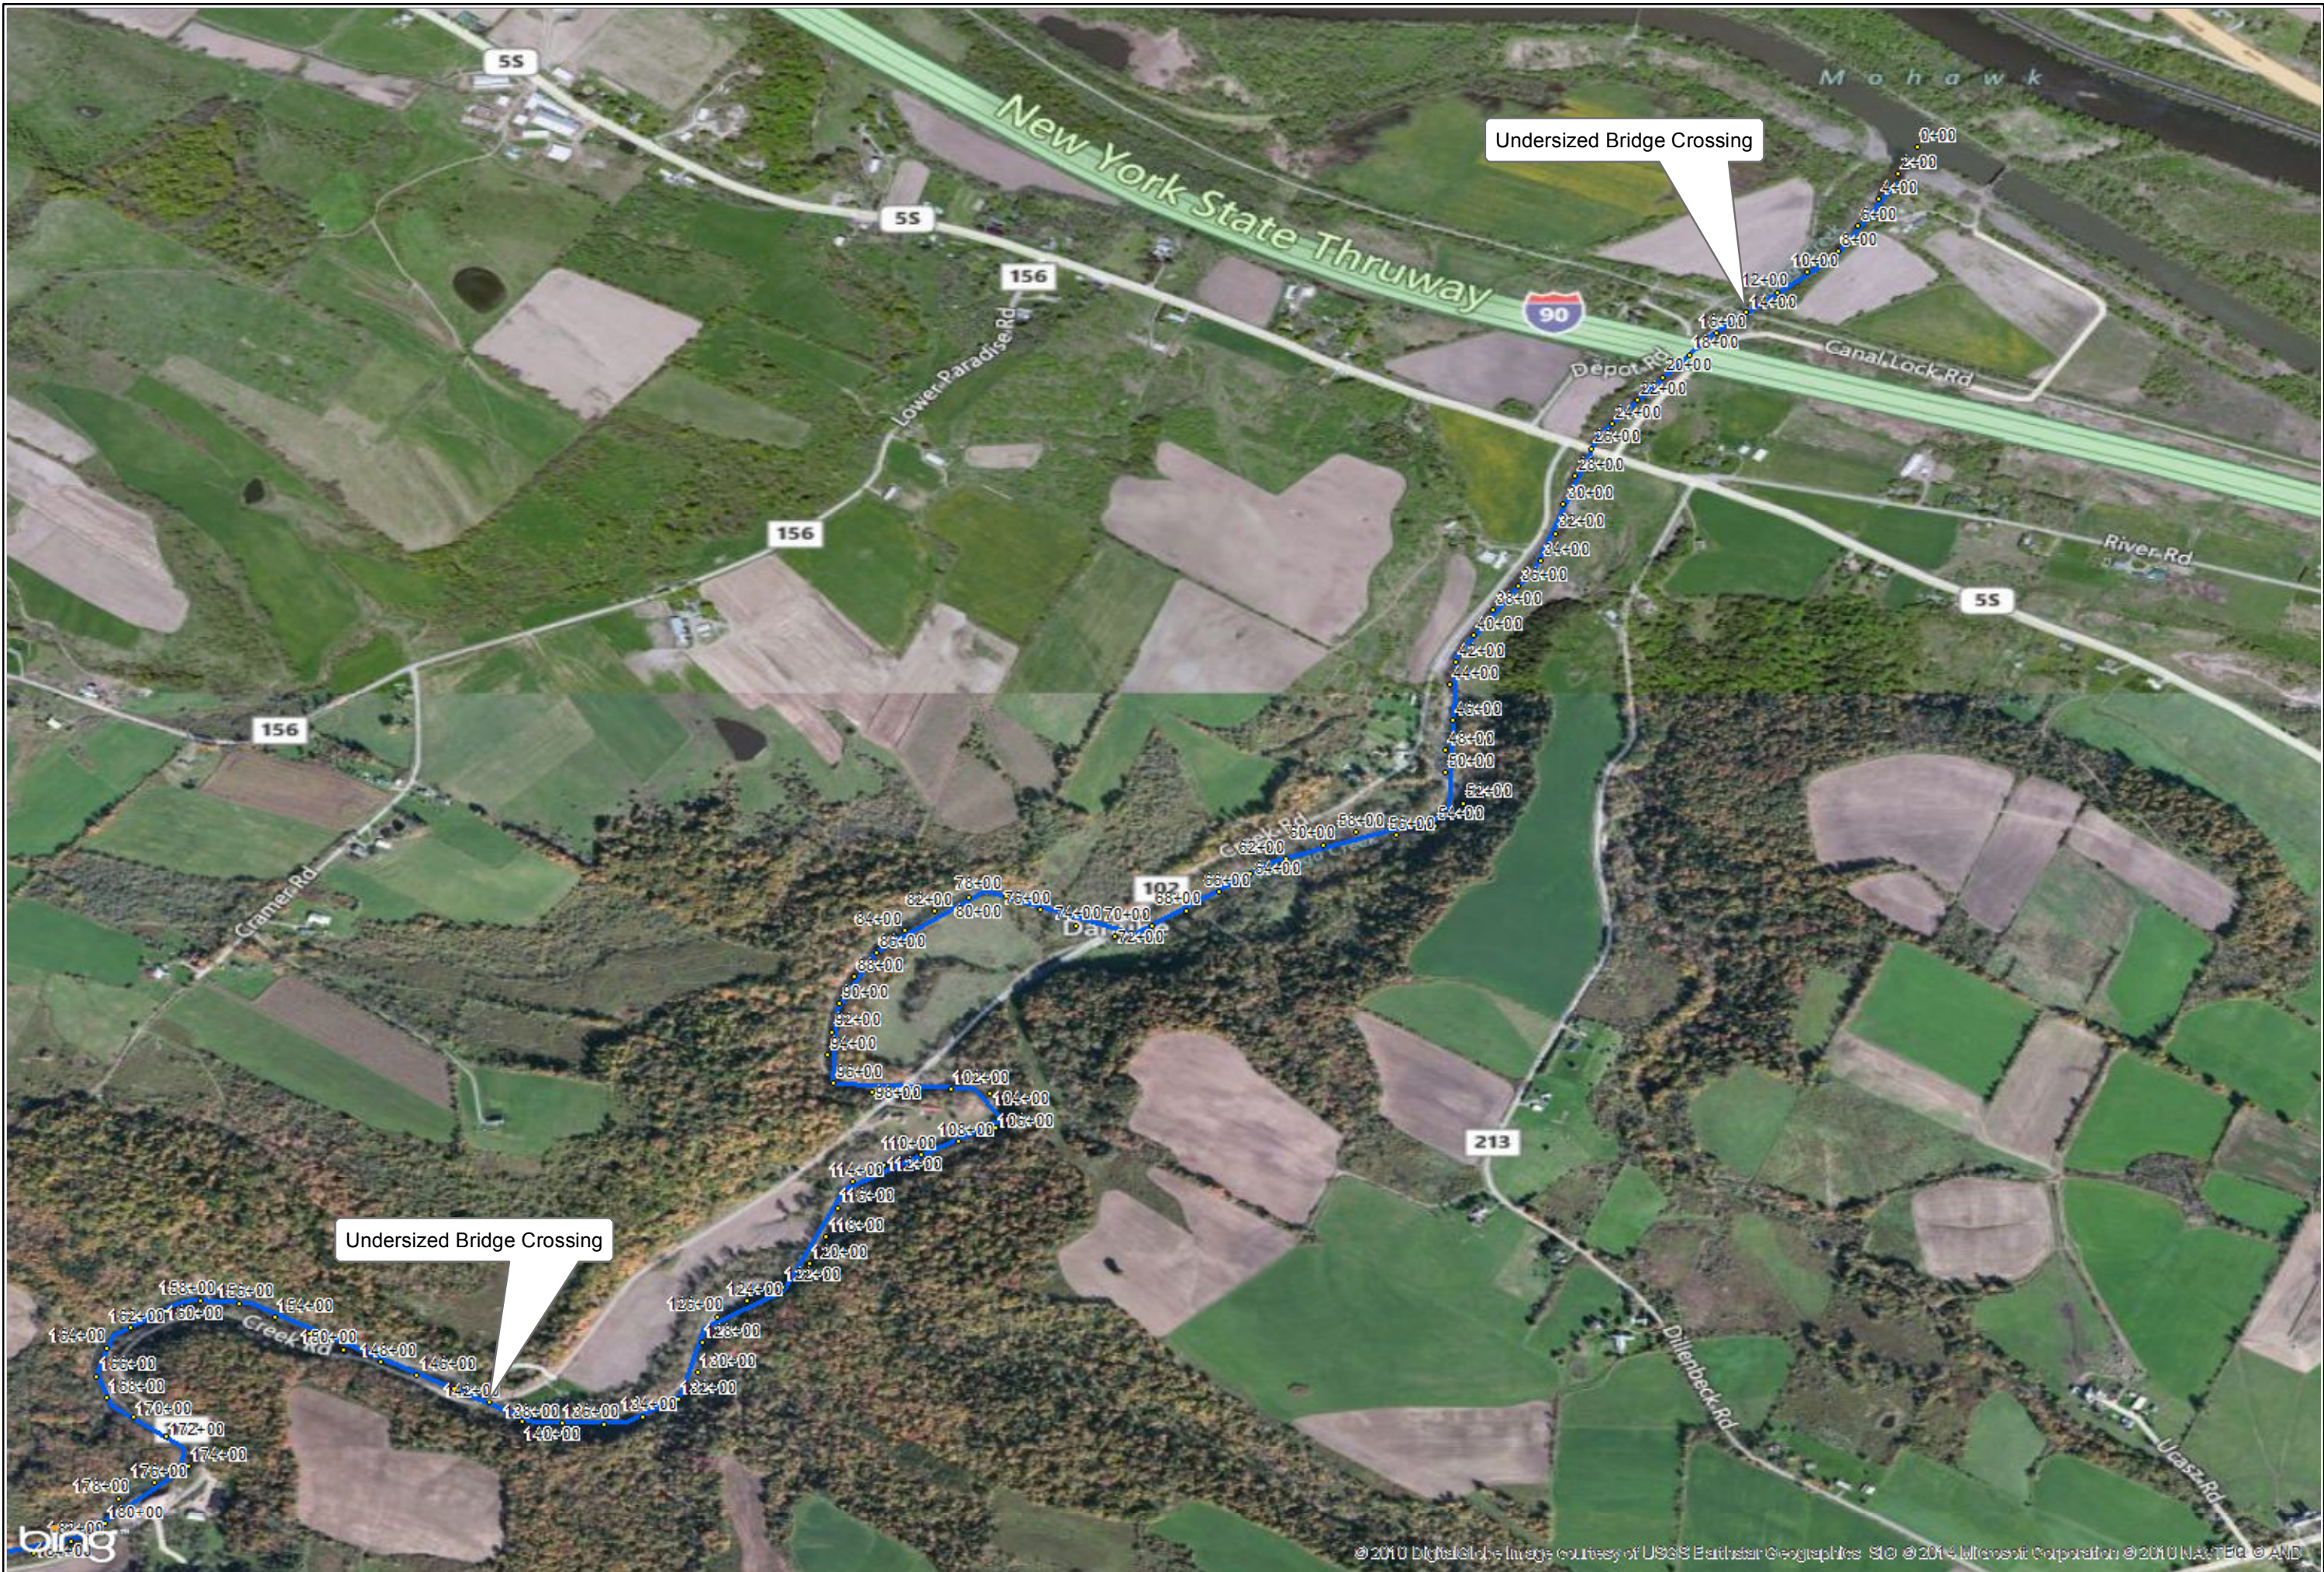
**Figure 5: Nowadaga Creek High Risk Area #1**  
 NYDOT: Emergency Transportation Infrastructure Recovery  
 Herkimer County, New York

Figure 5 is a location plan of High Risk Area #1. This area includes the Creek Road crossing near STA 142+00 and the rail-to-trail bridge near STA 14+25, both of which are prone to debris jams, ice jams, and clogging by woody debris, which can significantly exacerbate flooding. The bridge at STA 142+00 is poorly aligned with the creek channel, which further reduces hydraulic capacity and contributes to flood problems. This structure also appears to be in poor condition. A single-family residential structure on the left bank, just downstream of this crossing, has been severely damaged by flooding on more than one occasion.

Hydraulic modeling of Nowadaga Creek at Creek Road near STA 142+00 indicates that the bridge acts as a hydraulic constriction but does not overtop. However, when a moderate debris jam is simulated at the bridge, it does overtop. This is consistent with accounts of actual conditions during recent flood events.

- Replace the Creek Road Crossing with a new bridge that is better aligned with the creek and sized to reduce debris jams and alleviate the hydraulic constriction.
- When the rail-to-trail bridge is due for replacement, it should be appropriately sized, with consideration given to high flows, debris accumulation, and ice jamming. Until such time as the bridge is replaced, flood-proofing of nearby homes on a case-by-case basis is recommended.

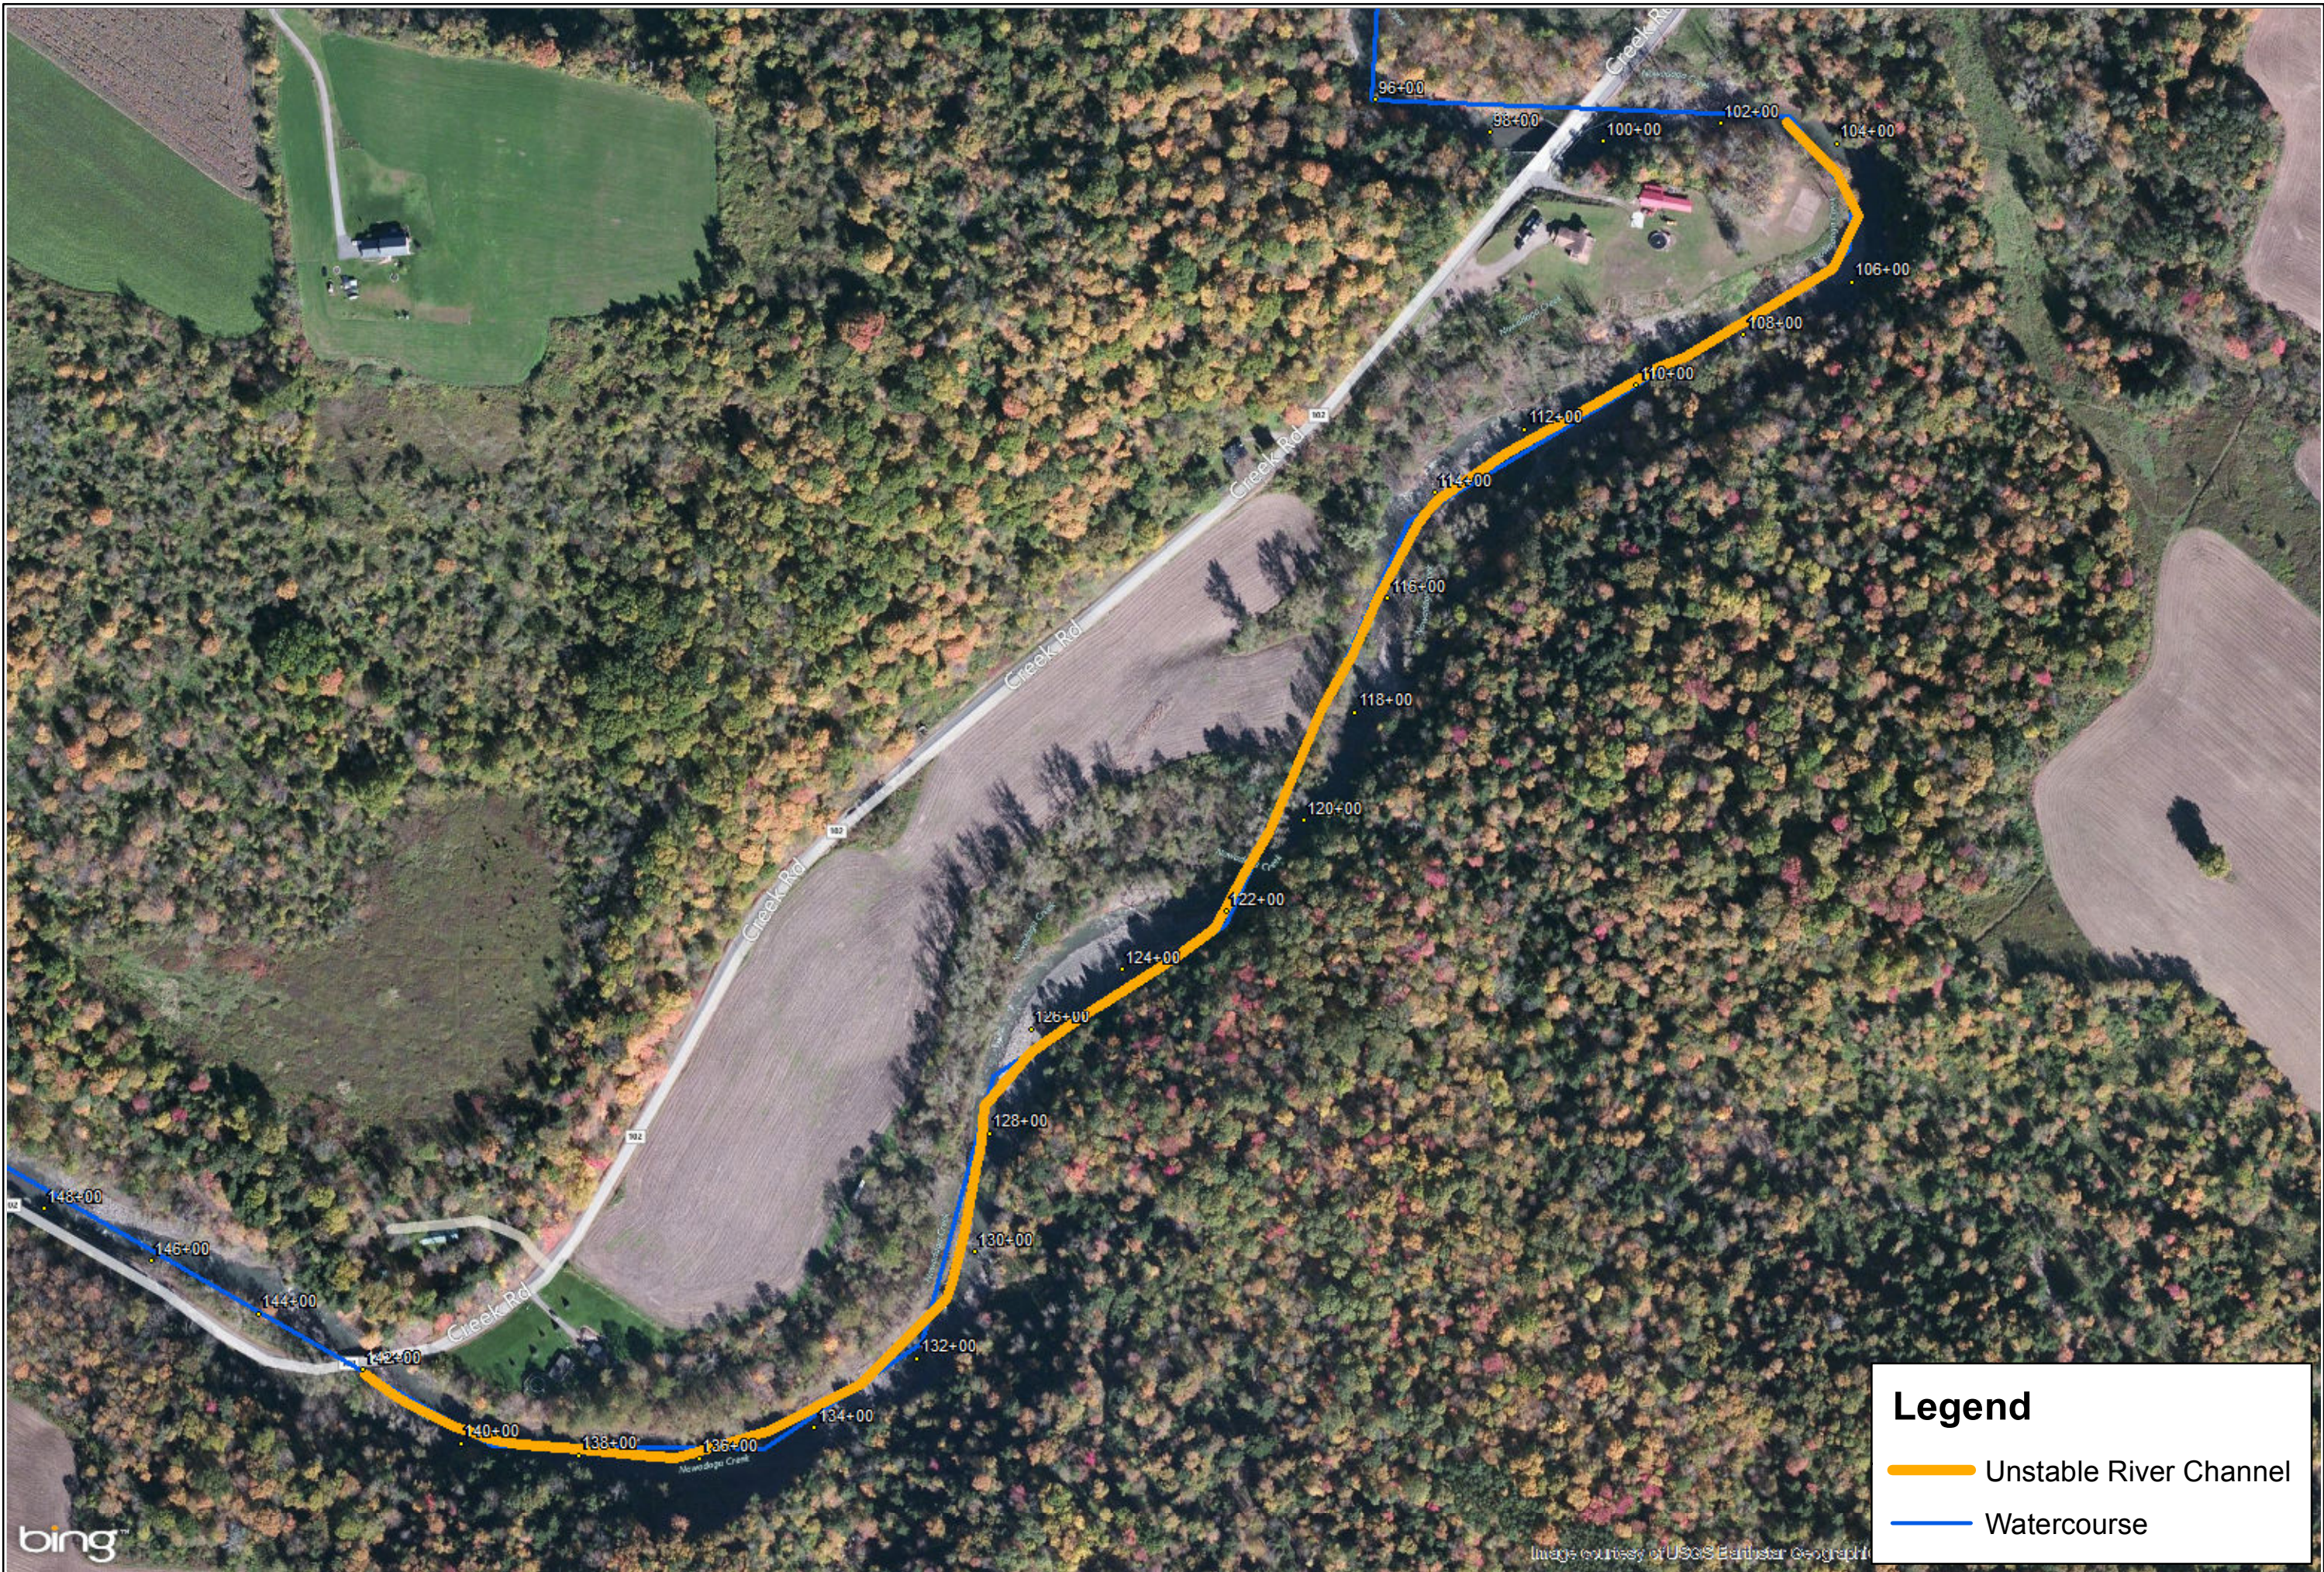
**Figure 7: Nowadaga Creek High Risk Area #2**  
**NYDOT: Emergency Transportation Infrastructure Recovery**  
**Herkimer County, New York**

Figure 7 is a location plan of High Risk Area #2. A highly unstable section of channel occurs between STA 103+00 and STA 142+00, where there is heavy deposition, channel avulsion, and bank erosion. A high bank failure occurs at STA 136+00.

- Stabilize the bank along approximately 200 feet of the channel to reduce sediment loading that is contributing to the downstream channel avulsion.
- Clear the sediment and woody debris from the channel to allow it to return to its previous location and allow the landowner to make use of the agricultural field. The channel should not be extensively dredged.

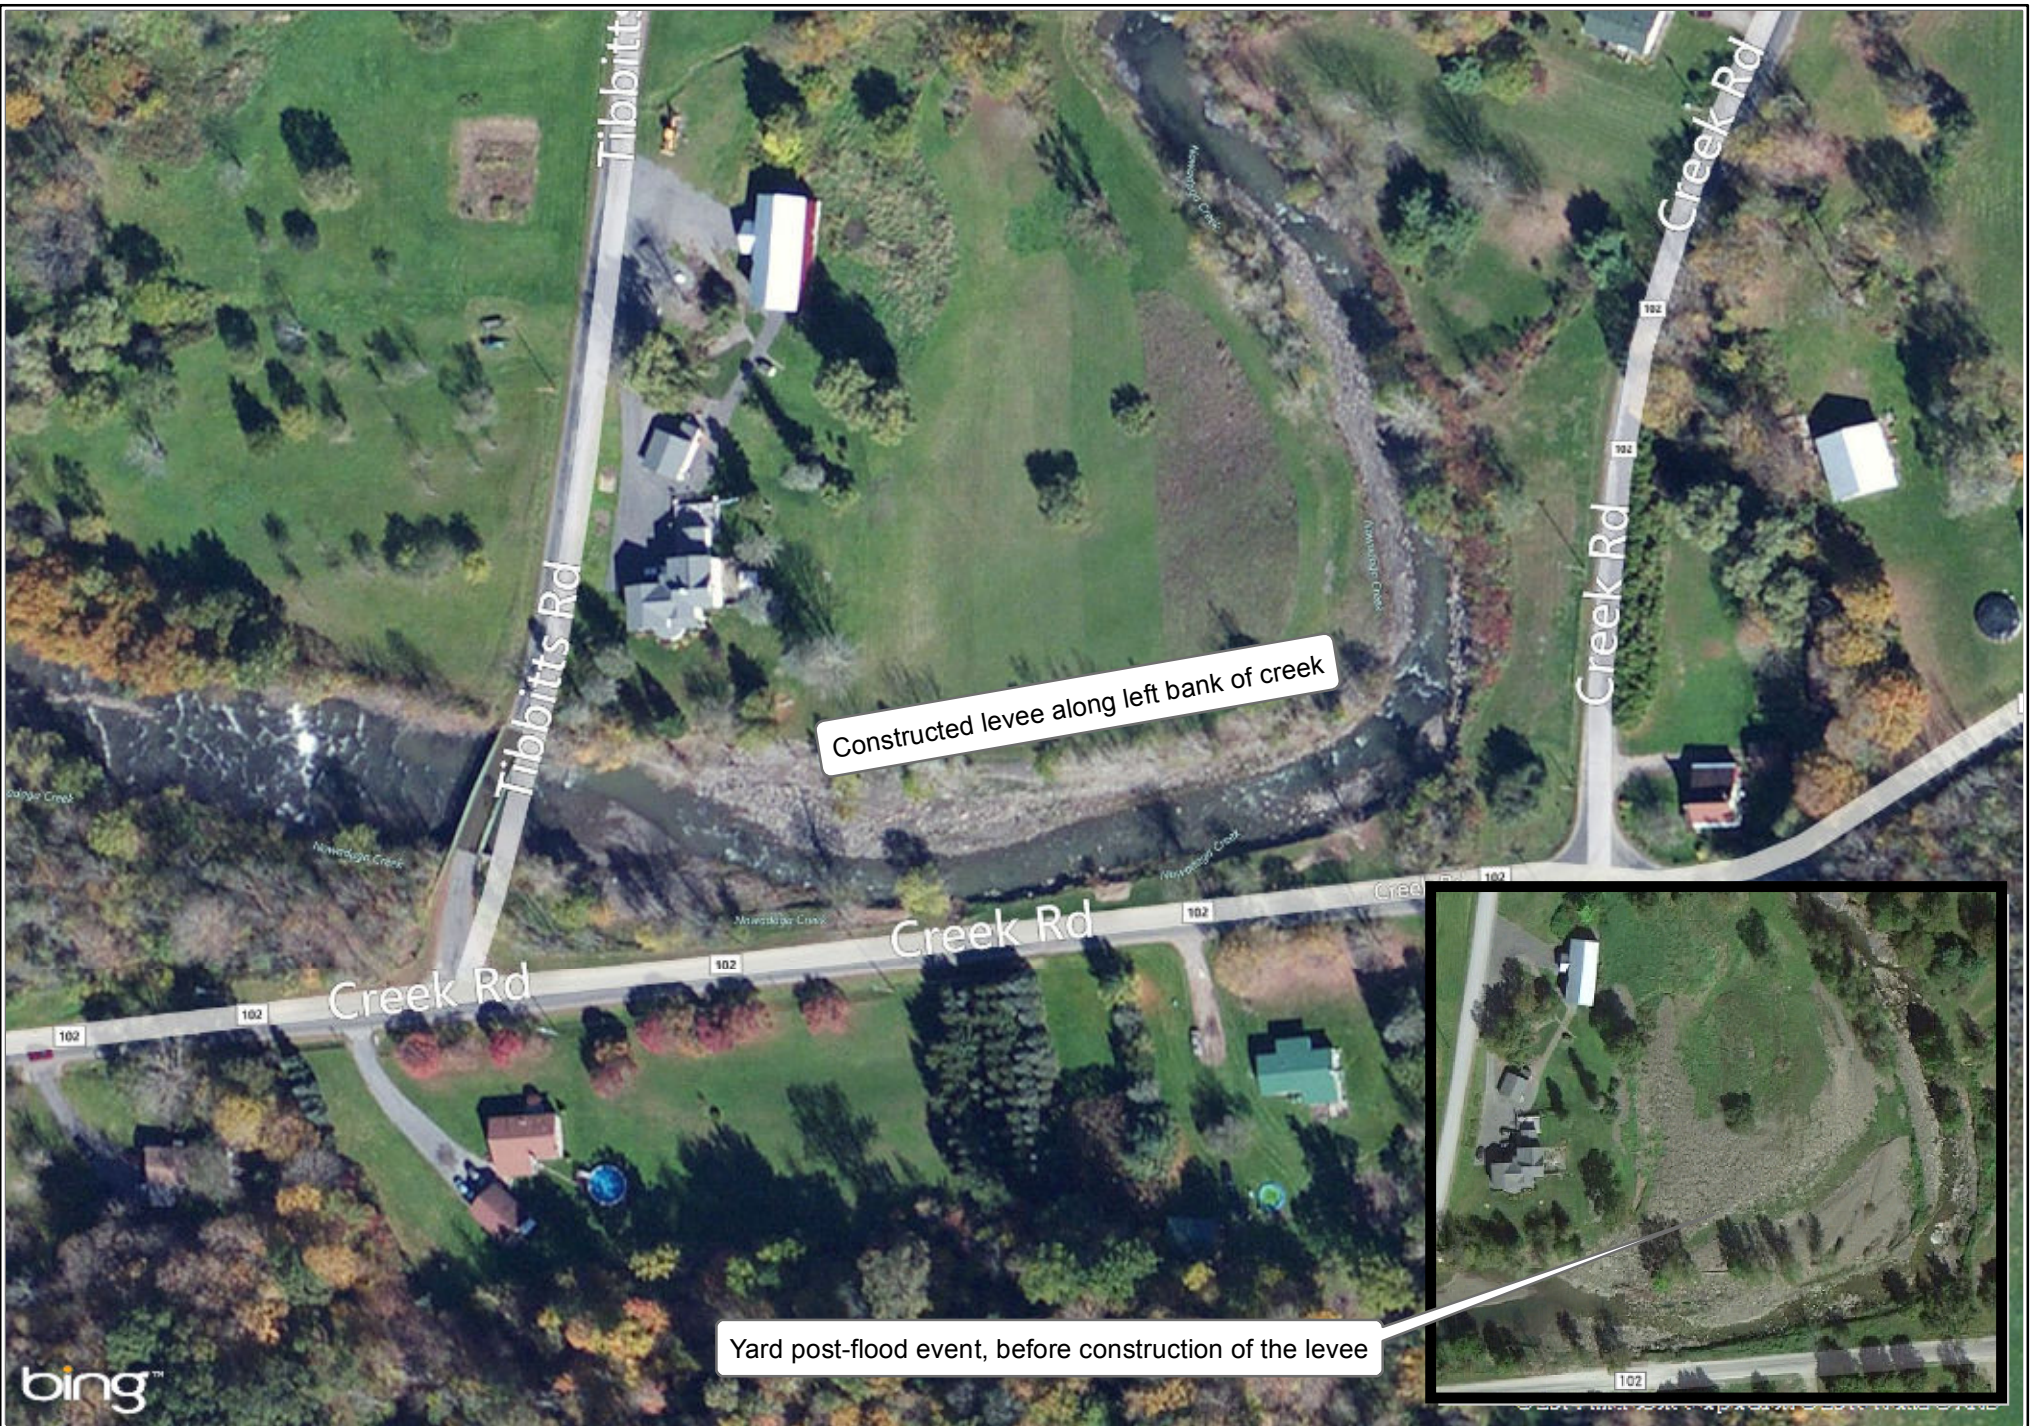
Figure 9:  
**Nowadaga Creek High Risk Area #4**

Figure 9 is a location plan of High Risk Area #4. Immediately downstream of Tibbitts Road on the left bank, a levee has been constructed by a local homeowner in the vicinity of STA 223+00 to STA 228+00. The levee isolates the creek from its natural floodplain on the inside of a sharp left bend. Hydraulic modeling indicates that while the levee may protect the home and yard from flooding it also causes an increase in water surface elevation along Creek Road and will contribute to flooding of the road and possibly adjacent homes during significant flood events. The levee also acts to constrict flows and increases flow velocities, contributing to erosion.

Alternative 4-1 is recommended to reconnect Nowadaga Creek to its floodplain and reduce flooding along Creek Road.
