EMERGENCY TRANSPORTATION INFRASTRUCTURE RECOVERY WATER BASIN ASSESSMENT AND FLOOD HAZARD MITIGATION ALTERNATIVES

BIG CREEK ONEIDA COUNTY, NEW YORK

April 2014

MMI #5231-01

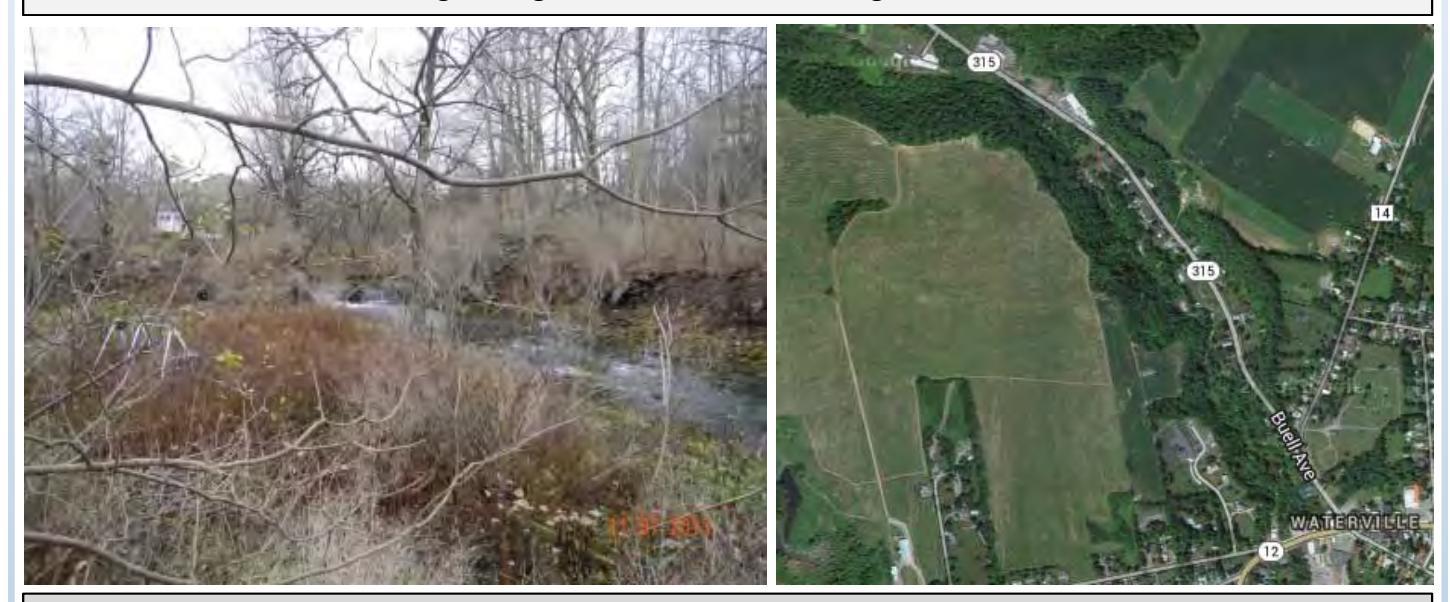
High-Risk Area #1 – Route 315 Downstream of Waterville

Site Description: High Risk Area #1 involves the area downstream of Waterville (STA 238+00 to STA 310+00) where floodwaters have overtopped the banks and caused bank erosion and failures. The multiple bank failures through this reach collectively contribute to the sediment load that is carried downstream as well as flooding damage to downstream dwellings.

- Develop and implement a program for stream maintenance and repair including stabilization and restoration of bank failures and erosional sites.
- Incorporate a combination of conventional and bioengineering techniques to prevent bank erosion.

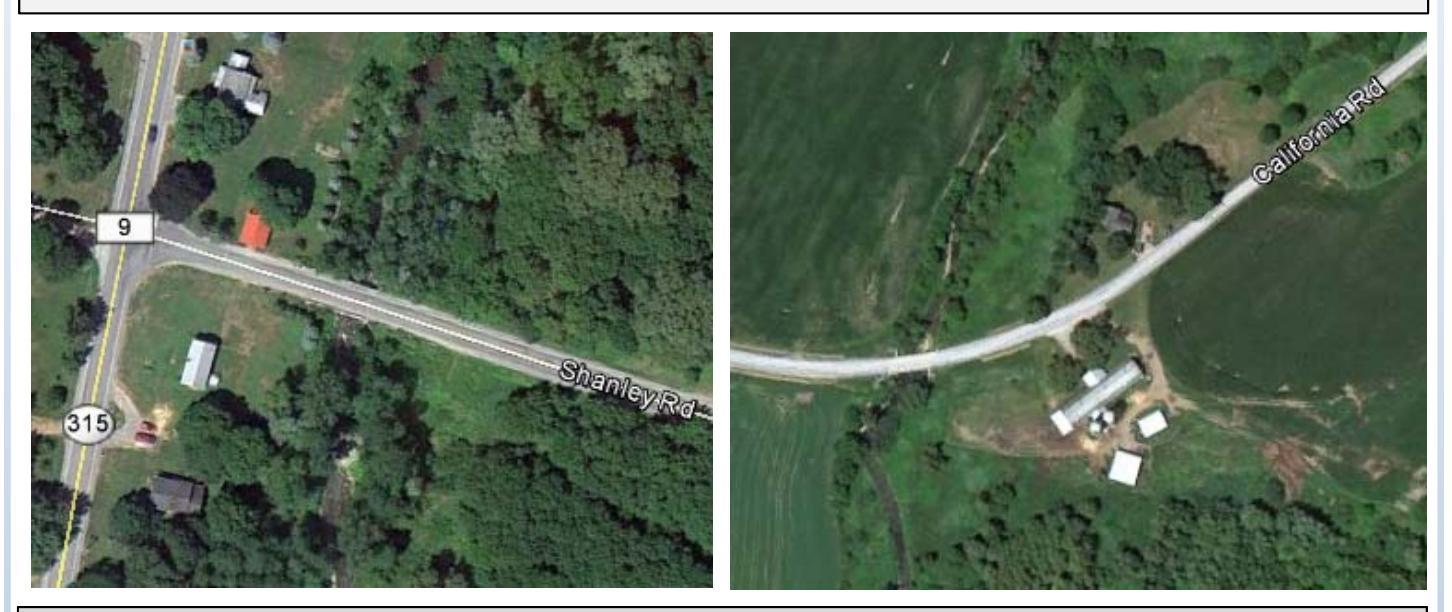
High-Risk Area #2 – Low Priority Undersized Bridges

Site Description: Numerous additional crossings within High Risk Area #2 including Shanley Road (STA 71+00) and California Road (STA 24+00), are also undersized but create less of a hydraulic constriction and do not cause extensive flooding of structures.

• When these bridges are scheduled for replacement, they should be designed to span the creek's bankfull width and convey flood flows without causing hydraulic constrictions.
