EMERGENCY TRANSPORTATION INFRASTRUCTURE RECOVERY
WATER BASIN ASSESSMENT
AND FLOOD HAZARD MITIGATION ALTERNATIVES

BELLINGER BROOK AT THE VILLAGE OF HERKIMER
HERKIMER COUNTY, NEW YORK

April 2014

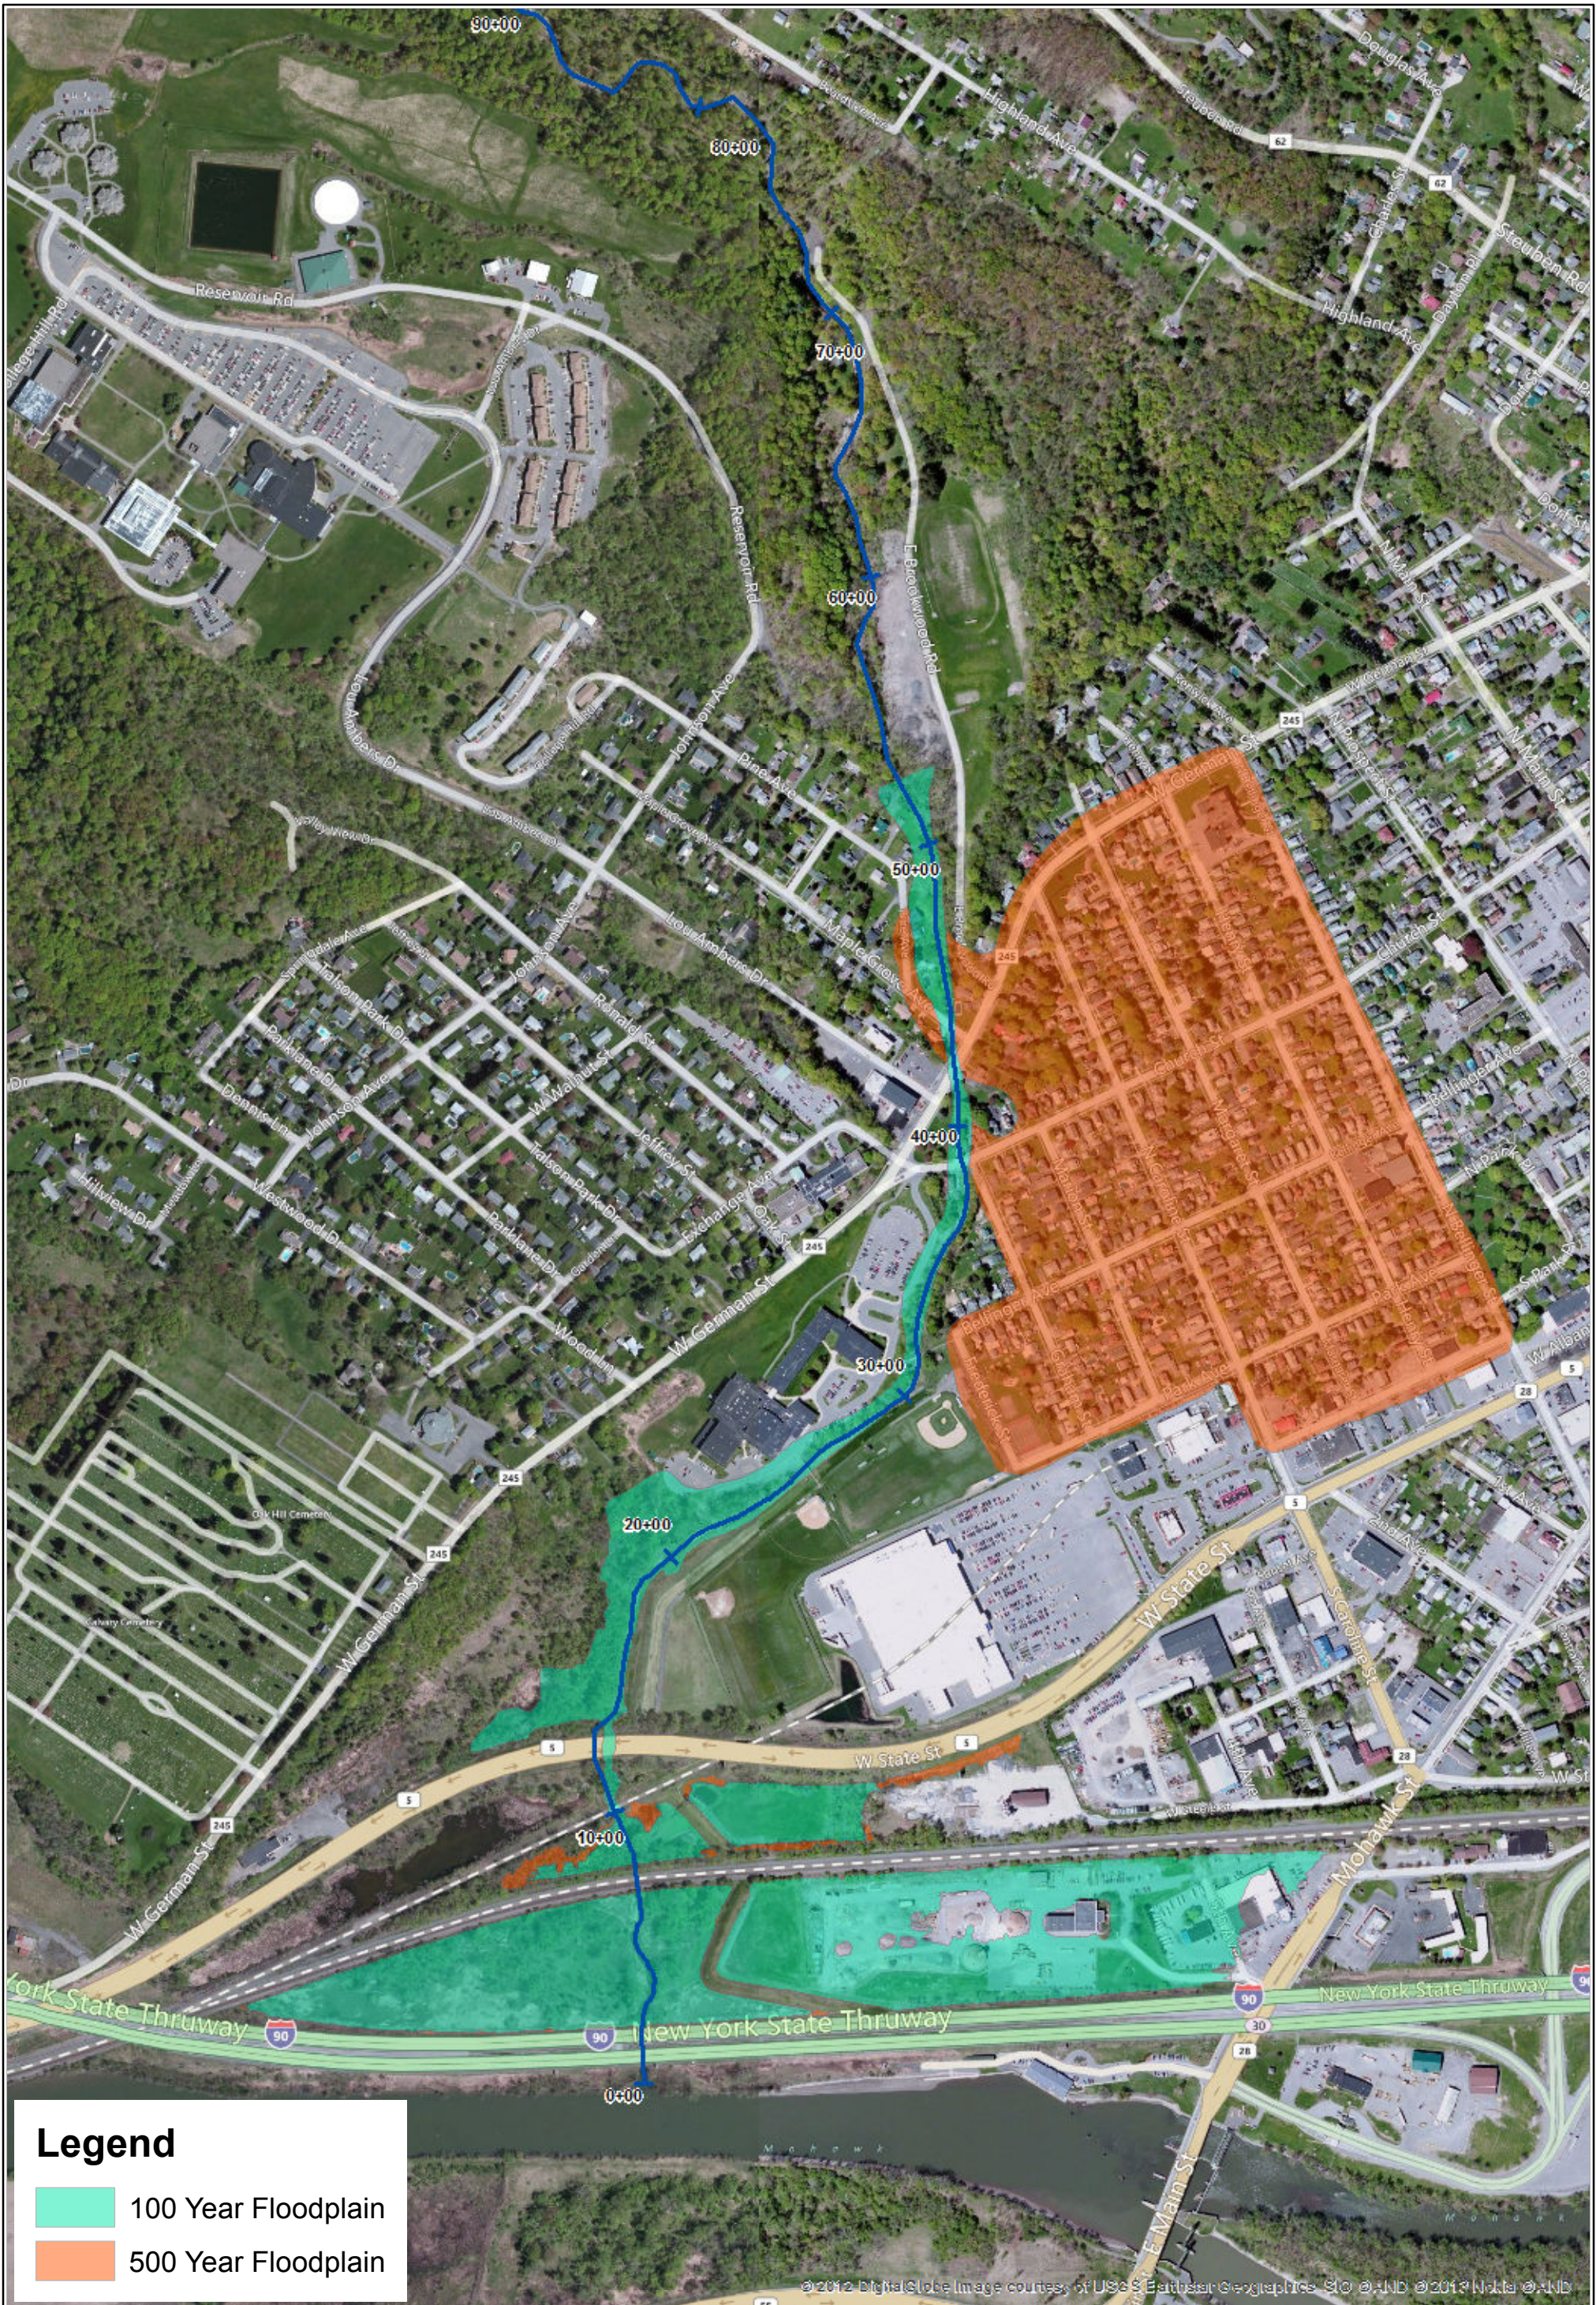
Figure 5: Bellinger Brook FEMA Floodlines

FEMA FIRMs are available for the village of Herkimer but do not include areas outside of the village in the town of Herkimer. FEMA mapping (Figure 5) indicates that during a 500-year frequency event, waters from Bellinger Brook overtop the channel in the vicinity of Maple Grove Avenue and West German Street and flood an extensive area of houses to the east. However, when these bridges become clogged and overtop, this area is at risk of flooding in much lower intensity storm events, as evidenced in the June 2013 event.

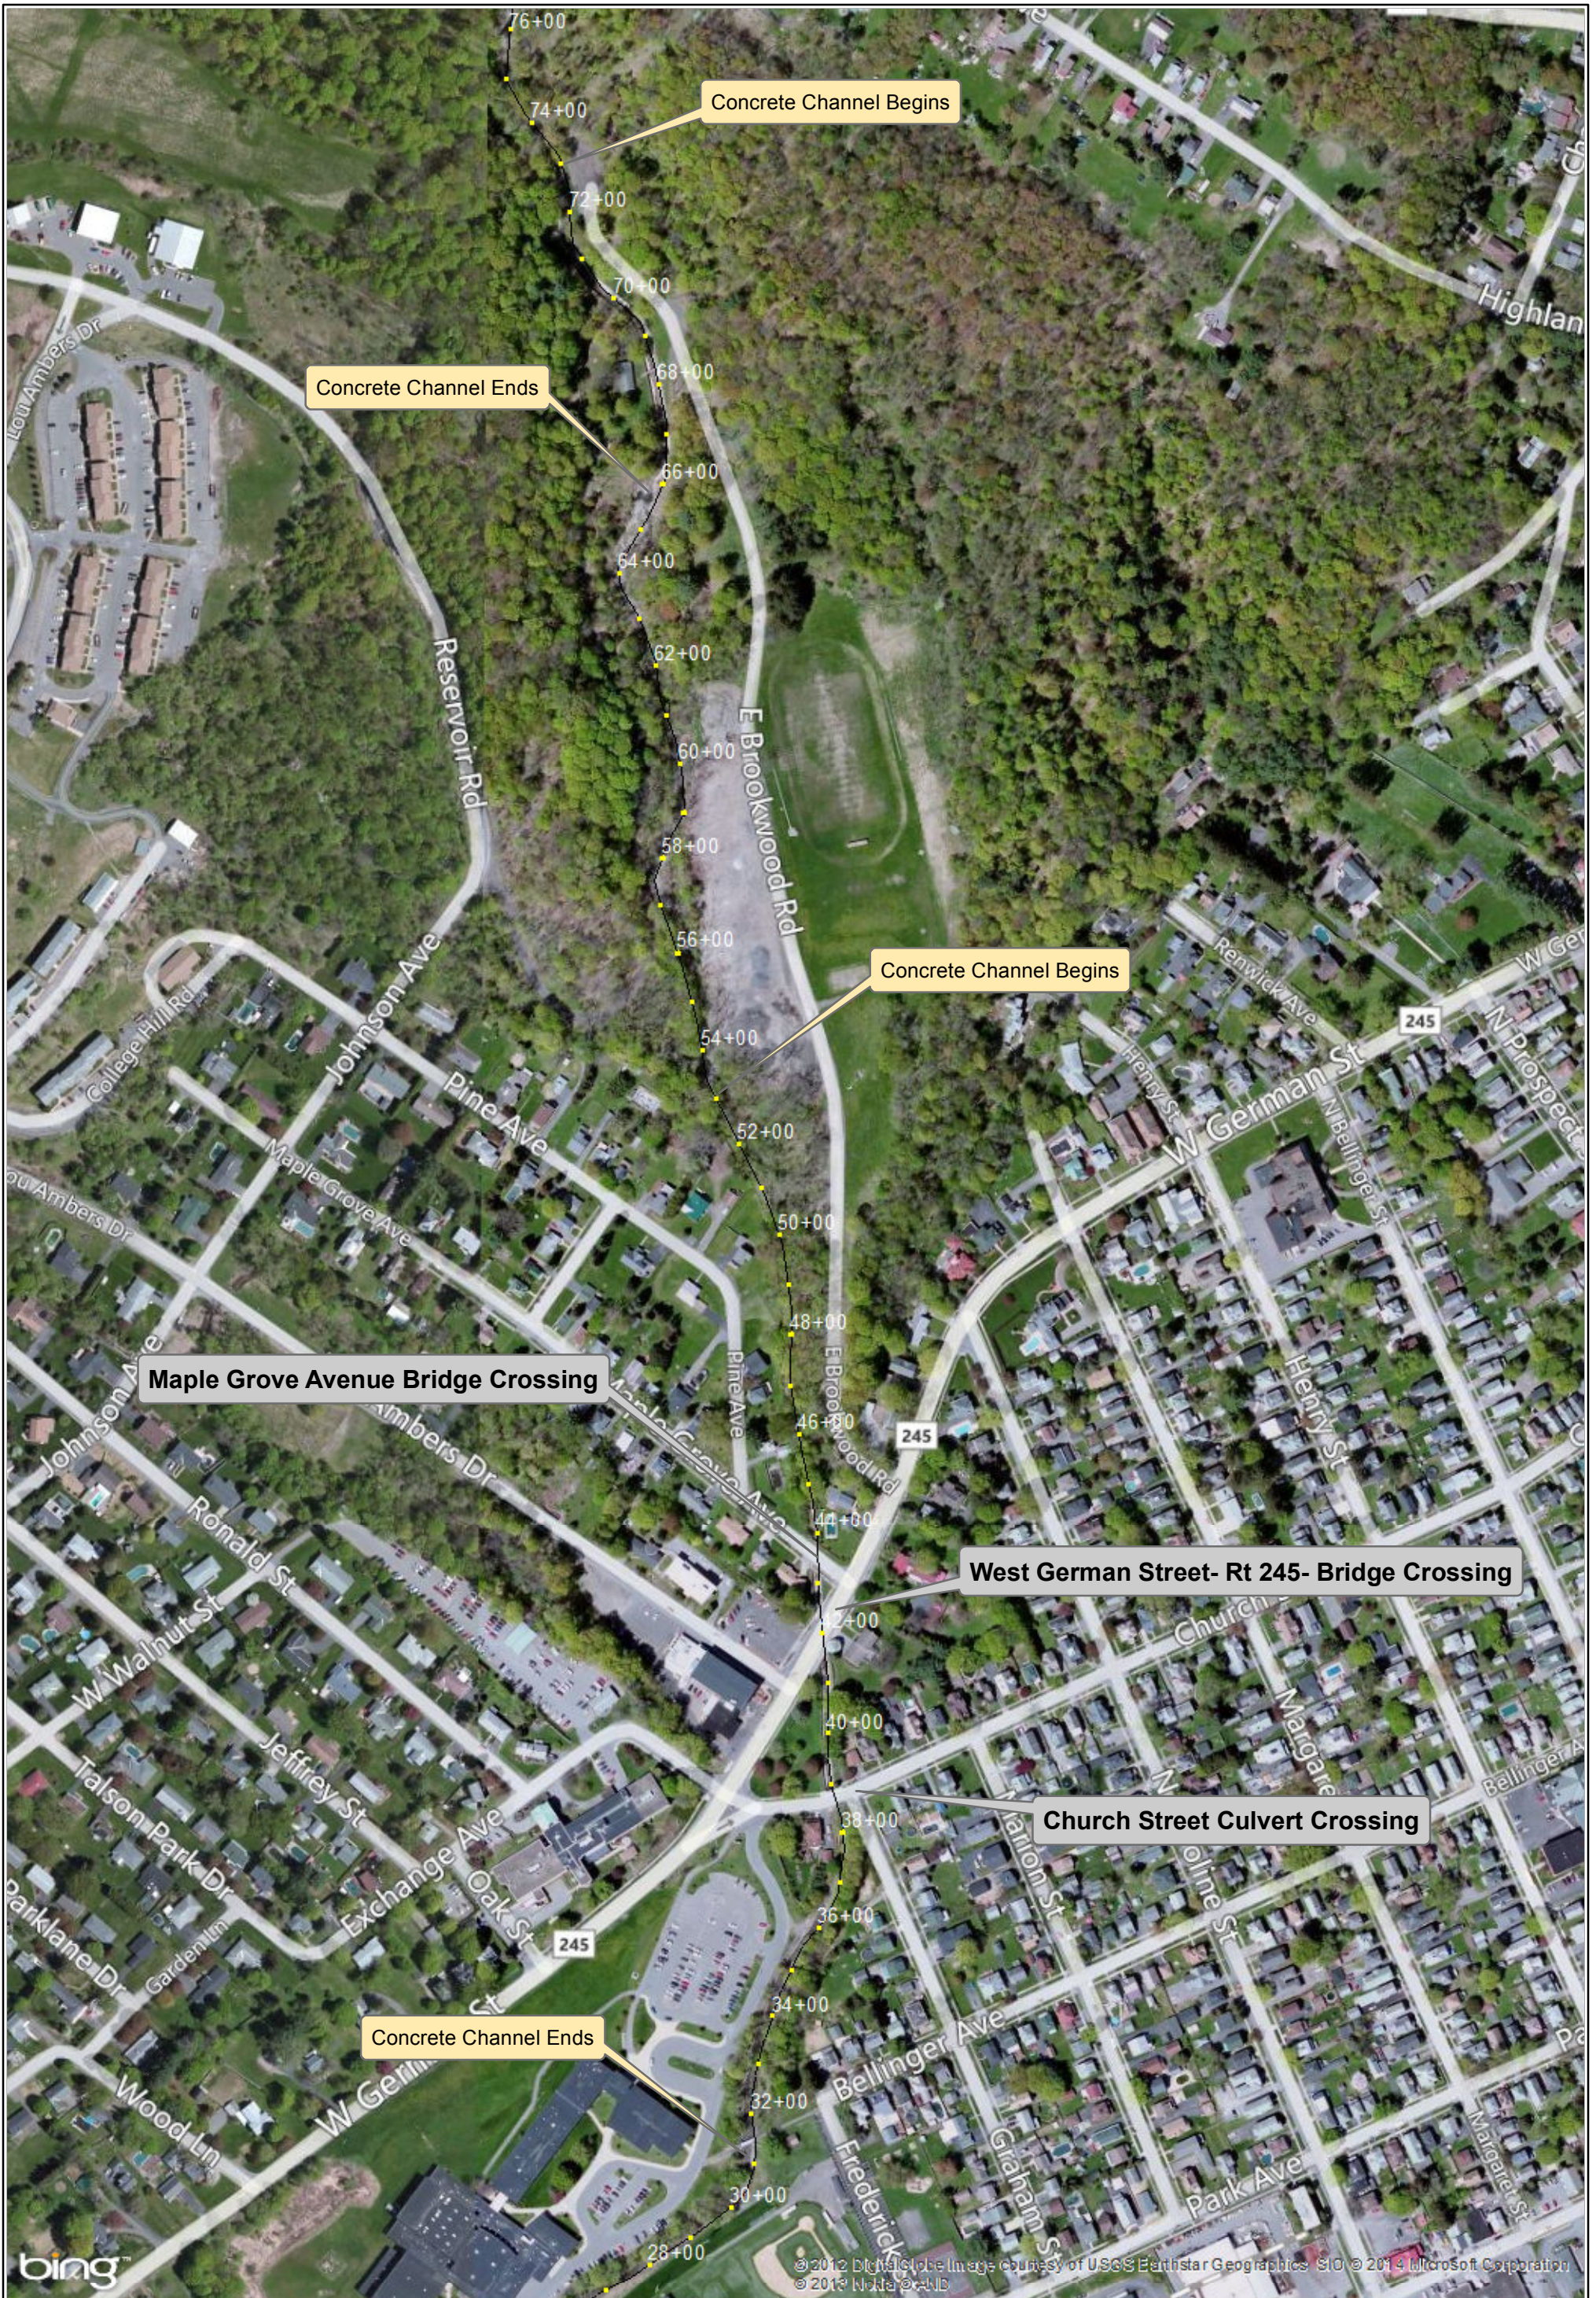
Figure 9: Bellinger Brook High Risk Area #2

Figure 9 is a location plan of High Risk Area #2. This area extends 4,200 linear feet, from STA 73+00 downstream to STA 31+00. Between these stations, Bellinger Brook flows through a channel with a concrete-lined bottom and mortared stone walls along its banks. The channel passes through a residential area where it flows beneath three roadway crossings, all of which have been identified as undersized and act as restrictions to flow during severe flood events.

- Modify the channel to a multi-stage compound channel, including an inner 25-foot wide by two-foot deep bankfull channel with a minimum of 10 feet of floodplain bench on both sides.
- Acquire easements and several high risk residential properties near Maple Grove Avenue, West German Street, and Church Street to accommodate the larger stream corridor.

- Remove the Maple Grove Avenue Bridge and convert the road to a cul-de-sac.
- Replace the West German and Church Street bridges with new 45-foot minimum span bridges.

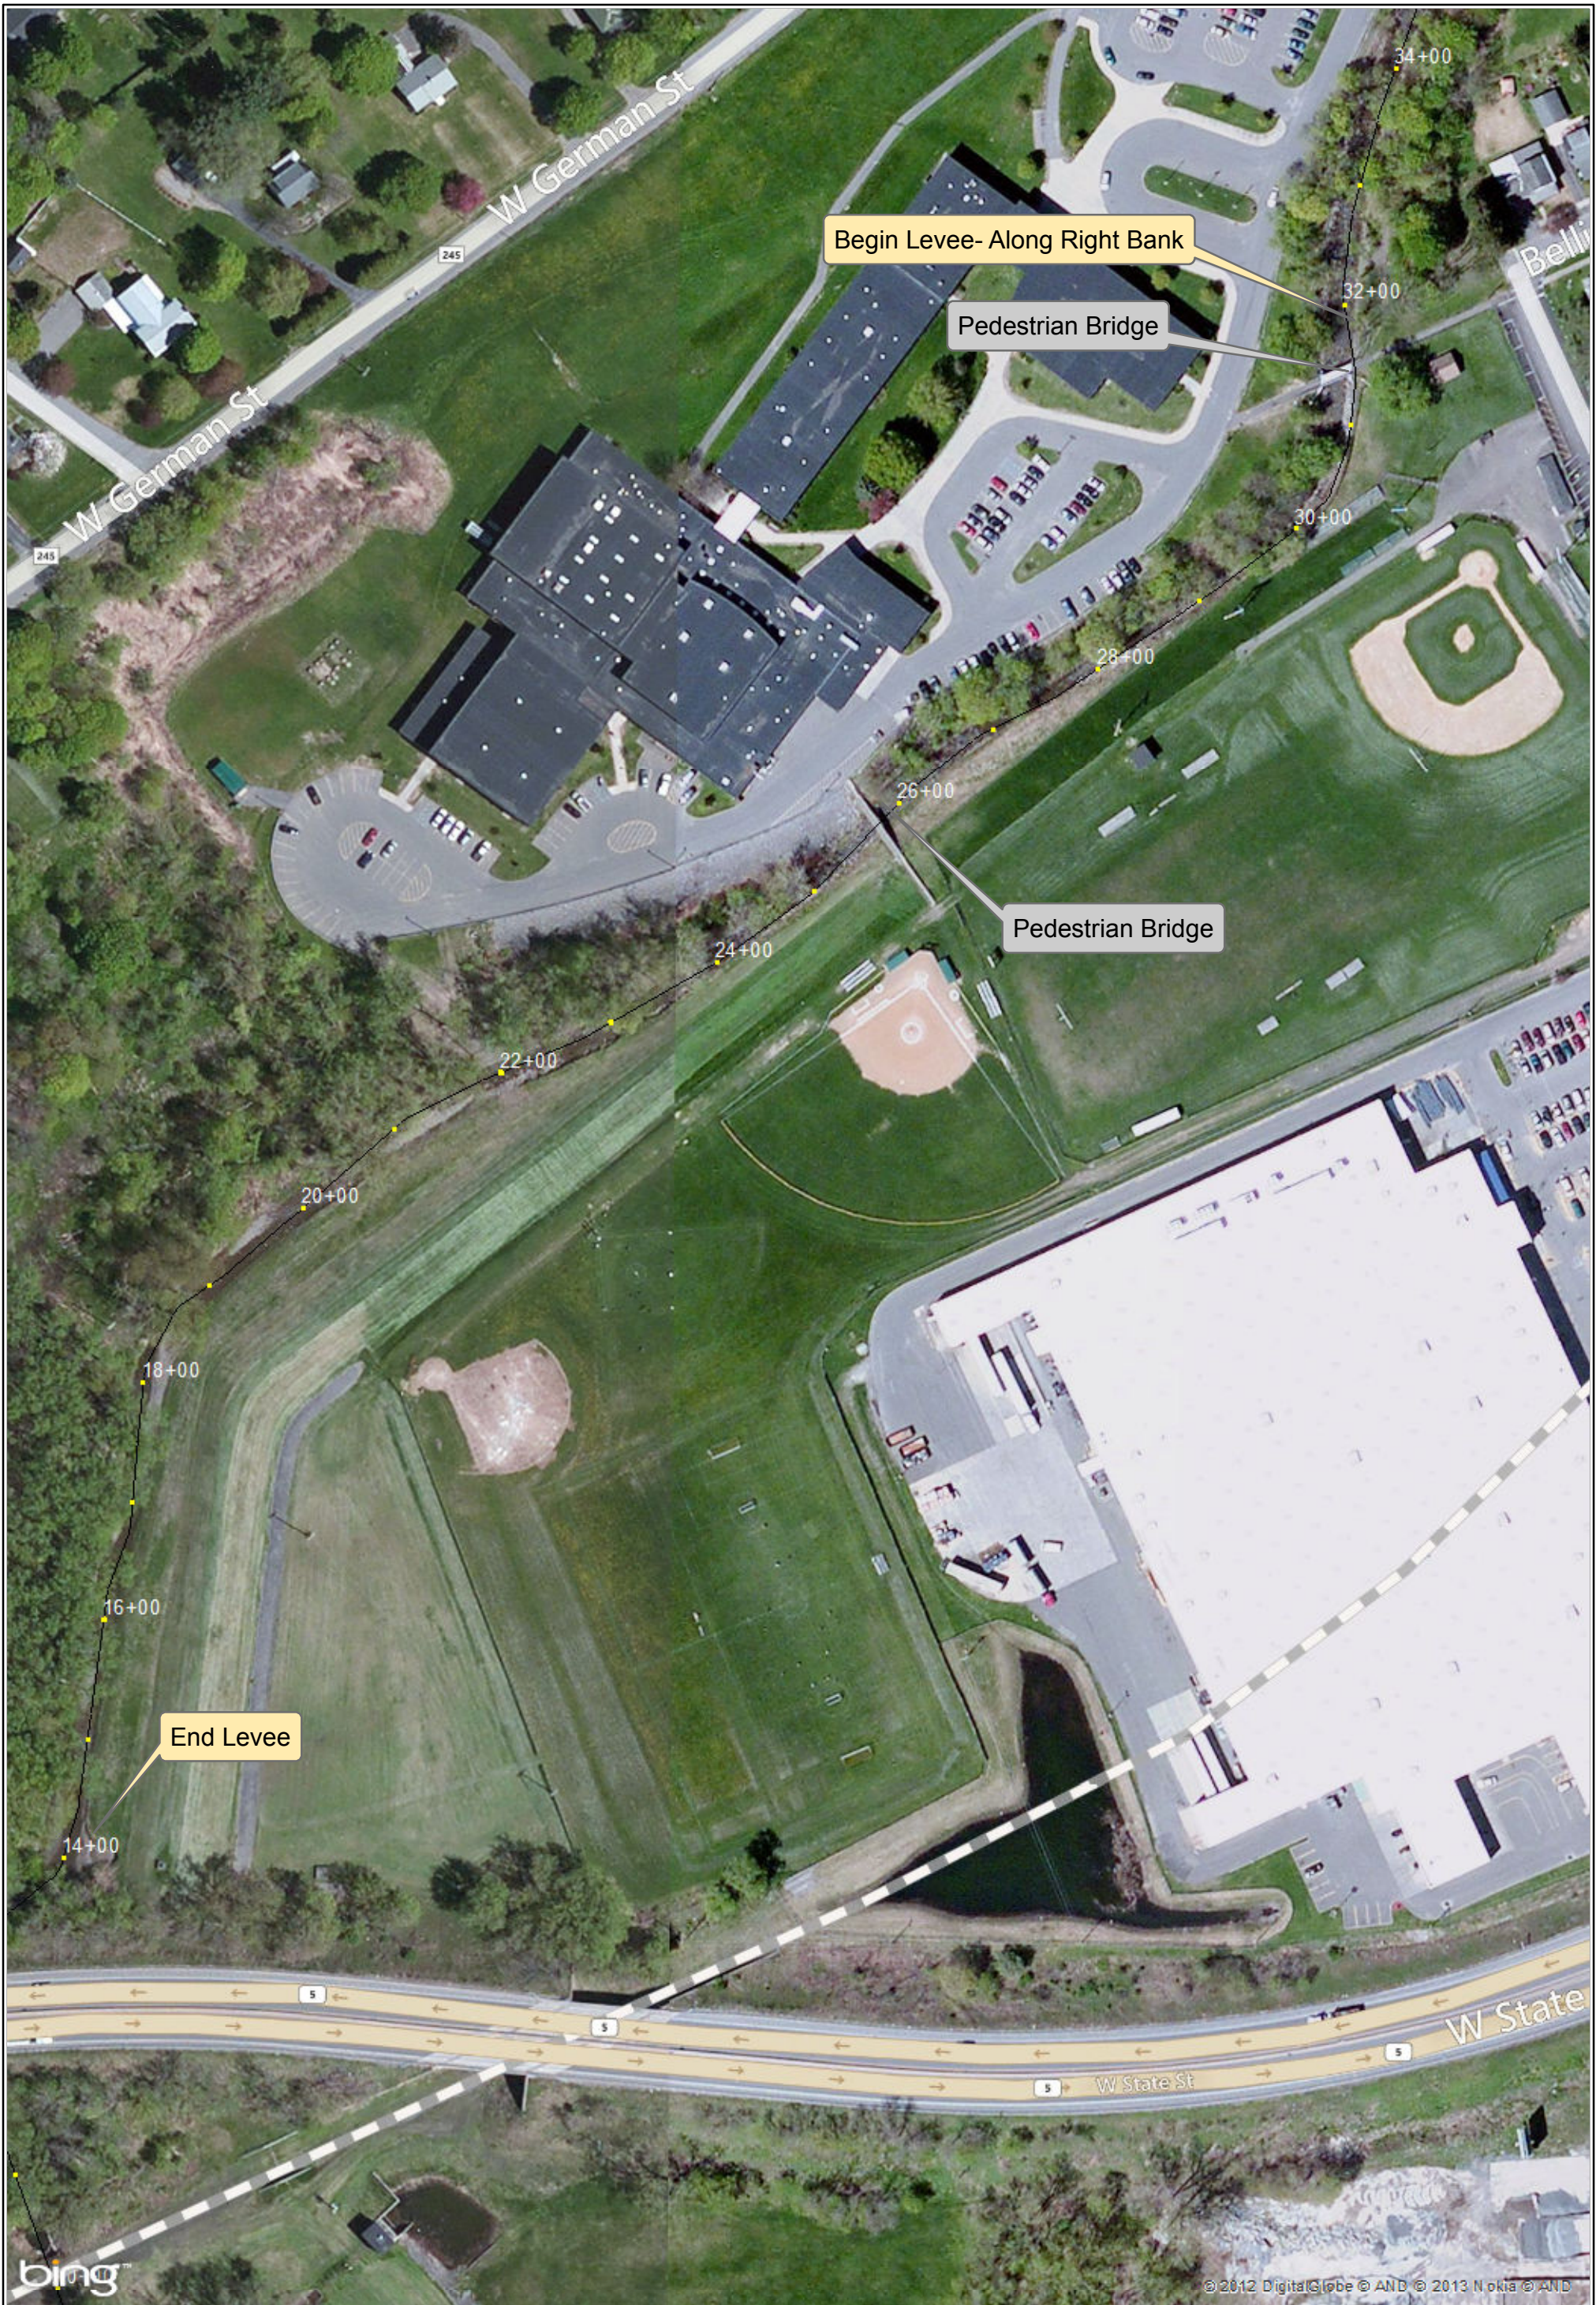
Figure 12: Bellinger Brook High Risk Area #3

Figure 12 is a location plan of High Risk Area #3. Due to the floodplain encroachment associated with the Herkimer Junior/Senior High School and athletic field complex, Bellinger Brook is excessively incised and channelized from STA 36+50 to STA 16+00. It does not have a floodplain. This 1,650-linear-foot reach of channel experiences deep waters flowing at high velocities during flood events, which cause very high shear forces along the channel and bank.

Bellinger Brook is lined on its left bank through this reach by a flood control levee. The levee shows signs of erosion at various points along its length. The brook is spanned by two pedestrian bridges that cross between the high school and the athletic fields, one at STA 31+50 (referred to as Bridge 1) and one at STA 25+75 (referred to as Bridge 2).

- Replace the pedestrian bridge near the Herkimer Junior/Senior High School with a larger structure with one of approximate 60-foot span.
- Repair and armor the levee to stabilize erosion and protect against future erosion.

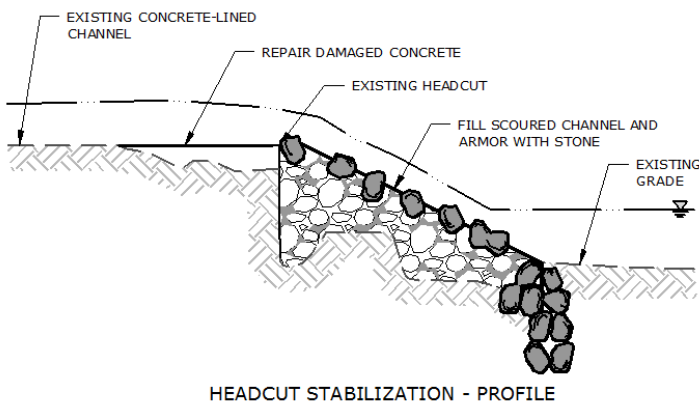
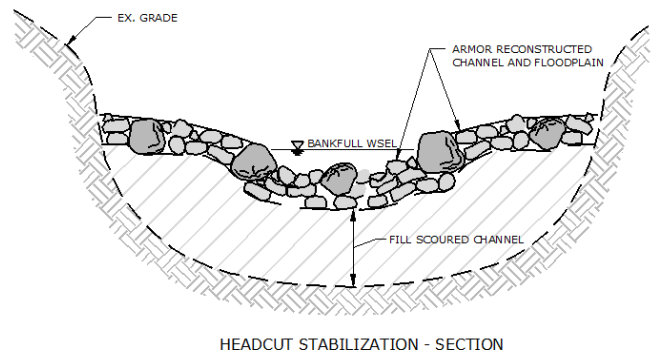
A large erosional headcut has formed in Bellinger Brook and has been arrested in place by a concrete "jack" grade control structure near STA 65+75, just downstream of the Brookwood Park pavilion. The headcut is a point of severe instability, a progressive major source of sediment, and at high risk of becoming more severe if not repaired.

- Place appropriately sized rock fill against the head cut and armor with large stone and/or sheet pile grade control structures.
- Stabilize the deteriorating concrete channel upstream of the grade control structure.
