NEWS from STATE FIRE

NEW YORK STATE
OFFICE OF FIRE PREVENTION & CONTROL
99 Washington Avenue, Suite 500, Albany, NY 12231-0001

STATE FIRE SAFETY ALERT ISSUED TO MUNICIPAL HIGHWAY DEPARTMENTS

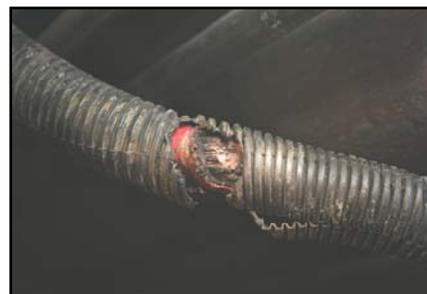
Richard Barlette, Chief of the OFPC Arson Bureau, said the equipment failures in the fires the bureau investigated were caused by electrical short circuiting as a result of worn electrical cable insulation. (See photo at right.) These failures appear to occur where large capacity electrical cables come in contact with the chassis frame or short to the ground. Additional electrical equipment problems have been discovered attributable to missing or improper fusing of installed equipment.
